32-BIT MICROCONTROLLER
MB91F464A/MB91F465K

FUNCTIONAL LIMITATION
CLOCK MODULATOR

2009-07-07

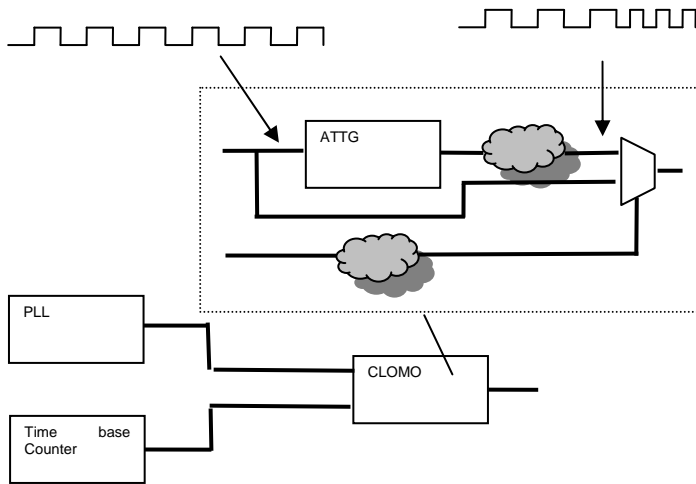
Startup behavior of the clock modulator outside dead band frequency

The clock modulator is switching the output clock from non-modulated clock to modulated clock. This is the correct and expected operation.

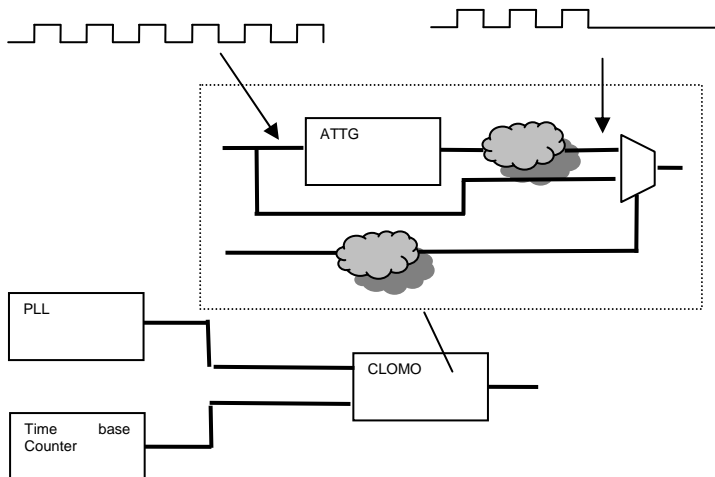
Startup behavior of the clock modulator within dead band frequency

The clock modulator is NOT switching the output clock from non-modulated clock to modulated clock.

A timing analysis on the clock input of the clock modulator showed a slew rate of more than 1200 ps. A comparison with devices without the dead band effect showed a much smaller slew rate at smaller than 500ps.

It is proven that the increased slew rate is causing jitter in the ATTG/DLL part of the clock modulator which leads to an instable calibration causing an invalid signal transition when switching between non-modulated and modulated clock.

- **$F_{in} \leq 48\text{MHz}$: possible to use as input frequency to clock modulation**
- **$F_{in} > 48\text{MHz}$: do not use as input frequency to clock modulation**
