Errata Sheet MB86295 Coral P

Errata List:**Jan., 02 2006**

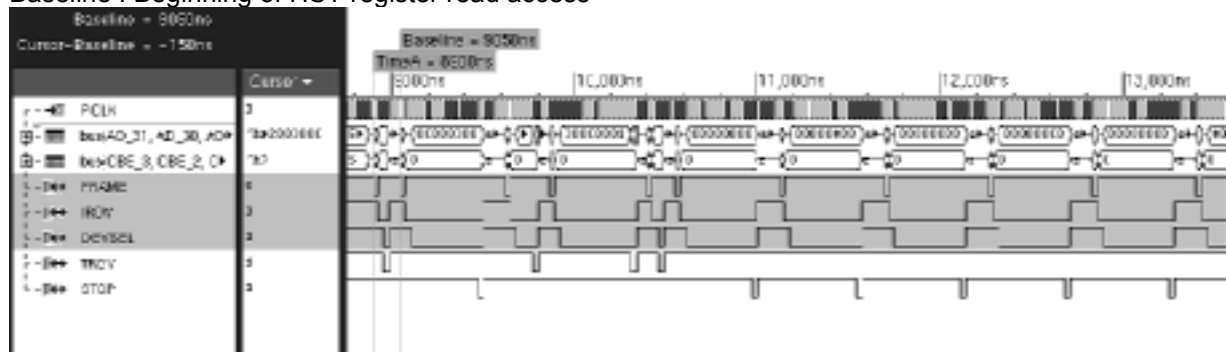
If the CPU accesses the HST register(0x1fc0000-0x1fc00f0) following the VRAM write access as shown in the Figure1, the PCI is hanged up. As the example, while it writes the display list in the VRAM in continuity, the CPU read the IST register by the handler of the interrupt, the the PCI is hanged up.

If the CPU accesses the HST register on the condition that the VRAM write access is waiting internally, the internal state goes wrong.

TimeA : Beginning of VRAM write access
Baseline : Beginning of HST register read access

Read video memory before reading the host register

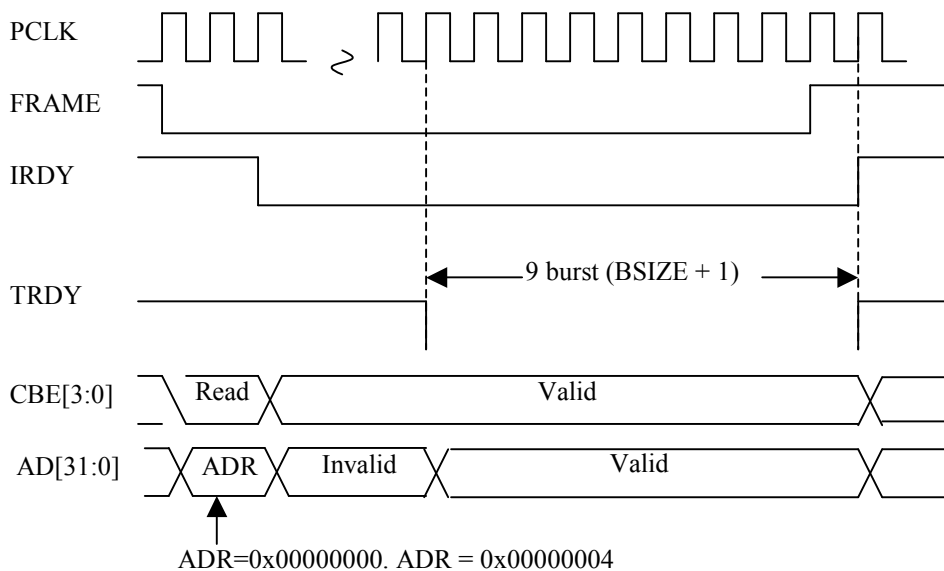
In Coral master read mode, Coral begins to read the previous even address and read the setting of burst size(BSIZE of BCR) plus "1".

Ex. Source address=0x00000004, BSIZE of BCR = 8,

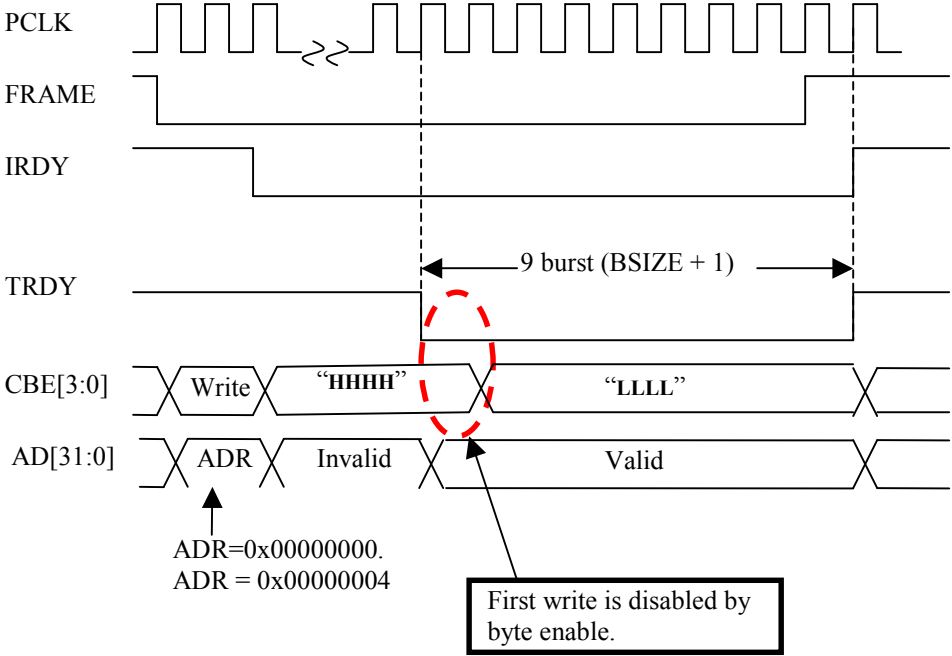
In **Coral master write mode**, Coral begins to write the previous even address with disable write byte enable and write the setting of burst size(BSIZE of BCR) plus "1".

Ex. Source address=0x00000004, BSIZE of BCR = 8,

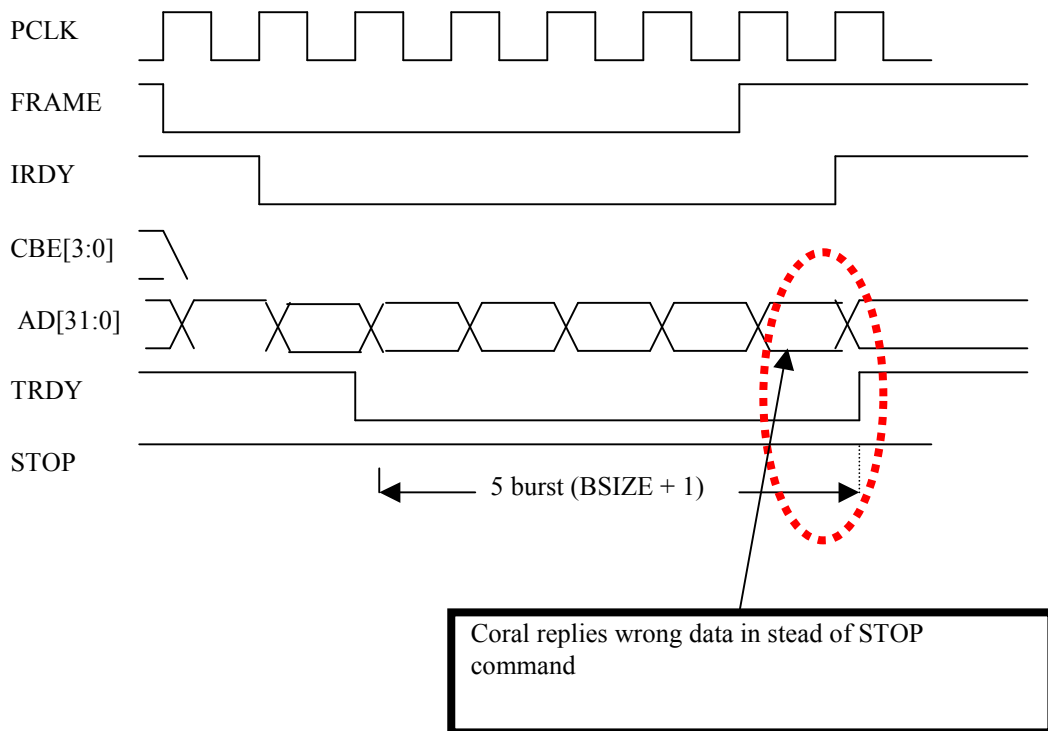
Coral reply the wrong data, if the read burst size comes more than the setting of SRBS.

After stored the data, Coral begins to reply the data by TRDY. But if the burst read comes more than the size of SBRBS, Coral replies the wrong data instead of issuing the STOP.

Ex. BSIZE of BCR = 4, Master issues the **burst read** more than "BSIZE+1" from Coral.

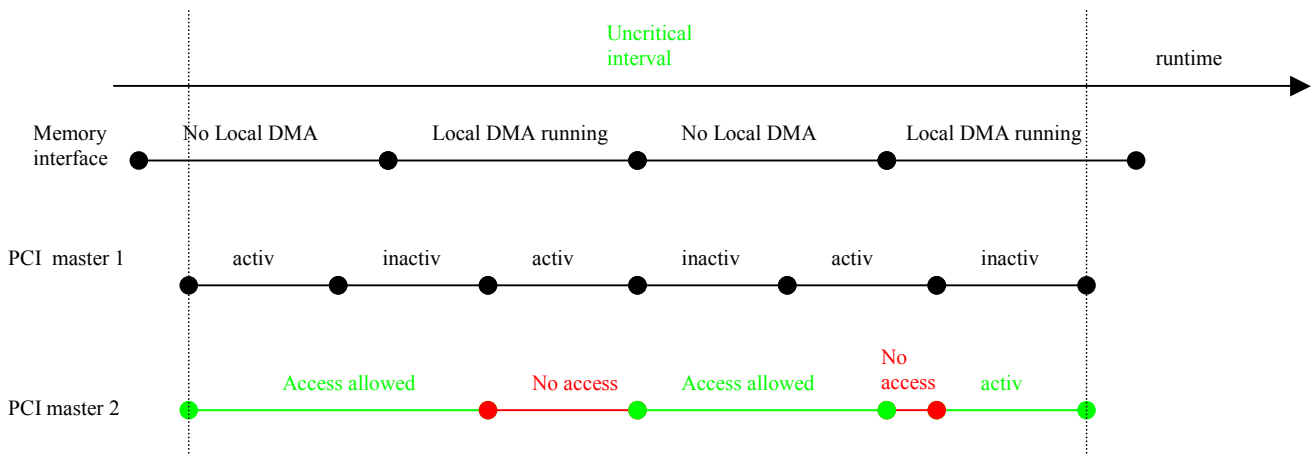
Figure 1 synchronising the access to the Coral

The Coral can fail in case of multi master access and a local DMA are running at the same time.

Because of the two independent data transfer from PCI master-A and B, it happens that write transaction from master-A occurs just after RETRY response of PCI from Coral-PA for the preceding read transaction of master-B. In certain condition of internal timing of Coral-PA among above transaction occurring, the write transaction by Master-A fails as the phenomenon that the data is written to different address intended (wrong address is used for the write transaction). In this problem, the wrong address value was swapped from the series of the data originally intended to store the memory. Therefore, the value of the wrong address is random value in general.

The access to the Coral must be synchronised.

Local DMA and multi master access may not occur at the same time. A single master access during a local DMA is running does not evoke the problem.
