Errata Sheet MB86296 Coral PA

Errata List:**October 28th, 2005**

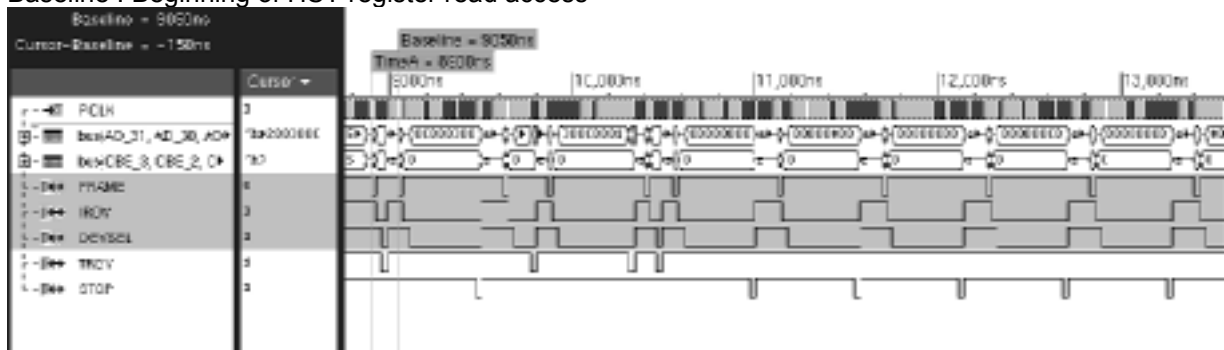
Access to host register area fails after video memory is write accessed (only ES sample)

If the CPU accesses the HST register(0x1fc0000-0x1fc00f0) following the VRAM write access as shown in the Figure1, the PCI is hanged up. As the example, while it writes the display list in the VRAM in continuity, the CPU read the IST register by the handler of the interrupt, the the PCI is hanged up.

If the CPU accesses the HST register on the condition that the VRAM write access is waiting internally, the internal state goes wrong.

this problem occurs only with ES-sample, it will be corrected before mass production

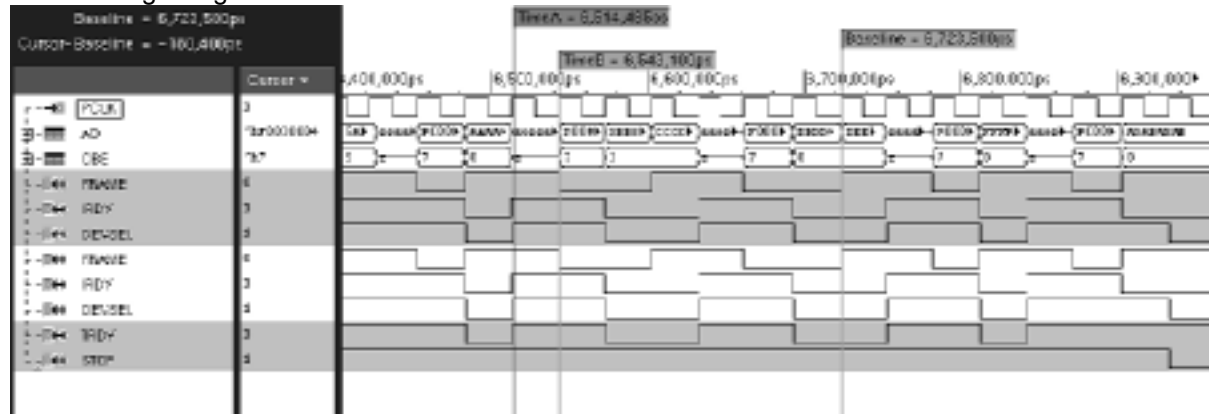
Failed data on 1CLOCK or less of the IDLE phase (only ES sample)

The data is garbled, when the IDLE phase of the write transaction is 1 or less CLOCK cycle (The period between TimeA and TimeB is 1CLOCK cycle as shown the Figure1).

The retrial termination is not performed by asserting the STOP signal by the Baseline clock.

PA : We will modify the logic of PA.

Modifying the logic, Coral-PA will accept 1 clock of the IDLE phase.

But still don't accept 0 clock of the IDLE phase(= This protocol called "fast write to back")

Therefore don't access the Coral-PA in fast write to back protocol.

this problem occurs only with ES-sample, it will be corrected before mass production

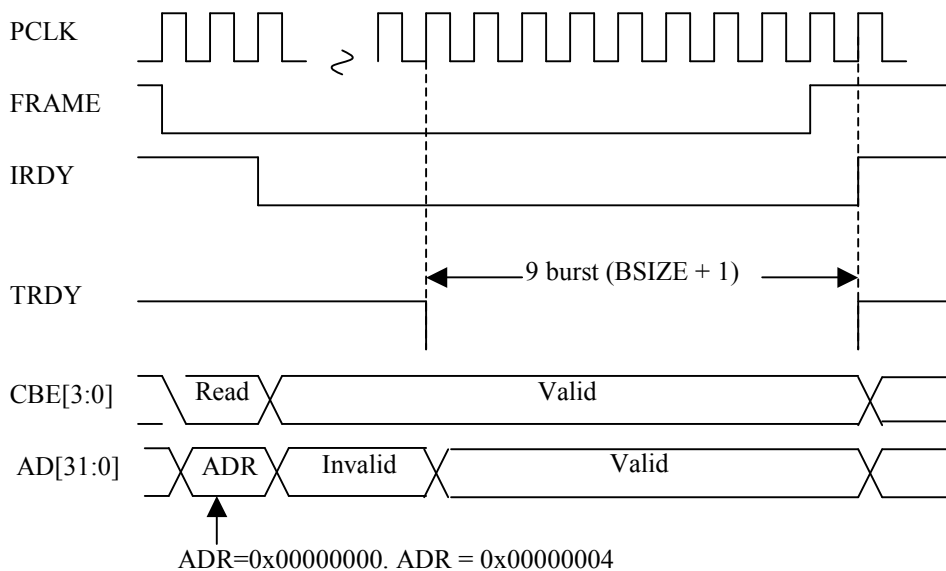
If Coral is the master device and the beginning address is set to the odd address in 64-bit boundary, Coral issue the previous even address.

In Coral master read mode, Coral begins to read the previous even address and read the setting of burst size(BSIZE of BCR) plus "1".

Ex. Source address=0x00000004, BSIZE of BCR = 8,

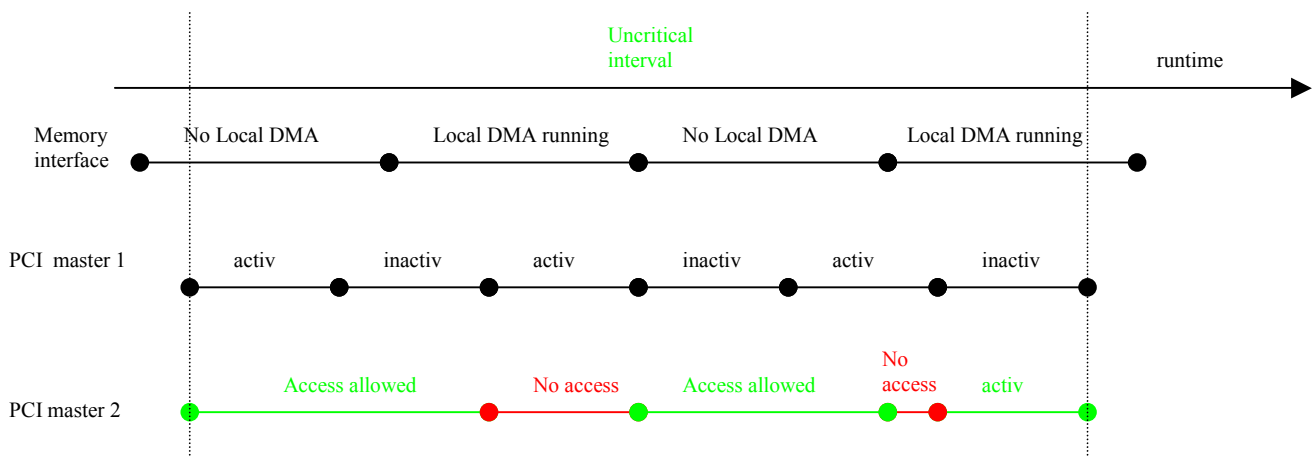
Figure 1 synchronising the access to the Coral

The Coral can fail in case of multi master access and a local DMA are running at the same time.

Because of the two independent data transfer from PCI master-A and B, it happens that write transaction from master-A occurs just after RETRY response of PCI from Coral-PA for the preceding read transaction of master-B. In certain condition of internal timing of Coral-PA among above transaction occurring, the write transaction by Master-A fails as the phenomenon that the data is written to different address intended (wrong address is used for the write transaction). In this problem, the wrong address value was swapped from the series of the data originally intended to store the memory. Therefore, the value of the wrong address is random value in general.

This problem occurs only in case the “Local Display List” transfer is initiated at the same time.

The access to the Coral must be synchronised.

Local DMA and multi master access may not occur at the same time. A single master access during a local DMA is running does not evoke the problem.
