# Errata Sheet MB88F332 Indigo

Errata List:

July 10th, 2009

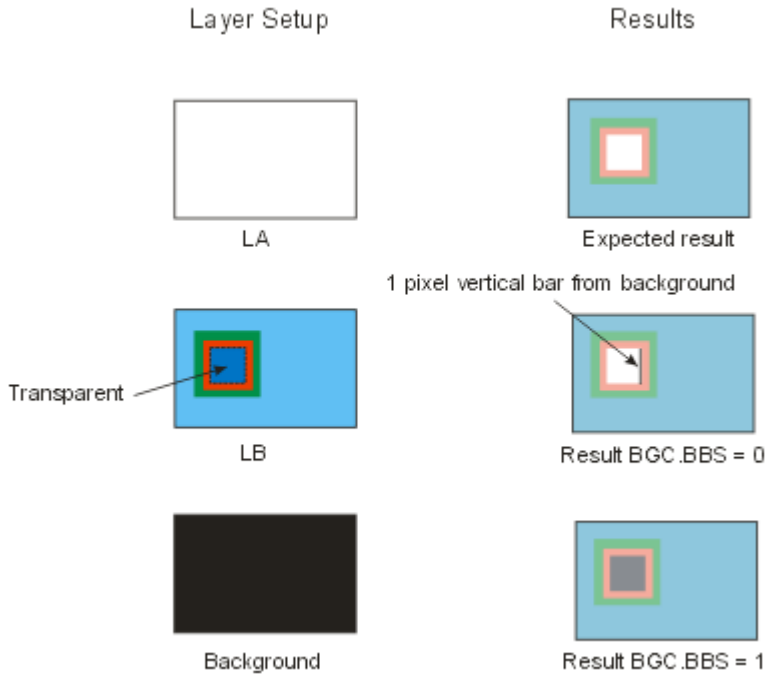
When the Video Display Controller is set up with LA on top of LB with blending in LA [LABLD], and transparency in LB [LBETC], e.g.

(Top)  
LA Layer (white, with alpha blending)  
LB Layer – (with a sprite and using a transparent color)  
Background Layer (black)  
(Bottom)

and background color blending is disabled (Background Color register [BGC], bit BBS=0), the pixels with the transparent color will show a 1-pixel wide bar with the background color on the righthand side. The same occurs if the ordering and roles of LA and LB are exchanged.

There is no workaround for this problem. However, the issue does not occur when background color blending is enabled (Display Background Color register [BGC], bit BBS=1).

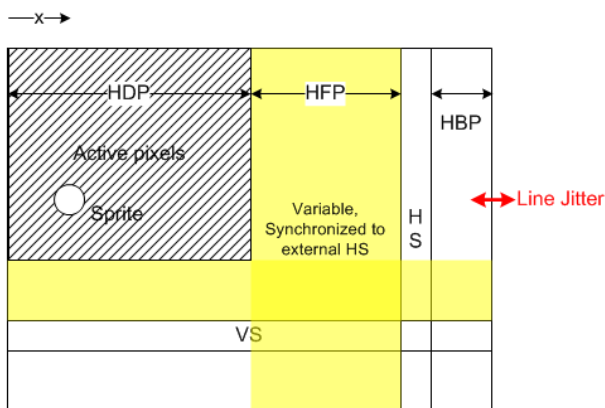
**Current Situation**

Panel output is affected by line jitter if the display controller module is used in the 'external synchronization' mode and the TCON module is simultaneously active (i.e. TCON bypass is disabled). Panel timing parameters such as horizontal back porch show a jitter of +/- 1 pixel clock period. Please note that although the jitter is physically present, it may not be visible if a panel is used that has an internal TCON (or similar logic circuitry). This is because some TCONs are able to compensate the jitter of the incoming H-sync by also evaluating the DE (Data Enable) signal.

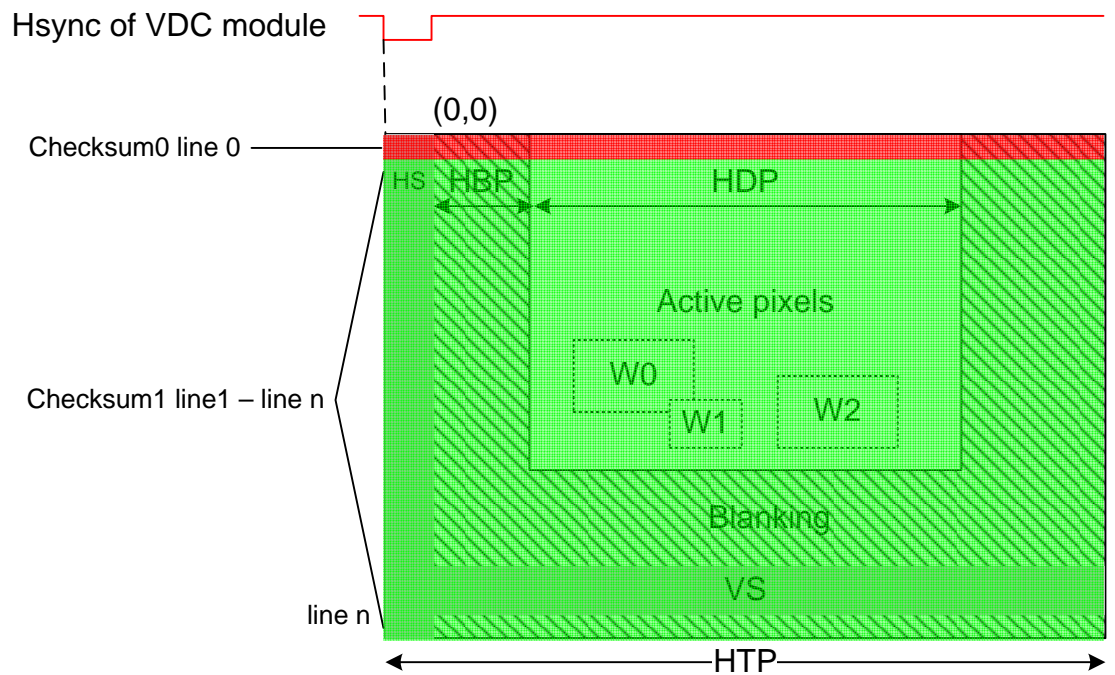
Two checksums (instead of one) are generated per frame; one covering line 0, the other from line 1 to line n (n = content of the display controller Vertical Total Raster register 'VTR' + 1). The result registers show only the result of line 0.  
Consequence: The content of line 1 to n can not be monitored directly by an external microcontroller using the result registers Signature[A|B][R|G|B]W0.

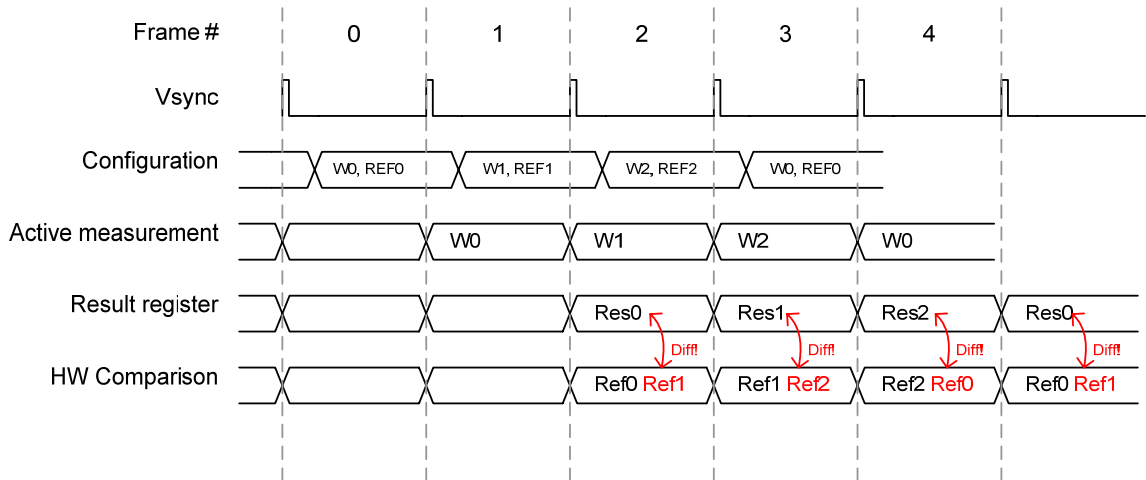
**Figure 1 - Example for cyclic monitoring of 3 windows**

The continuous monitoring of multiple windows with different coordinates is not possible in the way described in the Hardware Manual.

The following diagram shows (in black) the specified behaviour, whereas the red color illustrates the current behavior of the chip.
