# SPARC® Enterprise M4000/M5000 Servers Product Notes

For XCP version 1041

# SPARC Enterprise M4000/M5000 Servers Product Notes

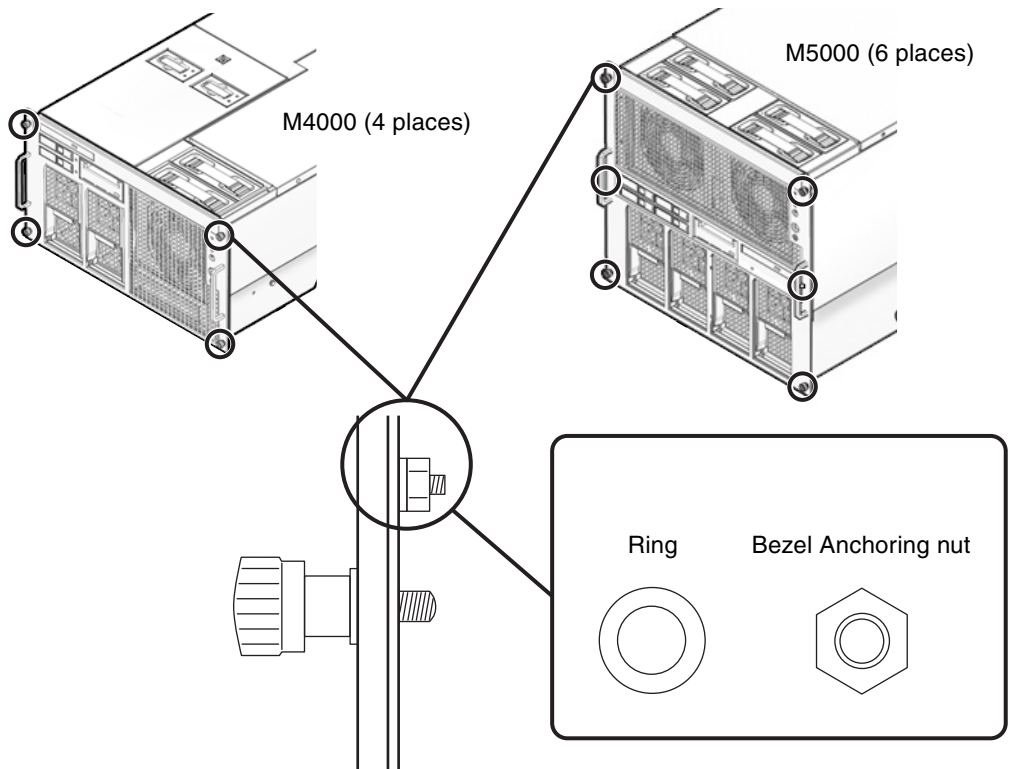
When you mount the SPARC Enterprise M4000 or M5000 server on the 19-inch rack, as you insert it all the way seated in the rack, the nut anchoring the bezel may interfere with the rack column and the server may fail to be seated correctly.

## 1. Remove the interfering bezel anchoring nut and ring.

In such a case, please replace the bezel anchoring nut and ring with the E-Ring.
