SPARC® Enterprise M4000/M5000 Servers Product Notes

For XCP version 1060

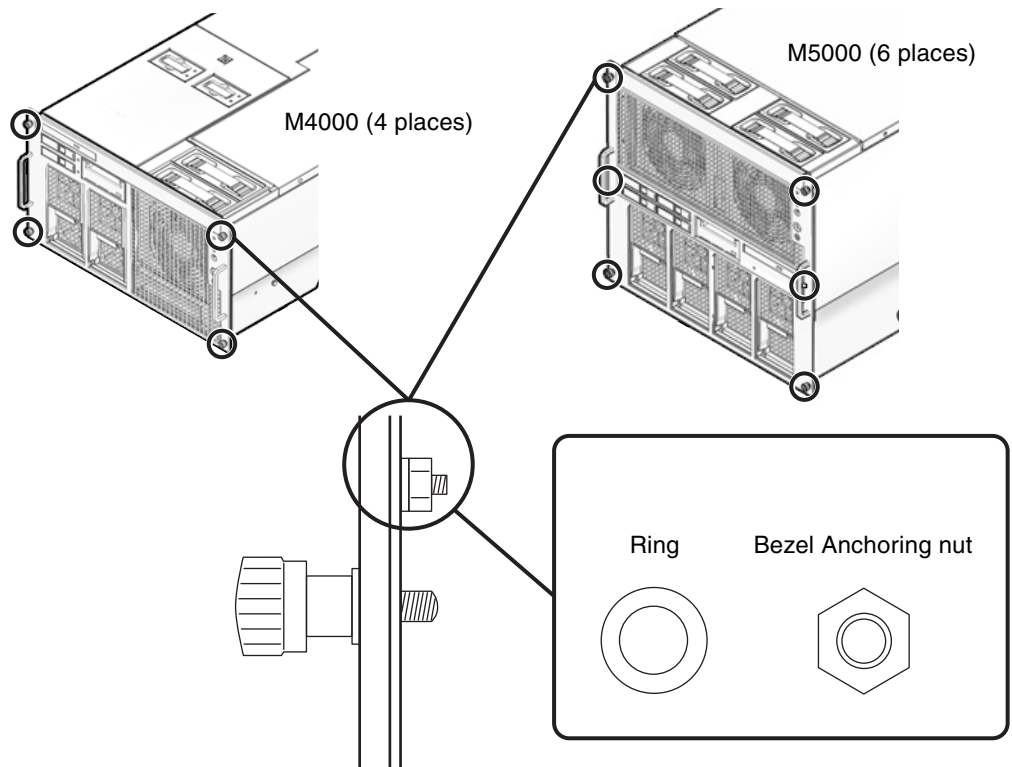
When you mount the SPARC Enterprise M4000 or M5000 server in the equipment rack, as you insert it all the way seated in the rack, the nut anchoring the bezel may interfere with the rack column and the server may fail to be seated correctly.

In such a case, please replace the bezel anchoring nut and ring with the E-Ring.

1. Remove the interfering bezel anchoring nut and ring.
