# SPARC® Enterprise M4000/M5000 Servers Product Notes

For XCP version 1061

# SPARC Enterprise M4000/M5000 Servers Product Notes

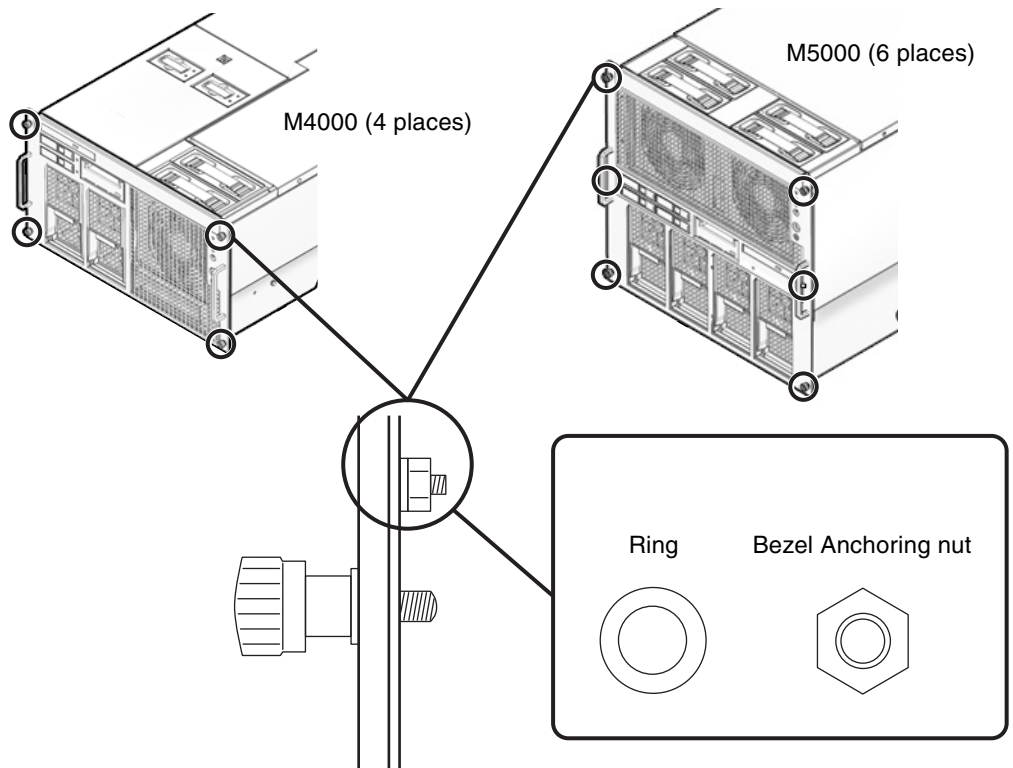
When you mount the SPARC Enterprise M4000 or M5000 server in the equipment rack, as you insert it all the way seated in the rack, the nut anchoring the bezel may interfere with the rack column and the server may fail to be seated correctly.

In such a case, please replace the bezel anchoring nut and ring with the E-Ring.

## 1. Remove the interfering bezel anchoring nut and ring.
