PRIMERGY CUSTOMER INFORMATION BULLETIN

PY-CIB050-00

Performance Might be Decreased with BIOS R1.29.0 or Newer

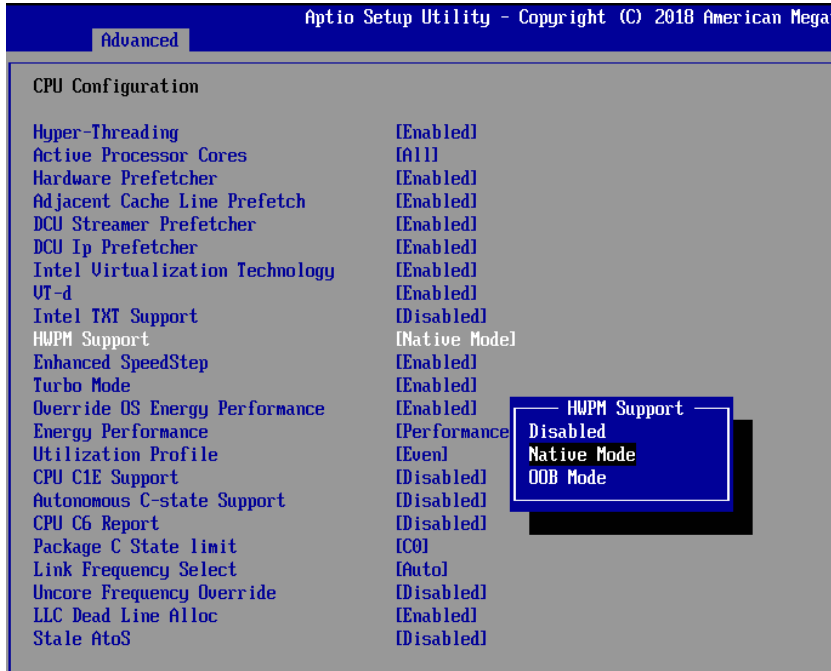
HWPM Support Options before R1.29.0:

Default value is “Native Mode”.

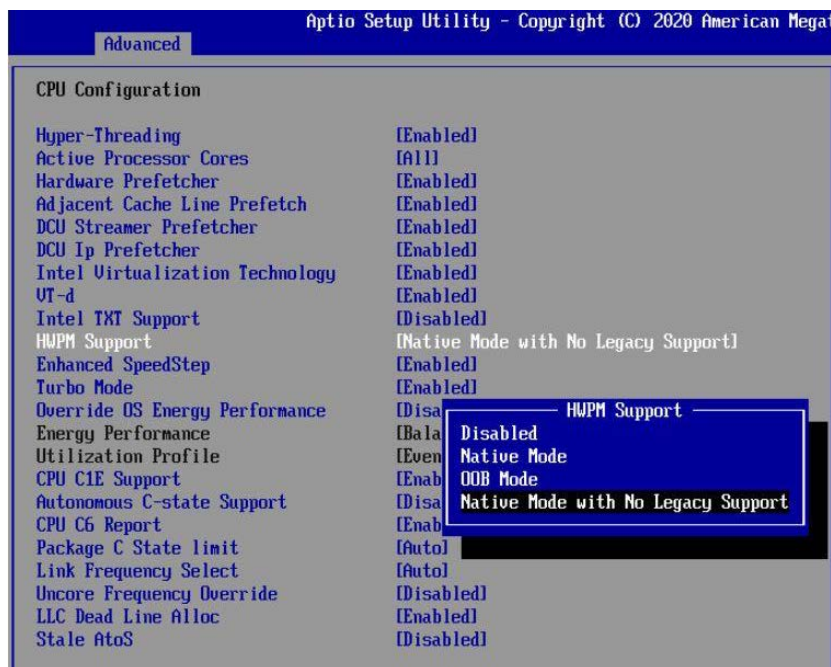
HWPM Support Options with R1.29.0 or newer:

With BIOS R1.29.0, a new option for Hardware Power Management (HWPM) in CPU Configuration under the Advanced menu in BIOS was introduced. The current value will be overwritten with the new value ("Native Mode with No Legacy Support").

Default value is “Native Mode with No Legacy Support”.

The new default setting might decrease the system performance significantly depending on the Operating System used.

For Windows Server 2016, 2019, RHEL 7.6 or newer, “Native Mode with No Legacy Support” is the optimal setting. We recommend to check and correct the setting to “Native Mode” in case you are using VMware, Windows Server 2012 R2, or older Linux distribution (for example RHEL 7.4).
