## VRS 4.1 for Fujitsu scanner (PFU OEM Bundle) Service Pack 1 Notes.

## **2. Contents of modified malfunctions**

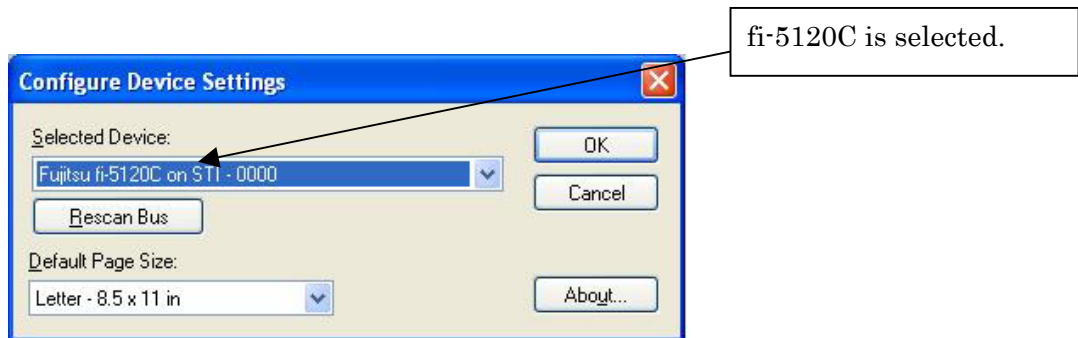
(Figure 2-1-2)

3) The "Configure Device Setting" window of ISIS driver is displayed.

Since the device is fi-5120C, you need to reselected fi-5220C from menu.

Applying the SP1 update makes the connection easier and smooth by not displaying the ISIS driver device selection window (Figure2-1-2) but by selecting the fi-5220C automatically.

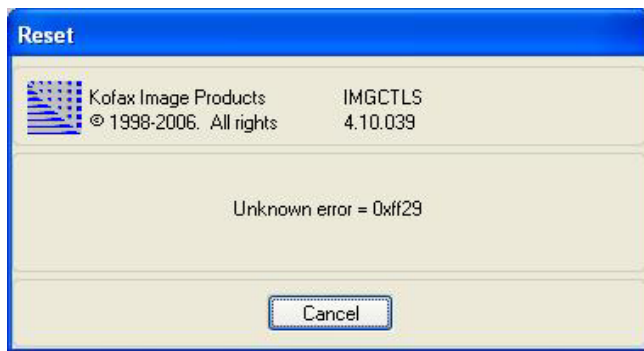
(Figure 2-1-4)

- 4) At the Figure2-1-2 as well as the Figure2-1-3, The Figure2-1-4 is displayed when selecting fi-5120C, and as a result fi-5220C is failed to correctly connected.

- 5) Once the above Figure2-1-4 occurs, the following operation is required.  
(The Figure2-1-2 is no longer displayed, and the error of the Figure2-1-4 always appears)

5-1) From the [Start] menu of the windows, run the [Scanner Configuration Utility].  
(Start -> Kofax VRS -> Scanner Configuration Utility)

5-2) Select fi-5220C, and then click the [Set as Default] button. No changes can be visible on the screen, but the Figure2-1-2 becomes to be displayed again.

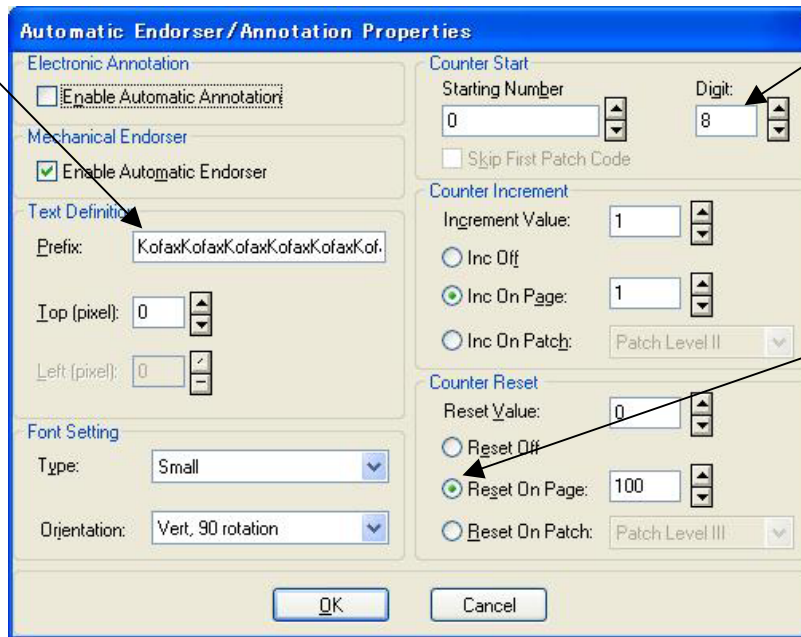
- 1) Select [Automatic Endorser / Annotation Properties] from the [Imaging] tag of the VCDEMO
- 2) Enable the “Counter Reset” mode and configure imprinter settings of 35 character strings + Counter eight(8)digits, then run the scanning.

3) When the total number of character strings + Counter digit exceeds 40 with the “Counter Reset” mode, its imprinting does not take place.

Applying the SP1 upgrade enables you to imprint up 43 character strings (the total number of character strings + Counter digit) even with the “Counter Reset” mode.

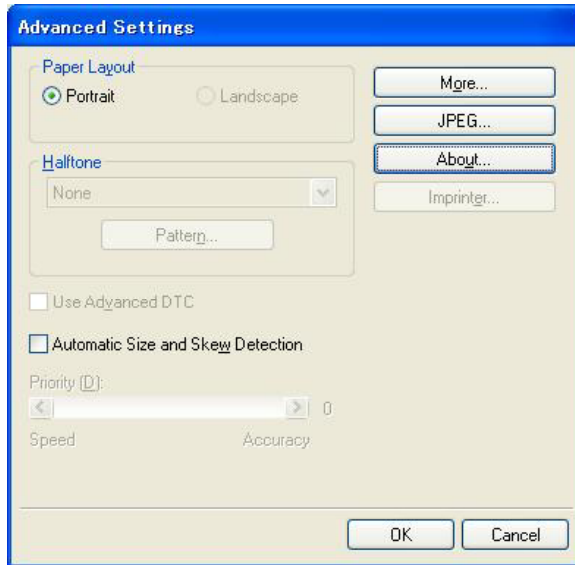
Installing fi-5530C ISIS driver after having installed fi-5120C ISIS driver, and then performing scanning via fi-5530C, the ISIS driver setting window is displayed in English

Applying the SP1 updates makes the driver window display in Japanese.

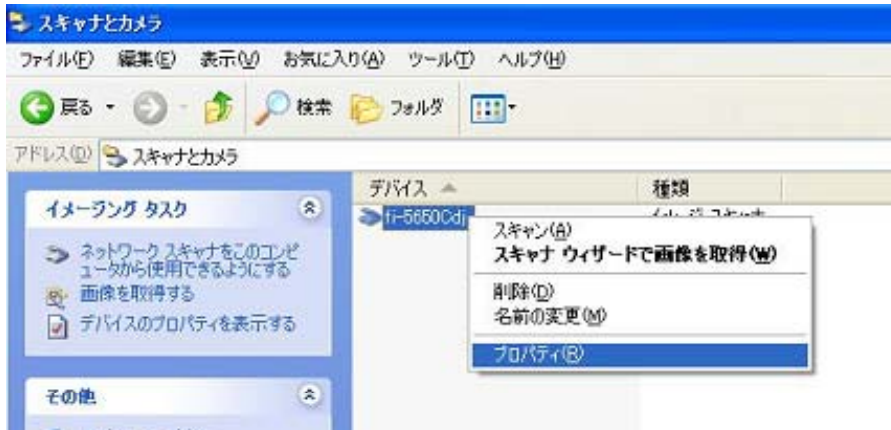
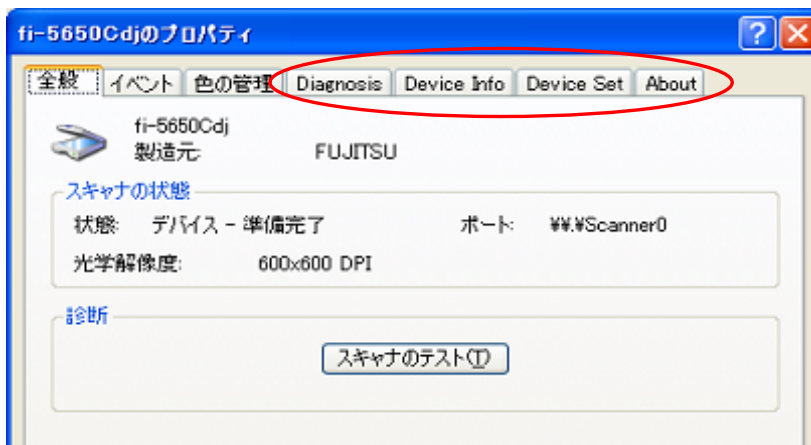
When confirming the property at “Scanner and Camera” having been fi-5650C connected, the property is partially displayed in English.

Applying the SP1 update makes the property display correctly in Japanese.

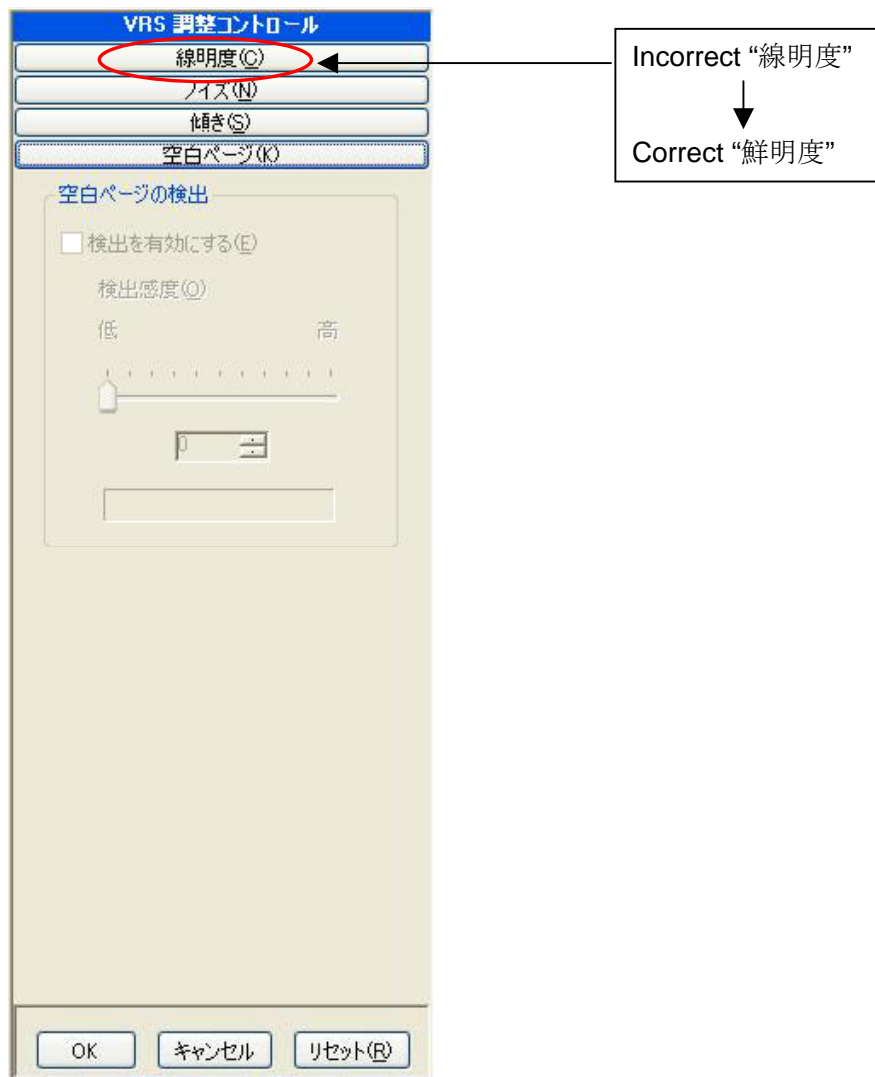
At the VRS adjustment control window, the Chinese character of “brightness” is incorrect.

Applying the SP1 update makes the driver window display in the correct Chinese characters.
