SPARC Enterprise™ M4000/M5000 Servers Product Notes

For XCP Version 1082

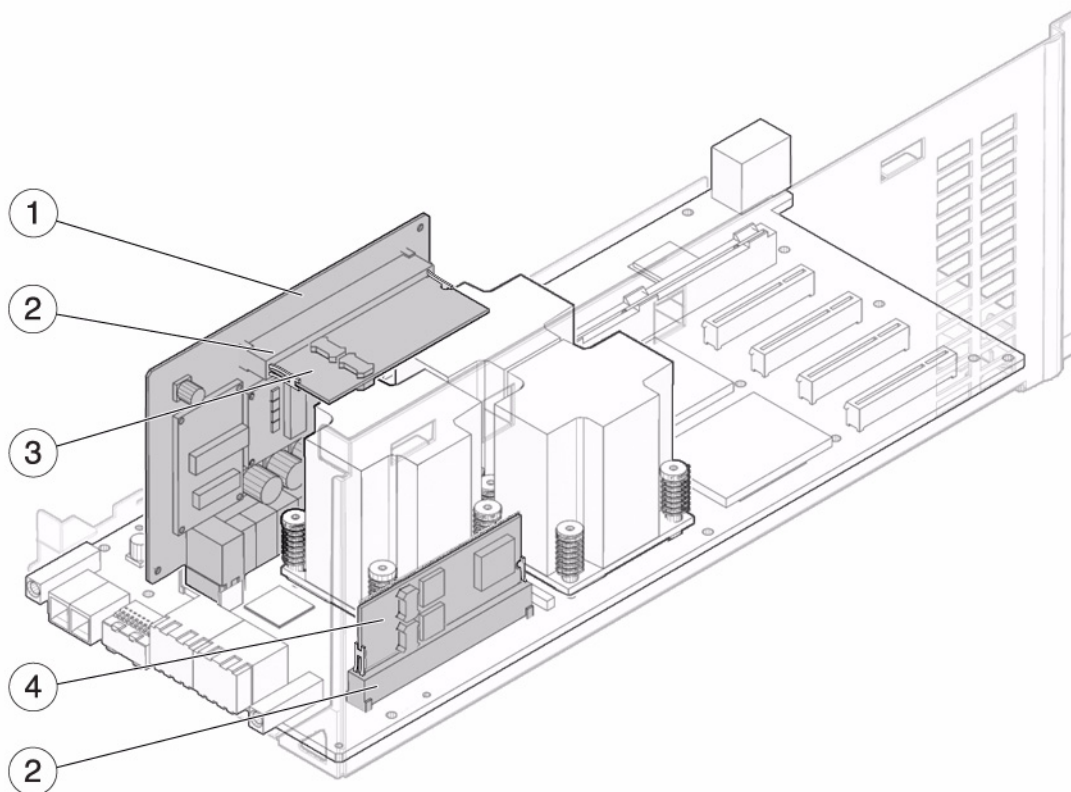
FIGURE 8-7 I/O Unit DC-DC Converter, DC-DC Converter Retainer, and DC-DC Converter Riser Location

This is to correct the description in Section 8.4, "I/O Unit DC-DC Converter Replacement" on page 8-14.

The DC-DC converters are cold replacement components. This means the entire server must be powered off and the power cords disconnected to replace a DC-DC converter on the I/O unit.

Caution – The DC-DC converter (DDC_B#0) that goes in the slot on the DC-DC Converter Riser has a metal heat sink. The DC-DC converter (DDC_A#0) that goes in the slot on the I/O board does not. If these converters are installed in the wrong slots, serious damage to the I/O unit will result.
