# SPARC® Enterprise M4000/M5000 Servers Product Notes

For XCP version 1040

# SPARC Enterprise M4000/M5000 Servers Product Notes

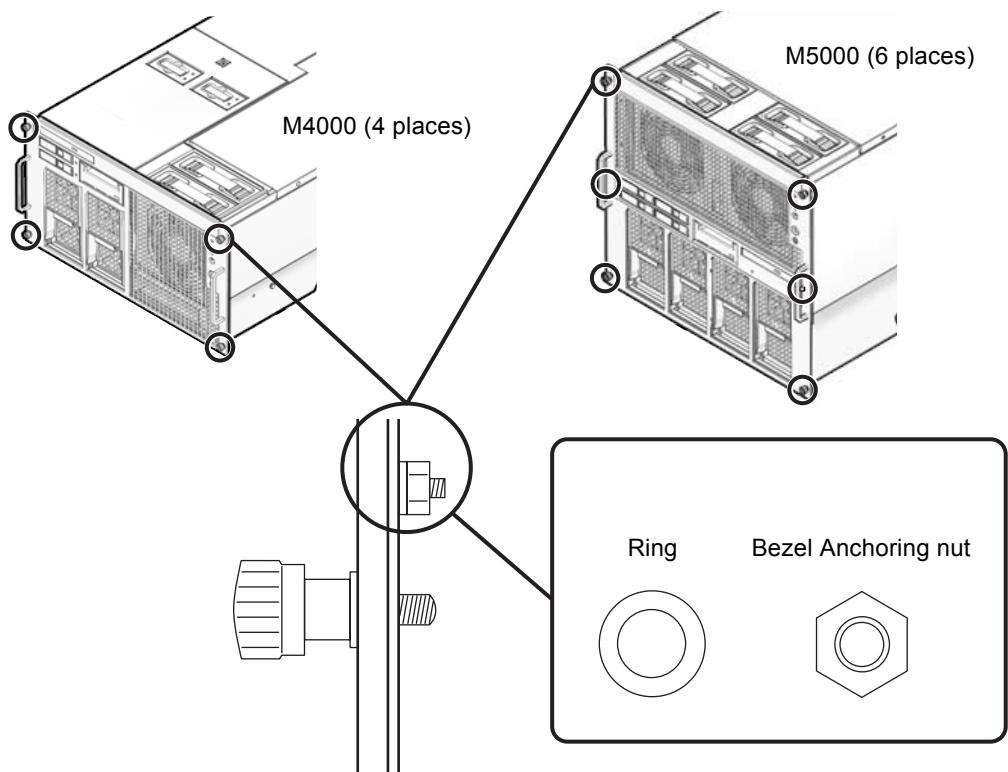
### 1. Remove the interfering bezel anchoring nut and ring.

When you mount the SPARC Enterprise M4000 or M5000 server on the 19-inch rack, as you insert it all the way seated in the rack, the nut anchoring the bezel may interfere with the rack column and the server may fail to be seated correctly.

In such a case, please replace the bezel anchoring nut and ring with the E-Ring.
