SPARC Enterprise M3000/M4000/M5000/ M8000/M9000 Servers

Product Notes for XCP Version 1113

Manual Code: C120-E688-02EN
October 2012, Revision A

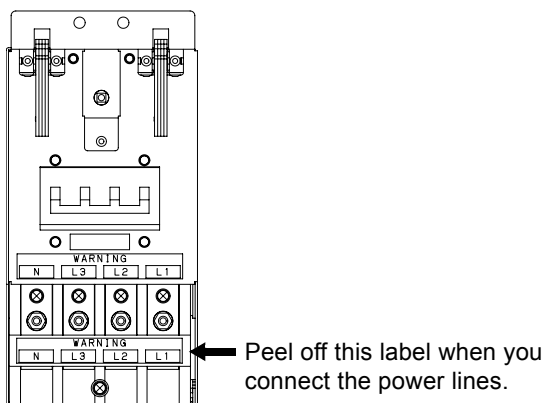
FIGURE 6-1 AC Section with Warning Label

The warning label on the AC section indicates that the terminal connection sequence has been changed. Connect in accordance with the terminal sequence described on the warning label.
