# **SPARC Enterprise M3000/M4000/M5000/ M8000/M9000 Servers**

Product Notes for XCP Version 1116

Manual Code: C120-E705-01EN  
August 2013, Revision A

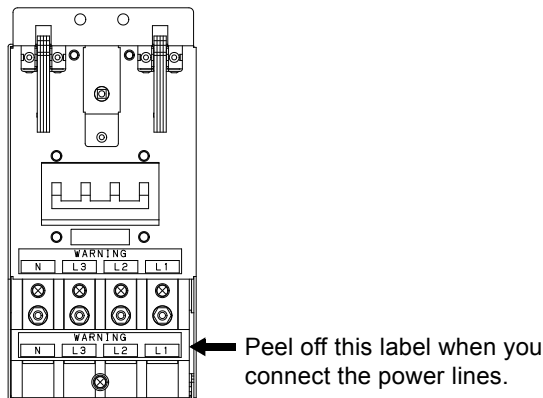
**FIGURE 6-1** AC Section with Warning Label

The warning label on the AC section indicates that the terminal connection sequence has been changed. Connect in accordance with the terminal sequence described on the warning label.
