SPARC® Enterprise M4000/M5000 Servers Product Notes

For XCP version 1071

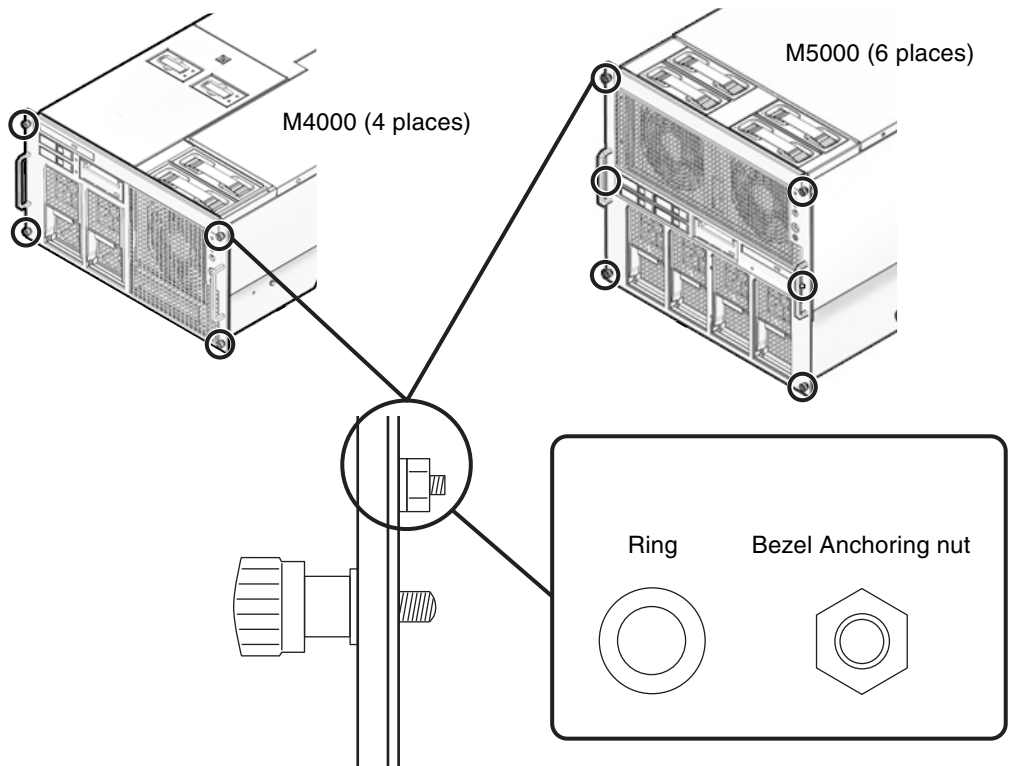
When you mount the SPARC Enterprise M4000 or M5000 server in the equipment rack, as you insert it all the way seated in the rack, the nut anchoring the bezel may interfere with the rack column and the server may fail to be seated correctly.

In such a case, please replace the bezel anchoring nut and ring with the E-Ring.

1. Remove the interfering bezel anchoring nut and ring.
