SPARC® Enterprise M4000/M5000 Servers Product Notes

For XCP version 1072

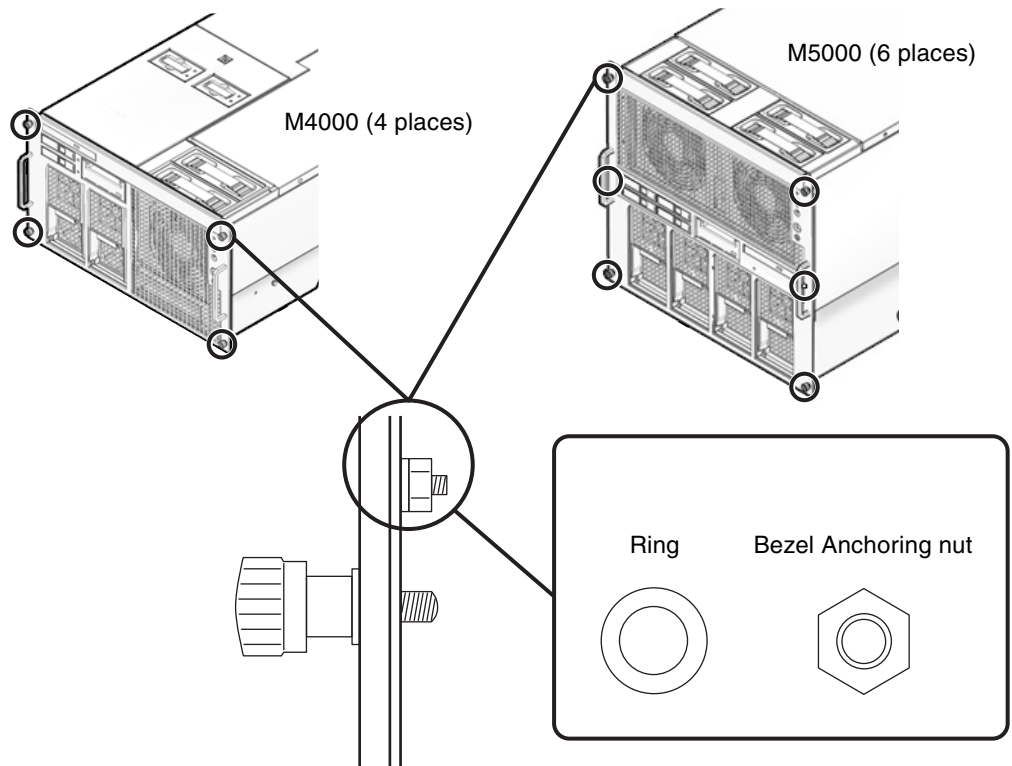
When you mount the SPARC Enterprise M4000 or M5000 server in the equipment rack, as you insert it all the way seated in the rack, the nut anchoring the bezel may interfere with the rack column and the server may fail to be seated correctly.

In such a case, please replace the bezel anchoring nut and ring with the E-Ring.

1. Remove the interfering bezel anchoring nut and ring.
