SPARC Enterprise M3000/M4000/M5000/ M8000/M9000 Servers

Product Notes for XCP Version 1115

Manual Code: C120-E700-02EN
July 2013, Revision A

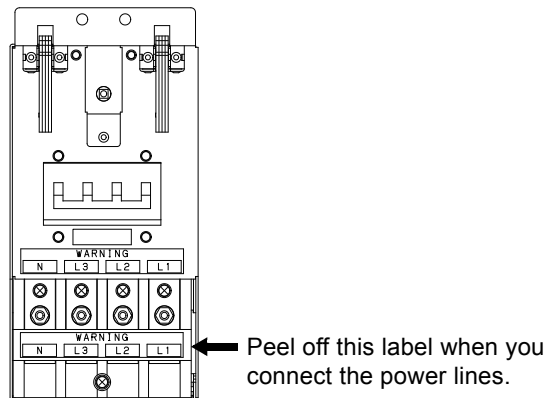
FIGURE 6-1 AC Section with Warning Label

The warning label on the AC section indicates that the terminal connection sequence has been changed. Connect in accordance with the terminal sequence described on the warning label.
