## VRS 4.1 for Fujitsu scanner (PFU OEM Bundle) Service Pack 1 Notes.

## **2. Contents of modified malfunctions**

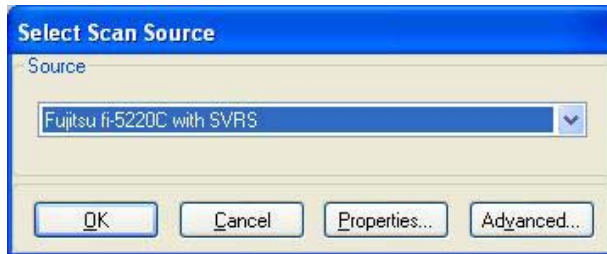
(Figure 2-1-1)

- 1) Select fi-5220C when installing VRS4.1.
- 2) Run the VCDEMO, then select fi-5220C as the Scan source.

Applying the SP1 update makes the connection easier and smooth by not displaying the ISIS driver device selection window (Figure2-1-2) but by selecting the fi-5220C automatically.

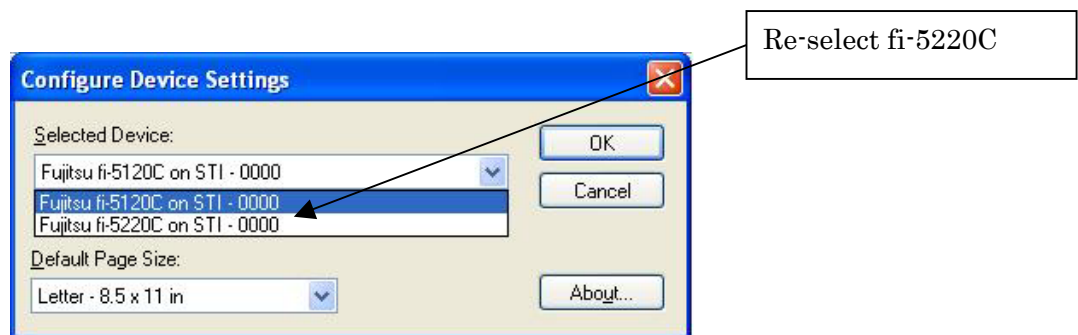
(Figure 2-1-3)

- 4) At the Figure2-1-2 as well as the Figure2-1-3, The Figure2-1-4 is displayed when selecting fi-5120C, and as a result fi-5220C is failed to correctly connected.

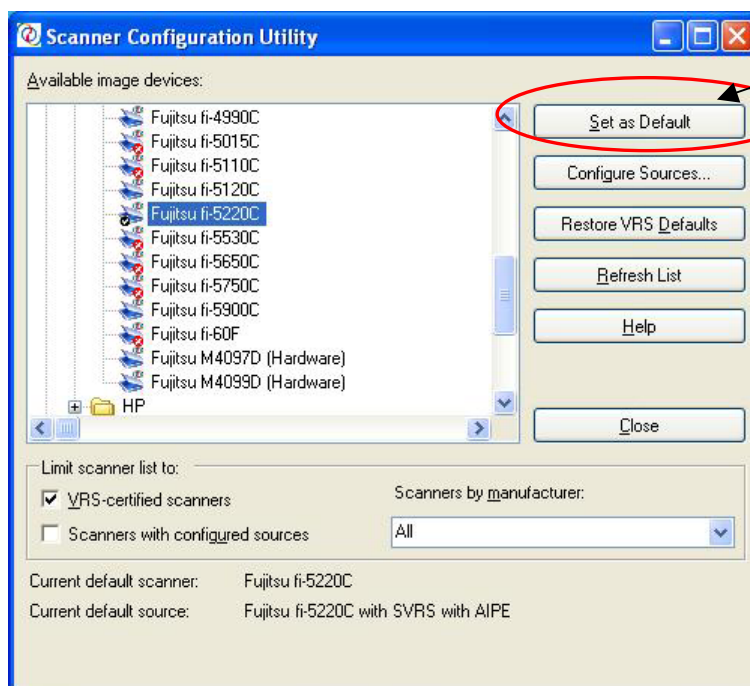
Set as Default

- 5) Once the above Figure2-1-4 occurs, the following operation is required.  
(The Figure2-1-2 is no longer displayed, and the error of the Figure2-1-4 always appears)

5-1) From the [Start] menu of the windows, run the [Scanner Configuration Utility].  
(Start -> Kofax VRS -> Scanner Configuration Utility)

5-2) Select fi-5220C, and then click the [Set as Default] button. No changes can be visible on the screen, but the Figure2-1-2 becomes to be displayed again.

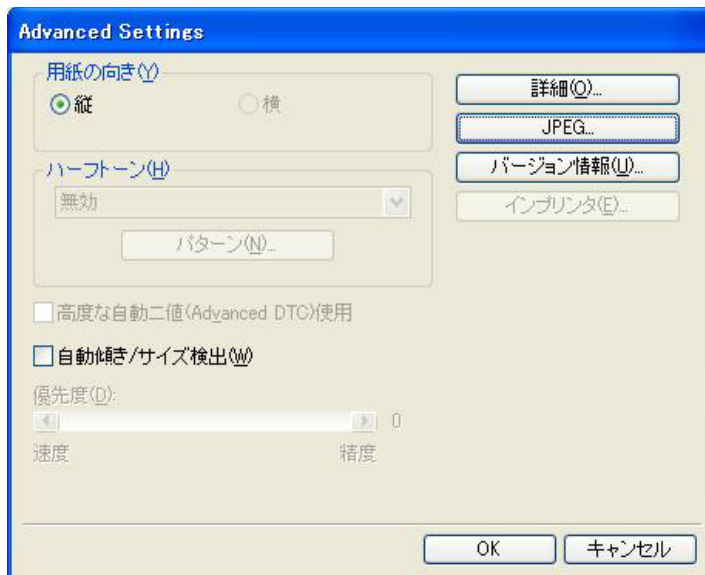
Installing fi-5530C ISIS driver after having installed fi-5120C ISIS driver, and then performing scanning via fi-5530C, the ISIS driver setting window is displayed in English

Applying the SP1 updates makes the driver window display in Japanese.

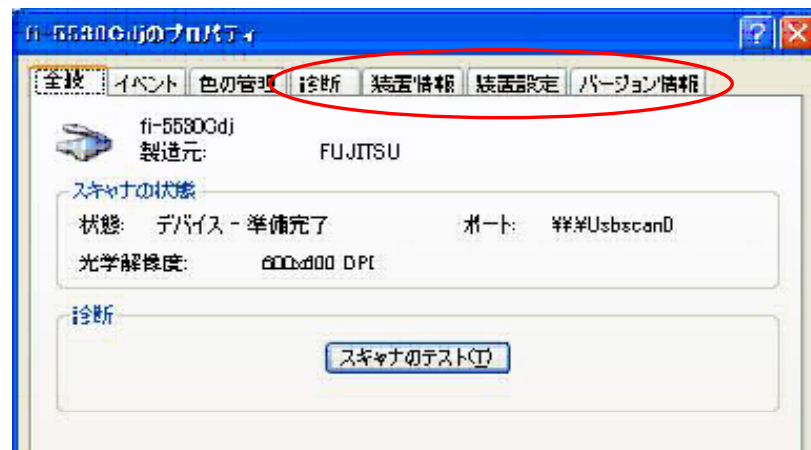
When confirming the property at “Scanner and Camera” having been fi-5650C connected, the property is partially displayed in English.

Applying the SP1 update makes the property display correctly in Japanese.
