SPARC Enterprise M3000/M4000/M5000/ M8000/M9000 Servers

Product Notes for XCP Version 1115

Manual Code: C120-E700-02EN
July 2013, Revision A

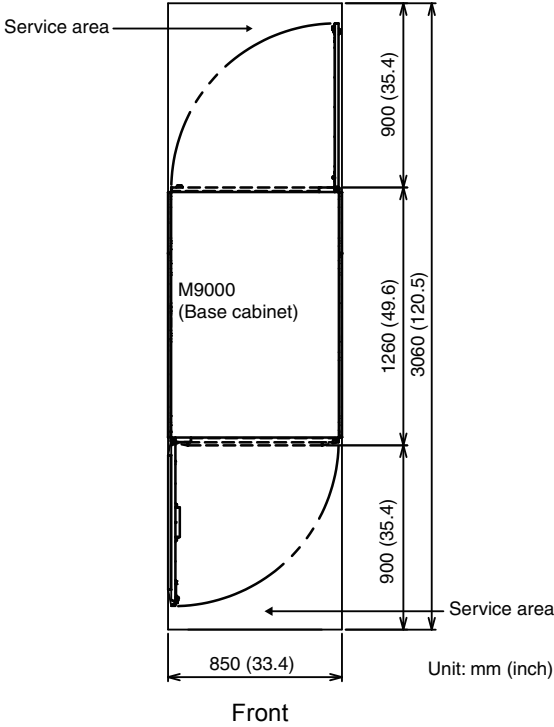
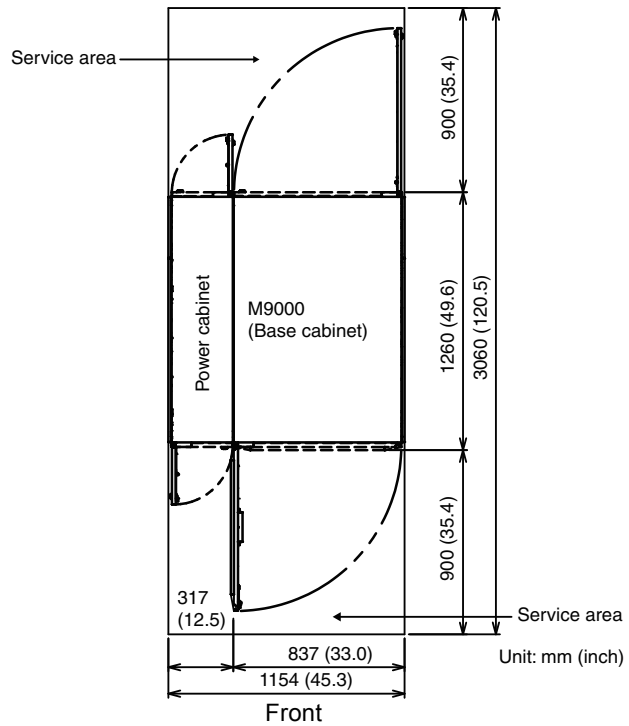
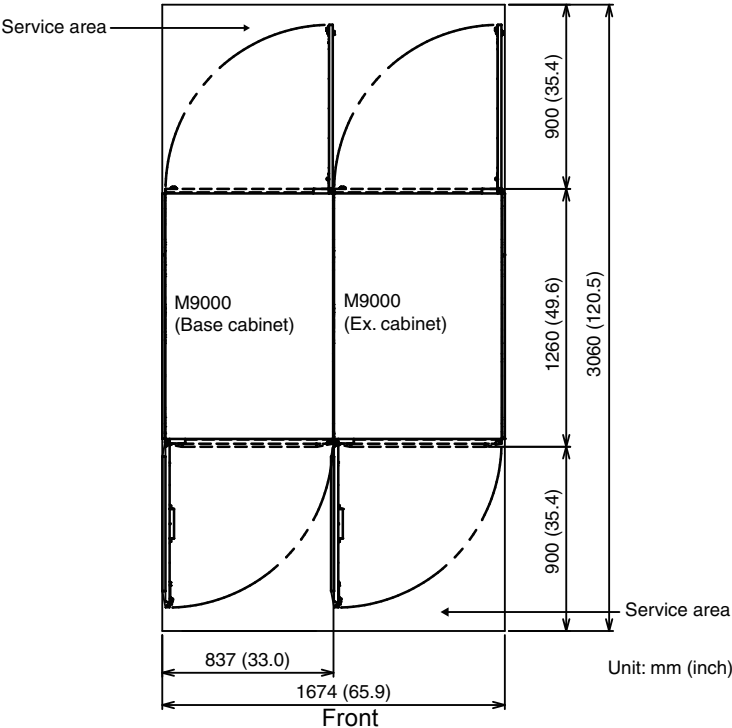
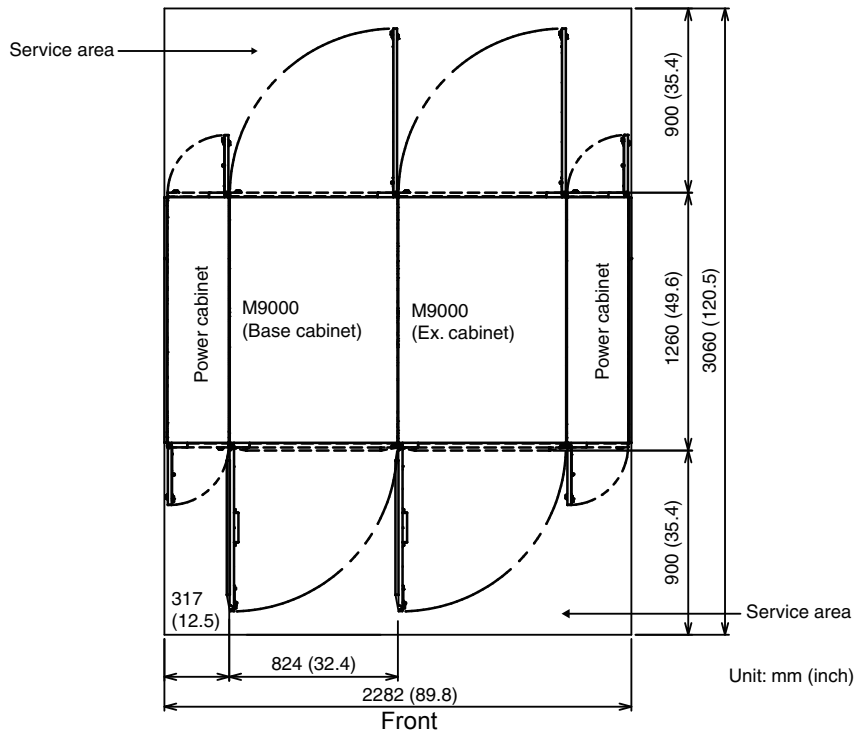
SPARC Enterprise M8000/M9000 Servers Site Planning Guide	1-18	A part of values in inches on FIGURE 1-13 to FIGURE 1-16 will be corrected. For detail, see “M9000 Servers Installation Area” on page 115 .
	1-35	For the order number of Vibration-proof bracket and Vibration-proof feet, see “Miscellaneous Information” on page 119 .
	3-22	FIGURE 3-9 AC section attached with the alert label is added.
SPARC Enterprise M8000/M9000 Servers Installation Guide	3-32	FIGURE 3-28 AC section attached with the alert label is added.
SPARC Enterprise M8000/M9000 Servers Service Manual	7-8	The mounting location of I/O Unit (IOU) indicated on FIGURE 7-4 will be corrected. For detail, see “I/O Unit (IOU) Mounting Locations” on page 118 ."
	18-10	Step 10 Additional instruction about the AC section attached with the alert label is added.
