SPARC Enterprise M3000/M4000/M5000/ M8000/M9000 Servers

Product Notes for XCP Version 1122

Manual Code: C120-0048-01EN
November 2016, Revision A

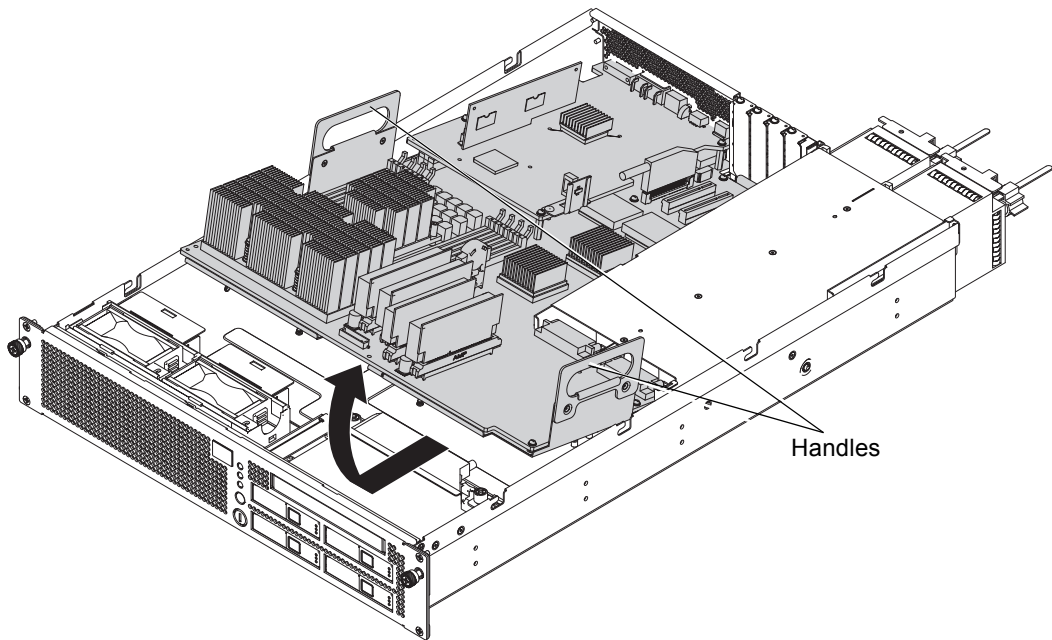
2. Hold the two opaque handles on both sides of the motherboard unit and lift the motherboard unit while sliding it out.

FIGURE 6-5 Removing the Motherboard Unit

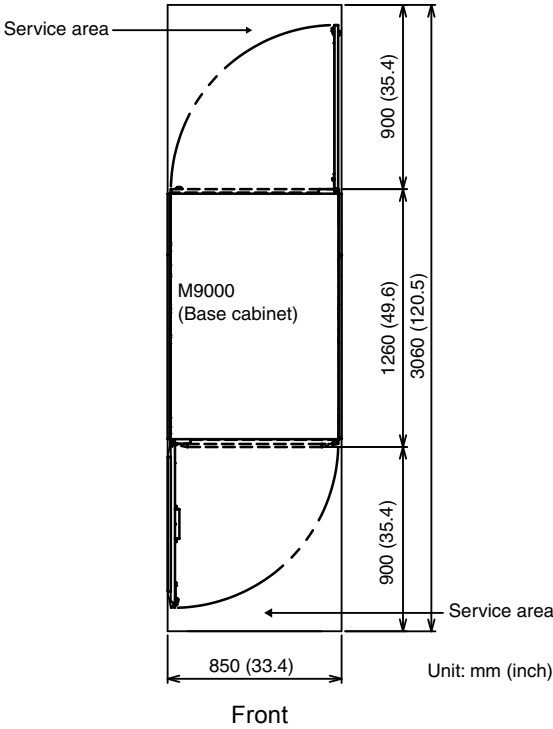
FIGURE 1-13 M9000 Server (Base Cabinet) Installation Area

SPARC Enterprise M8000/M9000 Servers Site Planning Guide	1-18	A part of values in inches on FIGURE 1-13 to FIGURE 1-16 will be corrected. For detail, see “M9000 Servers Installation Area” on page 121.
	1-35	For the order number of Vibration-proof bracket and Vibration-proof feet, see “Miscellaneous Information” on page 125.
SPARC Enterprise M8000/M9000 Servers Service Manual	7-8	The mounting location of I/O Unit (IOU) indicated on FIGURE 7-4 will be corrected. For detail, see “I/O Unit (IOU) Mounting Locations” on page 124.”

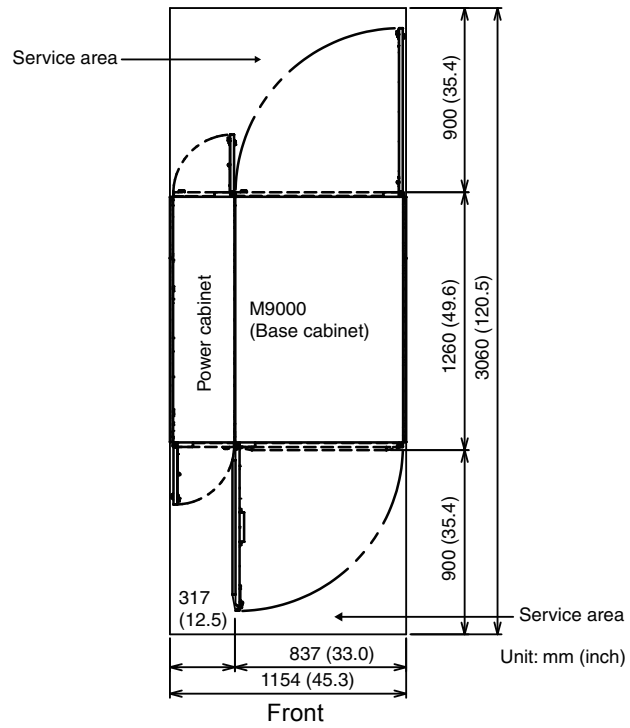
FIGURE 1-14 M9000 Server (Base Cabinet) + Power Cabinet Installation Area

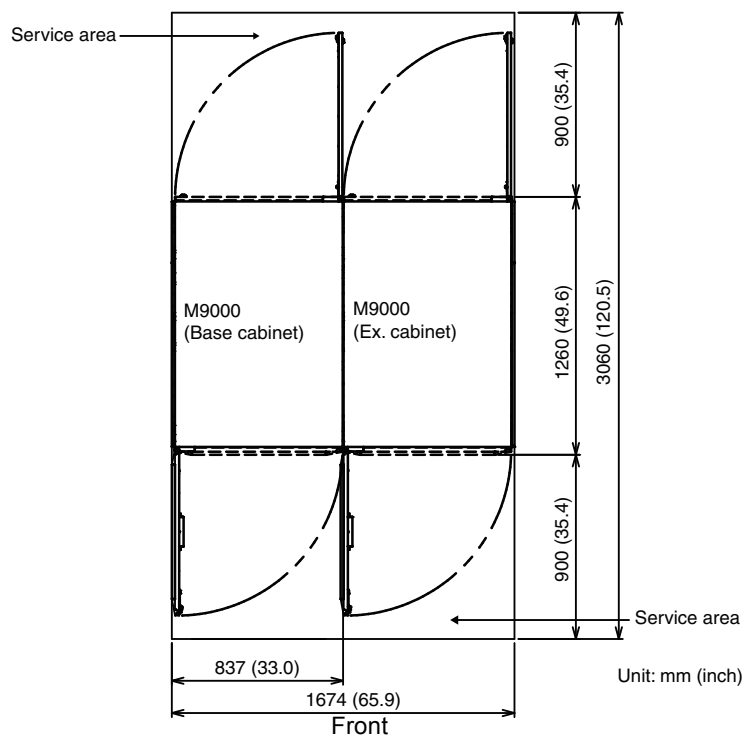
FIGURE 1-15 M9000 Server (Base Cabinet + Expansion Cabinet) Installation Area

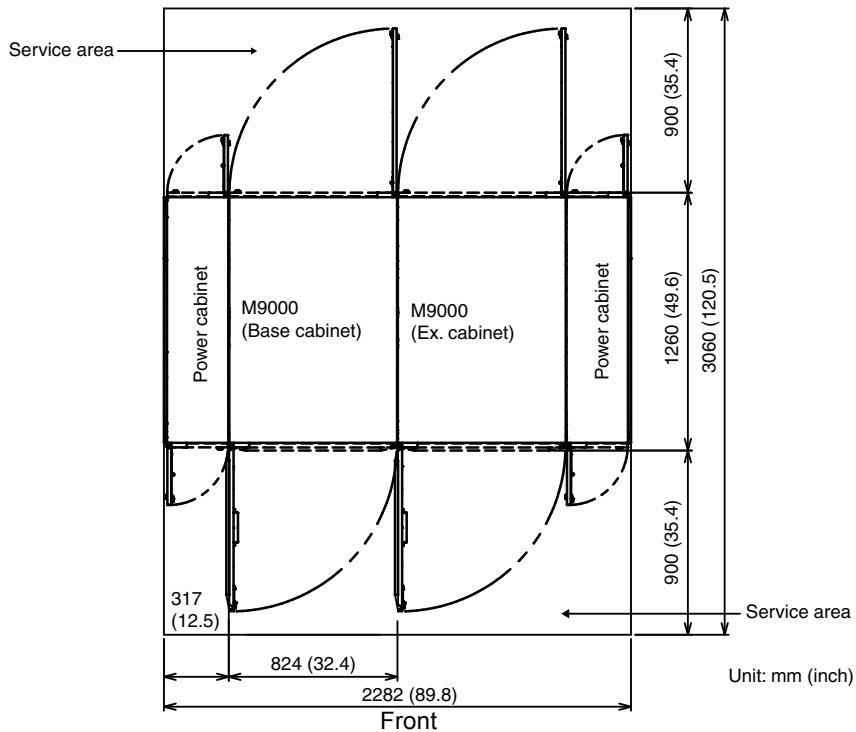
FIGURE 1-16 M9000 Server (Base Cabinet + Expansion Cabinet) + Power Cabinet Installation Are

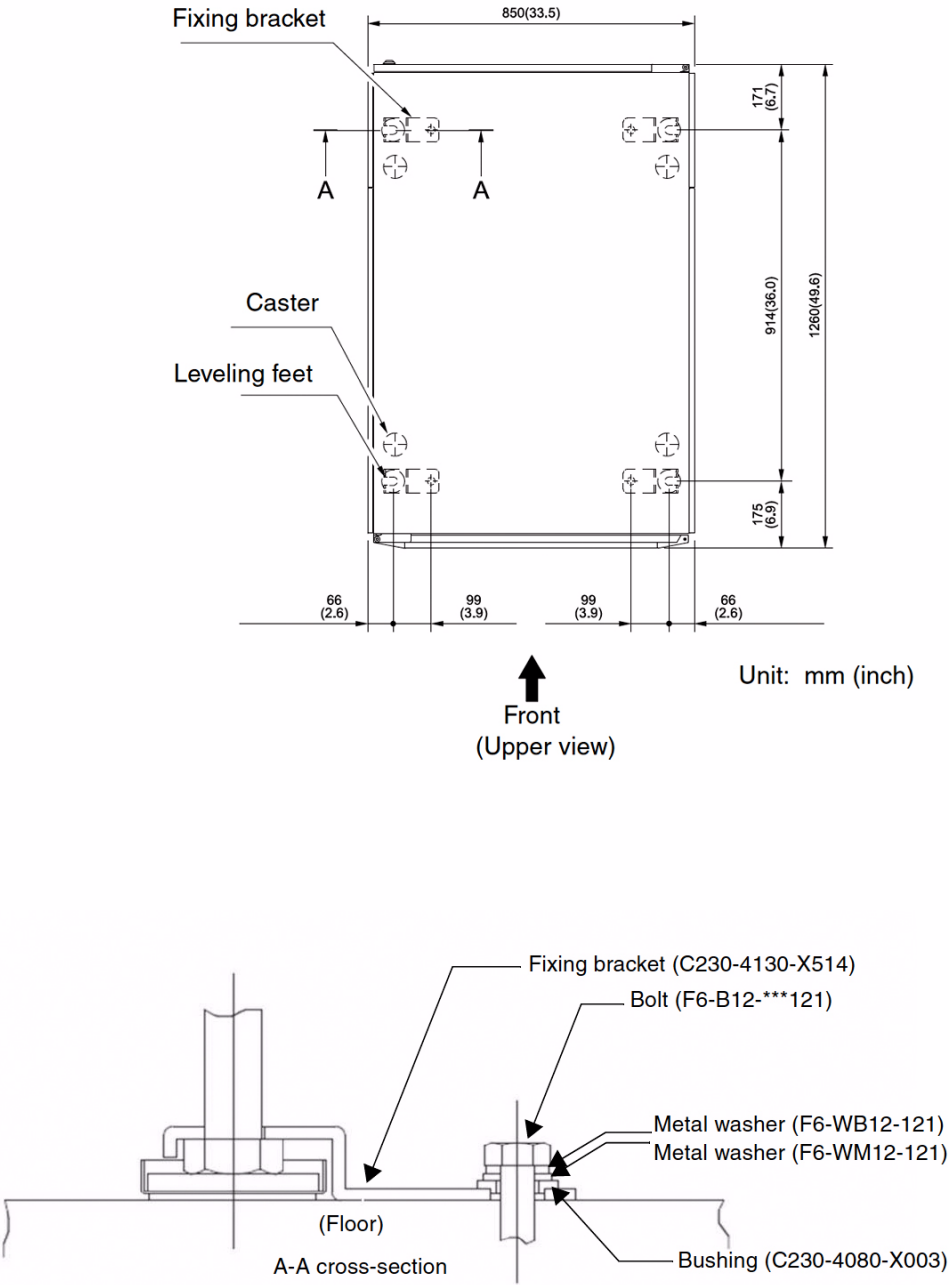
Note – Consult with the company that constructed the building because the length depends on the structure of the building.

FIGURE 6-1 Example of Securing the Cabinet to the Floor Surface Using the Fixing Bracket (M9000 Server)

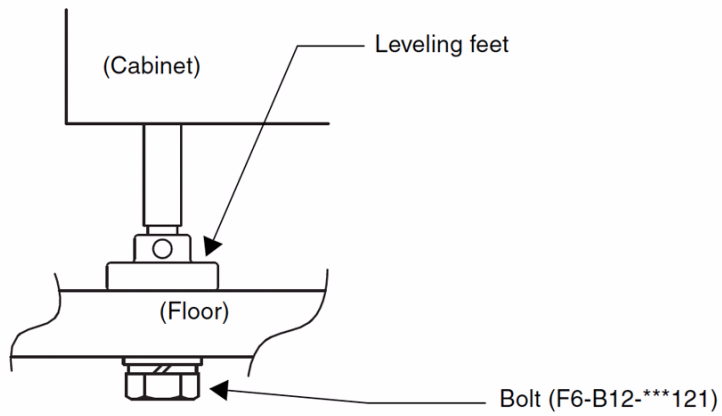
FIGURE 6-2 Example of Securing the Cabinet Through a Hole in the Floor
