# **SPARC Enterprise M3000/M4000/M5000/ M8000/M9000 Servers**

Product Notes for XCP Version 1119

Manual Code: C120-0013-01EN  
January 2015, Revision A

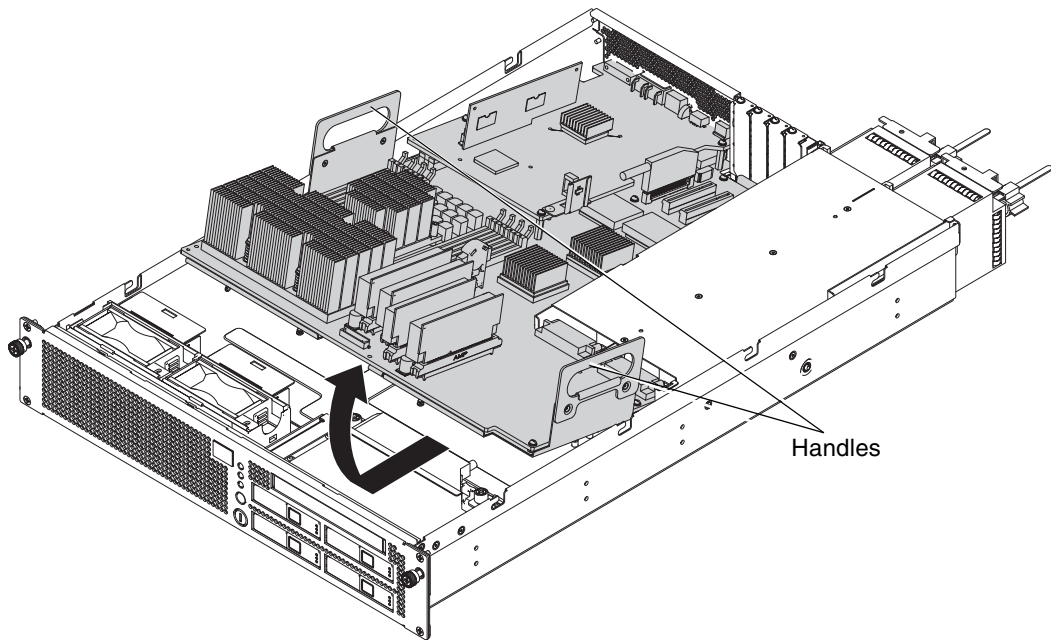
**FIGURE 6-5** Removing the Motherboard Unit

2. Hold the two opaque handles on both sides of the motherboard unit and lift the motherboard unit while sliding it out.

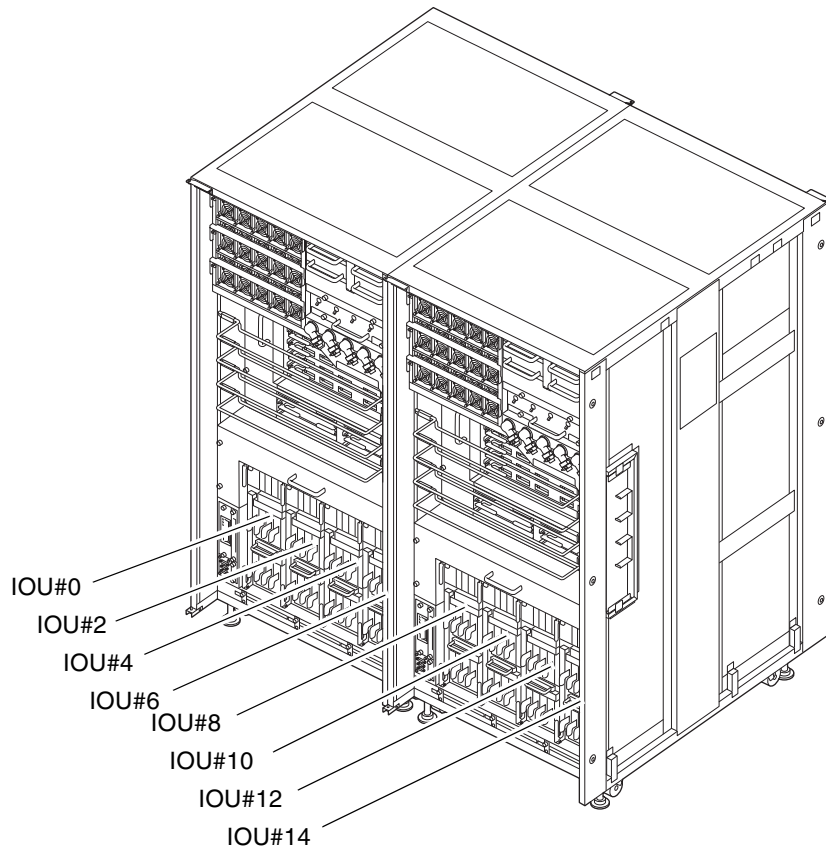
**FIGURE 7-4** IOU Mounting Locations (Front of M9000 with the Expansion Cabinet)

FIGURE 7-4 shows the mounting locations of IOUs in the M9000 server (with the expansion cabinet).

SPARC Enterprise M8000/M9000 Servers Site Planning Guide	1-18	A part of values in inches on FIGURE 1-13 to FIGURE 1-16 will be corrected. For detail, see <a href="#">“M9000 Servers Installation Area” on page 119</a> .
	1-35	For the order number of Vibration-proof bracket and Vibration-proof feet, see <a href="#">“Miscellaneous Information” on page 123</a> .
SPARC Enterprise M8000/M9000 Servers Service Manual	7-8	The mounting location of I/O Unit (IOU) indicated on FIGURE 7-4 will be corrected. For detail, see <a href="#">“I/O Unit (IOU) Mounting Locations” on page 122</a> ."
