# **SPARC Enterprise M3000/M4000/M5000/ M8000/M9000 Servers**

Product Notes for XCP Version 1117

Manual Code: C120-E721-01EN  
February 2014, Revision A

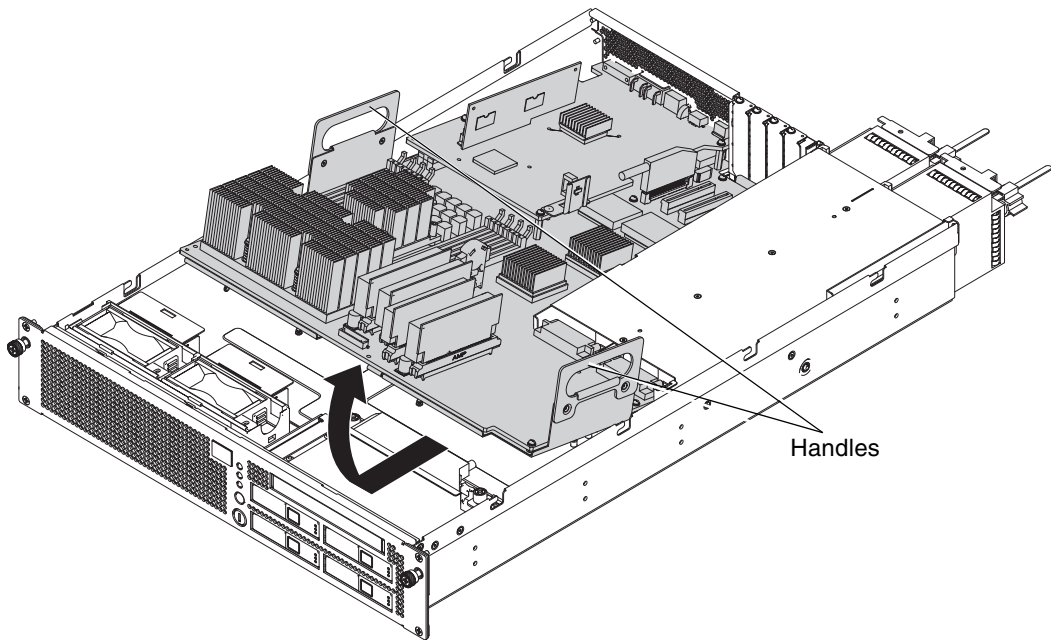
**FIGURE 6-5** Removing the Motherboard Unit

2. Hold the two opaque handles on both sides of the motherboard unit and lift the motherboard unit while sliding it out.
