SPARC Enterprise M3000/M4000/M5000/ M8000/M9000 Servers

Product Notes for XCP Version 1120

Manual Code: C120-0026-01EN
July 2015, Revision A

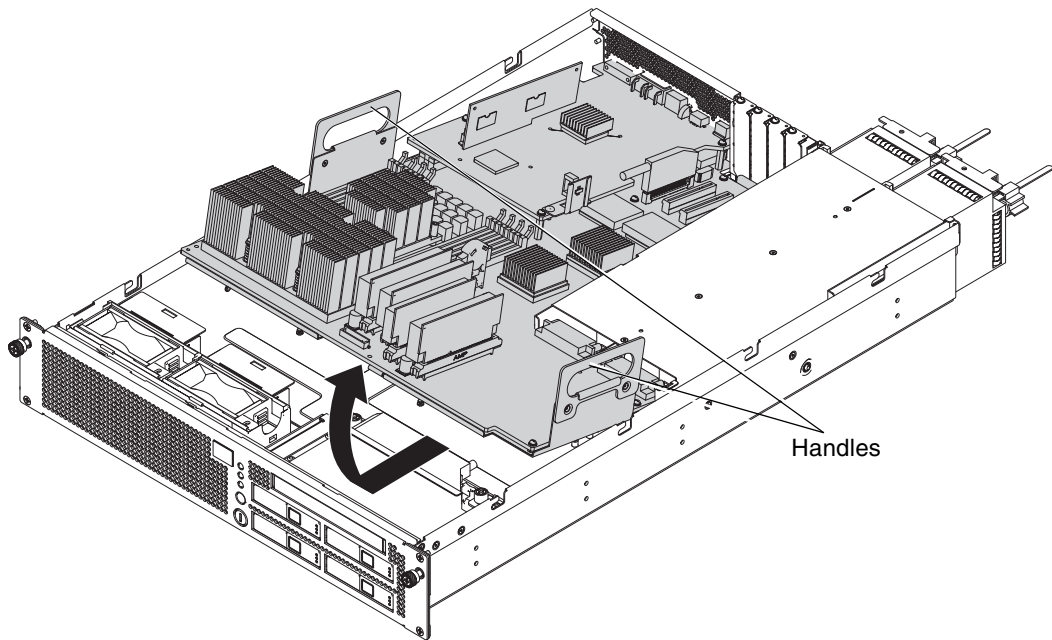
2. Hold the two opaque handles on both sides of the motherboard unit and lift the motherboard unit while sliding it out.

FIGURE 6-5 Removing the Motherboard Unit

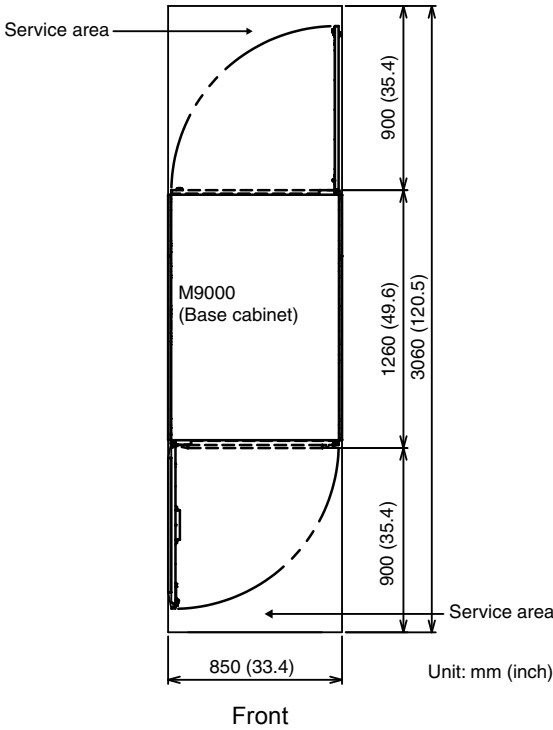
FIGURE 1-13 M9000 Server (Base Cabinet) Installation Area

SPARC Enterprise M8000/M9000 Servers Site Planning Guide	1-18	A part of values in inches on FIGURE 1-13 to FIGURE 1-16 will be corrected. For detail, see “M9000 Servers Installation Area” on page 119 .
	1-35	For the order number of Vibration-proof bracket and Vibration-proof feet, see “Miscellaneous Information” on page 123 .
SPARC Enterprise M8000/M9000 Servers Service Manual	7-8	The mounting location of I/O Unit (IOU) indicated on FIGURE 7-4 will be corrected. For detail, see “I/O Unit (IOU) Mounting Locations” on page 122 ."

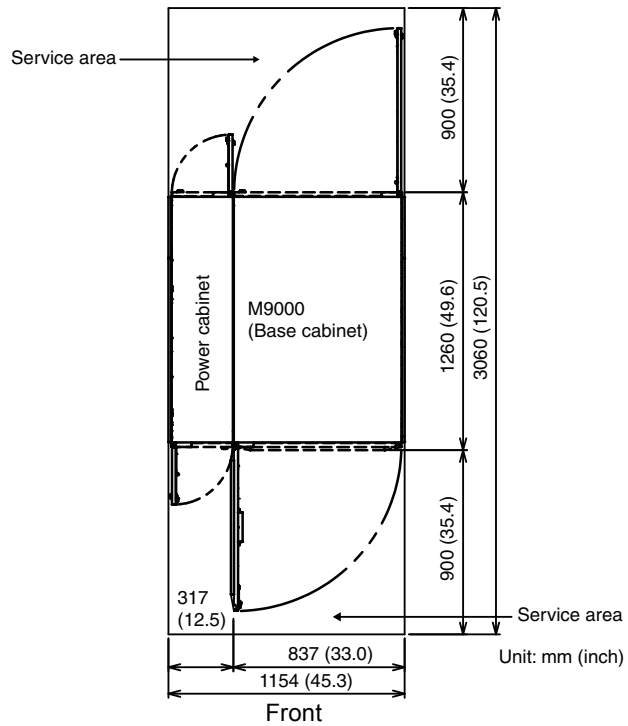
FIGURE 1-14 M9000 Server (Base Cabinet) + Power Cabinet Installation Area

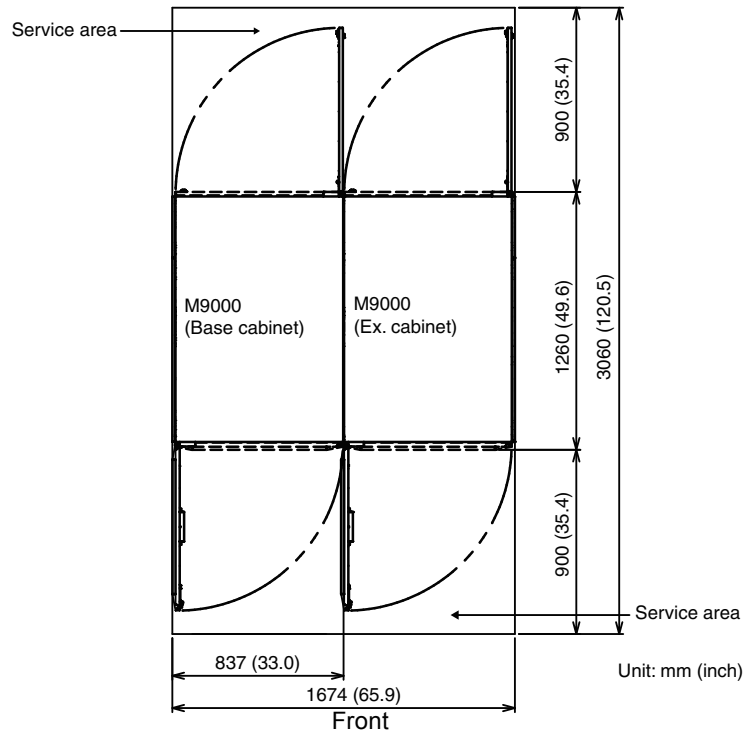
FIGURE 1-15 M9000 Server (Base Cabinet + Expansion Cabinet) Installation Area

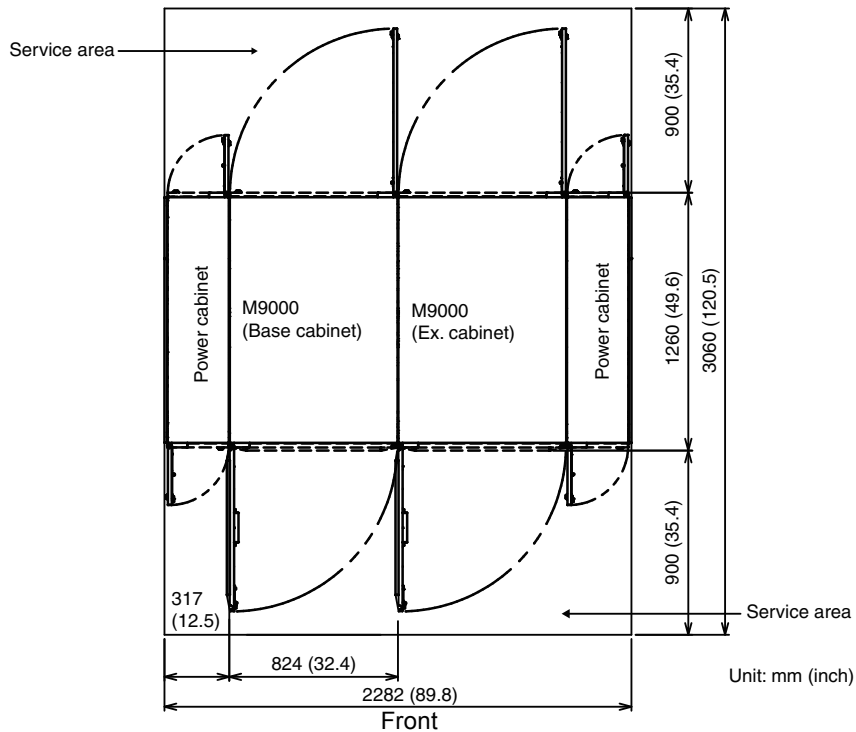
FIGURE 1-16 M9000 Server (Base Cabinet + Expansion Cabinet) + Power Cabinet Installation Are

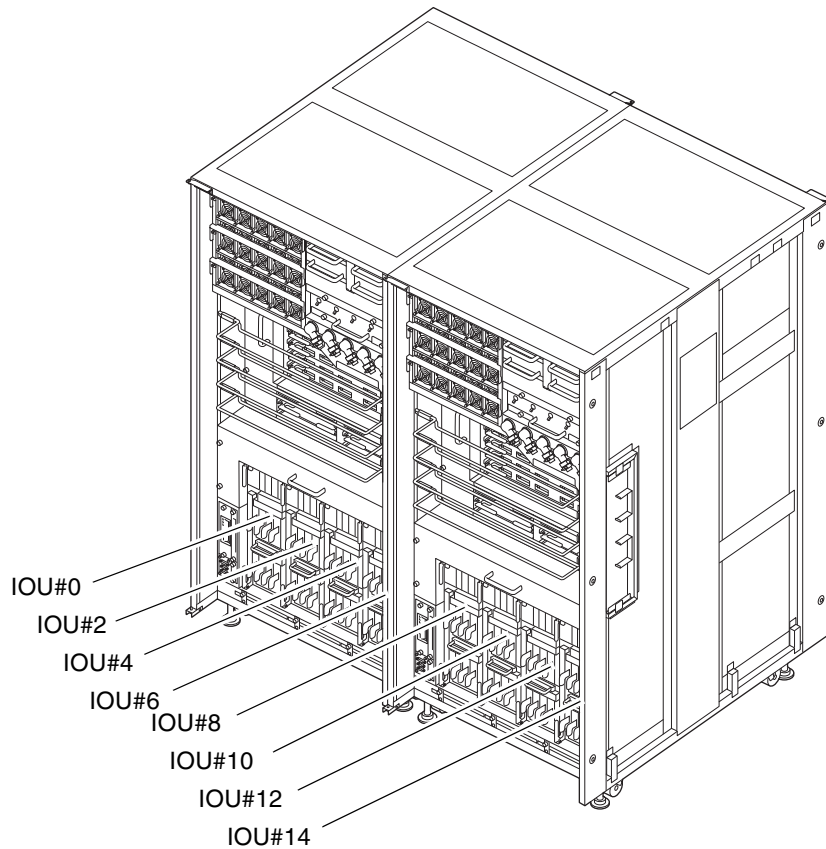
FIGURE 7-4 shows the mounting locations of IOUs in the M9000 server (with the expansion cabinet).

FIGURE 7-4 IOU Mounting Locations (Front of M9000 with the Expansion Cabinet)

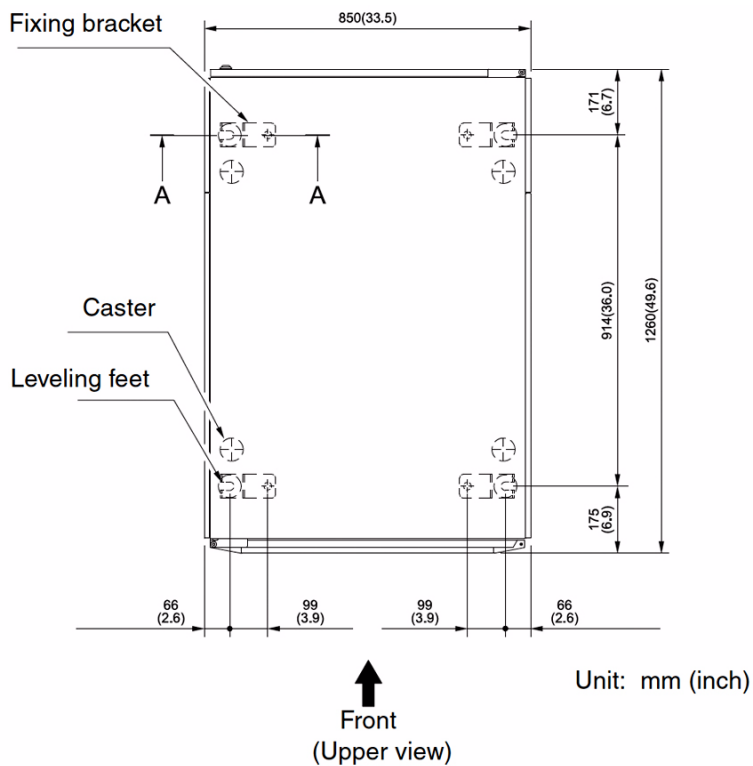
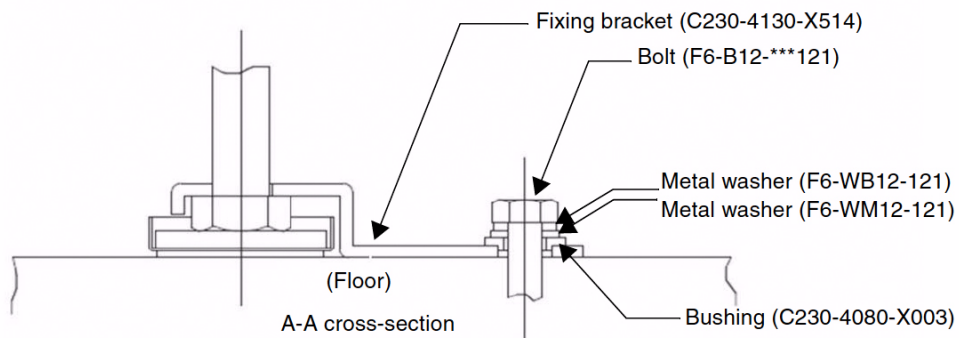
Note – Consult with the company that constructed the building because the length depends on the structure of the building.

FIGURE 6-1 Example of Securing the Cabinet to the Floor Surface Using the Fixing Bracket (M9000 Server)

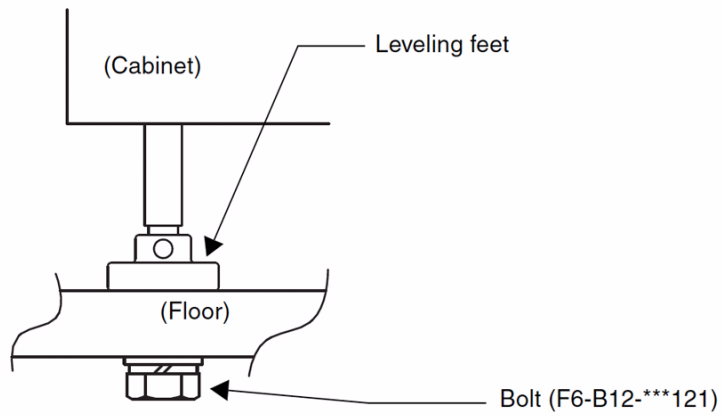
FIGURE 6-2 Example of Securing the Cabinet Through a Hole in the Floor
