# **SPARC Enterprise M3000/M4000/M5000/ M8000/M9000 Servers**

Product Notes for XCP Version 1124

Manual Code: C120-0066-02EN  
January 2019, Revision A

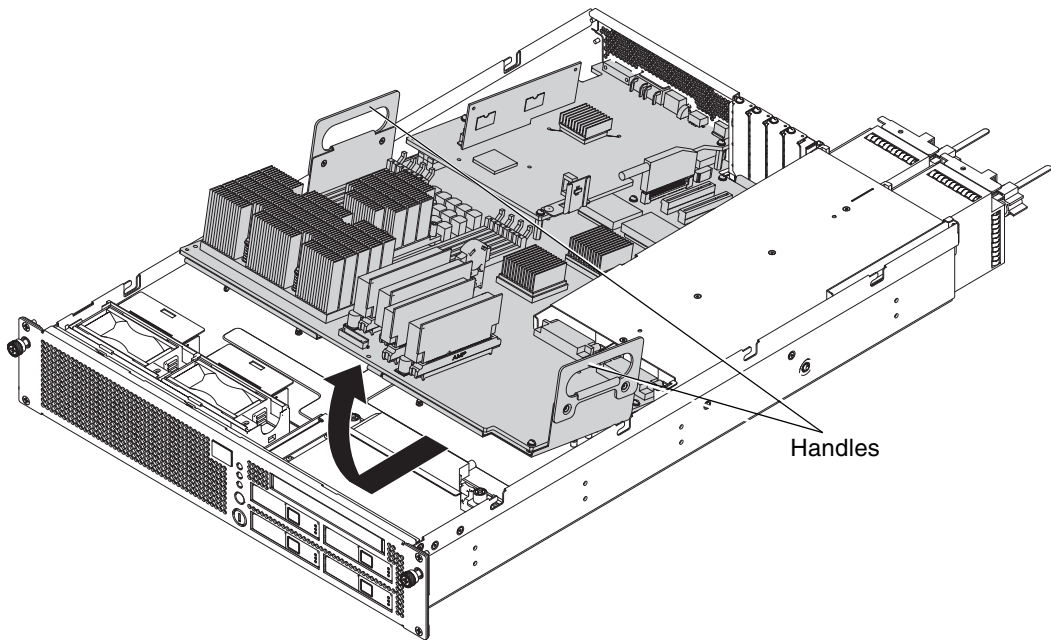
2. Hold the two opaque handles on both sides of the motherboard unit and lift the motherboard unit while sliding it out.

**FIGURE 6-5** Removing the Motherboard Unit

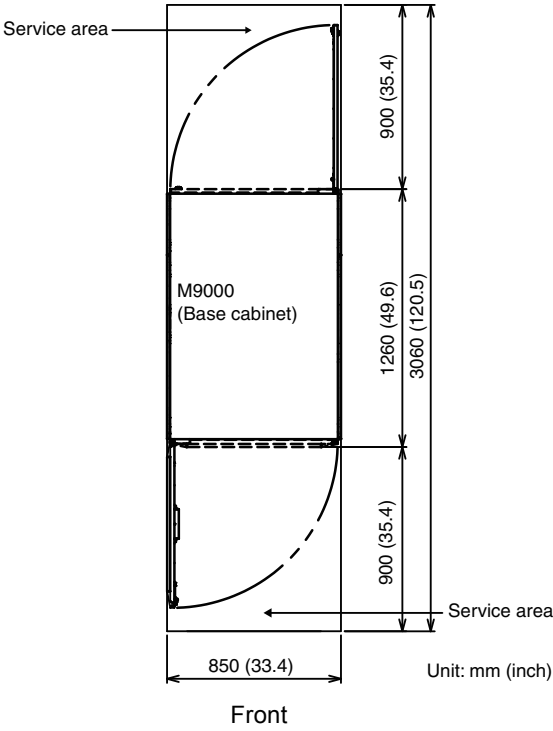
**FIGURE 1-13** M9000 Server (Base Cabinet) Installation Area

SPARC Enterprise M8000/M9000 Servers Site Planning Guide	1-18	A part of values in inches on FIGURE 1-13 to FIGURE 1-16 will be corrected. For detail, see <a href="#">“M9000 Servers Installation Area” on page 125</a> .
	1-35	For the order number of Vibration-proof bracket and Vibration-proof feet, see <a href="#">“Miscellaneous Information” on page 129</a> .
SPARC Enterprise M8000/M9000 Servers Service Manual	7-8	The mounting location of I/O Unit (IOU) indicated on FIGURE 7-4 will be corrected. For detail, see <a href="#">“I/O Unit (IOU) Mounting Locations” on page 128</a> ."

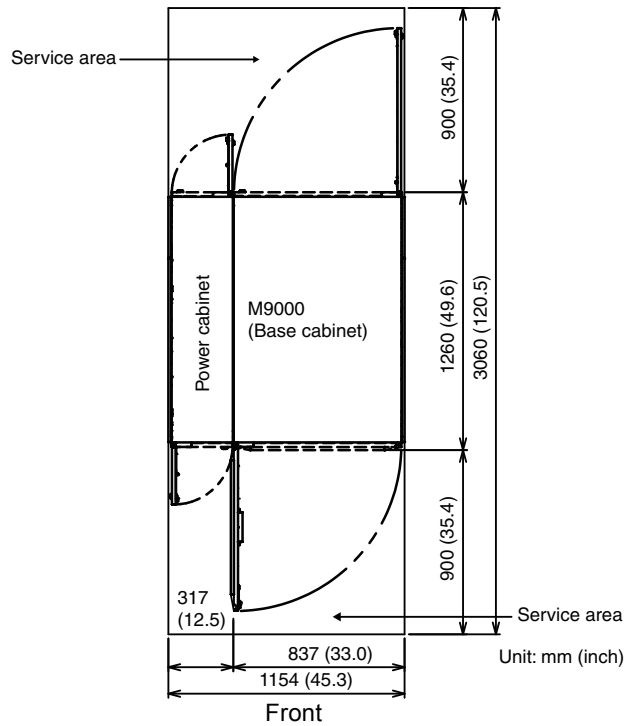
**FIGURE 1-14** M9000 Server (Base Cabinet) + Power Cabinet Installation Area

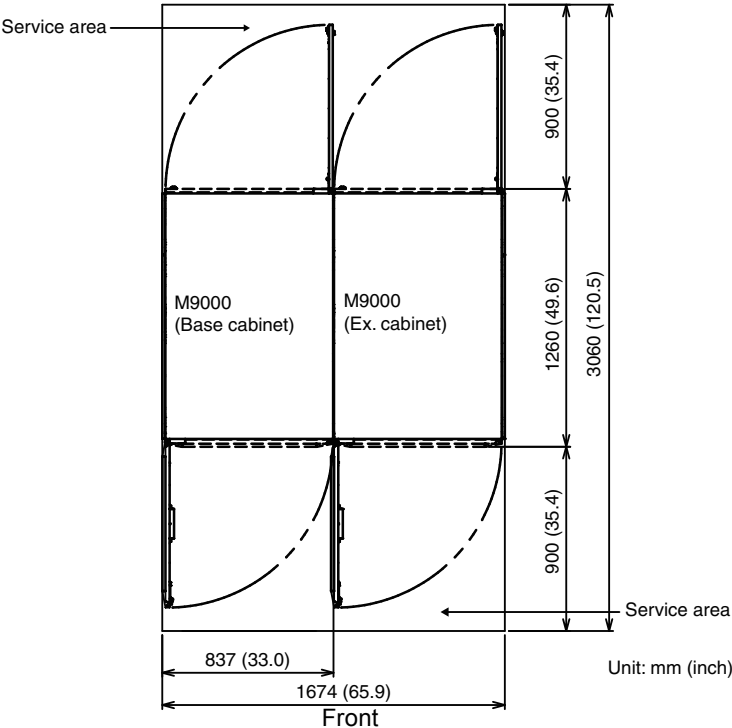
**FIGURE 1-15** M9000 Server (Base Cabinet + Expansion Cabinet) Installation Area

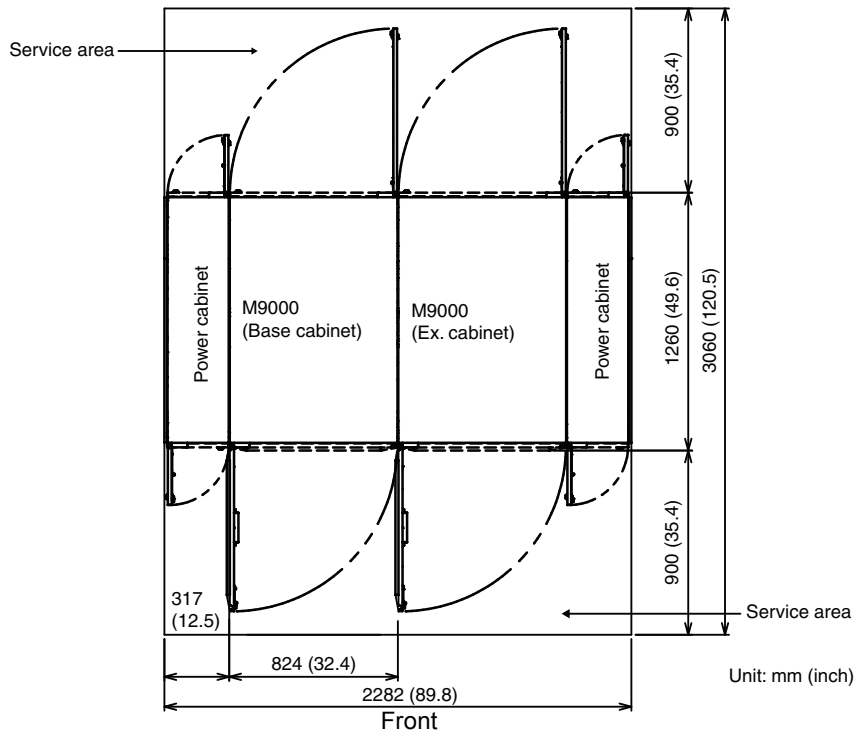
**FIGURE 1-16** M9000 Server (Base Cabinet + Expansion Cabinet) + Power Cabinet Installation Are

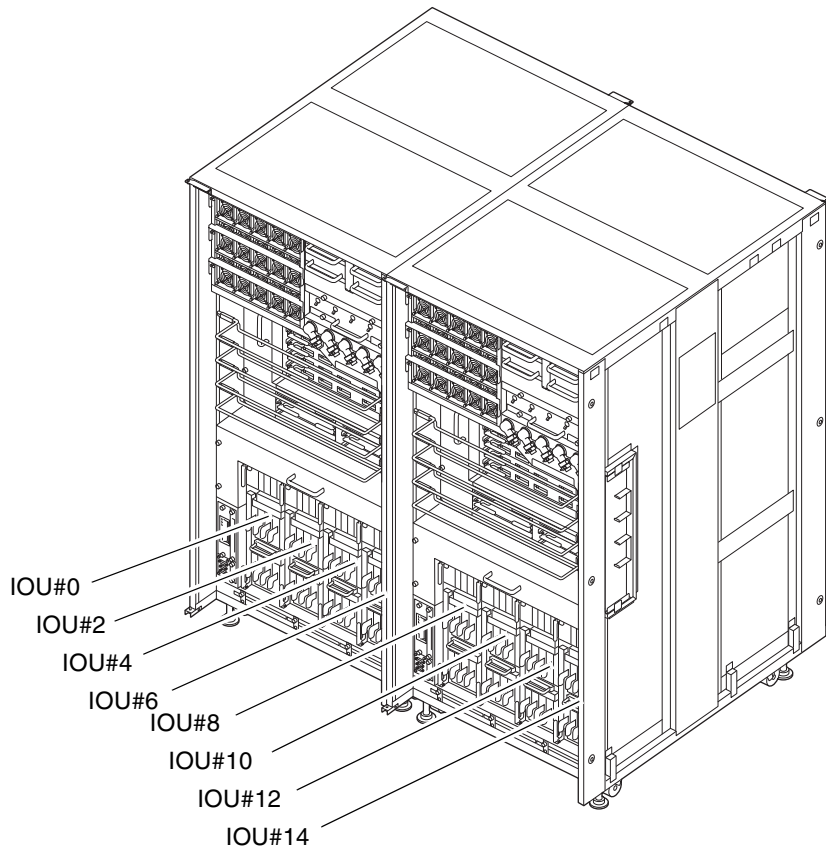
FIGURE 7-4 shows the mounting locations of IOUs in the M9000 server (with the expansion cabinet).

**FIGURE 7-4** IOU Mounting Locations (Front of M9000 with the Expansion Cabinet)

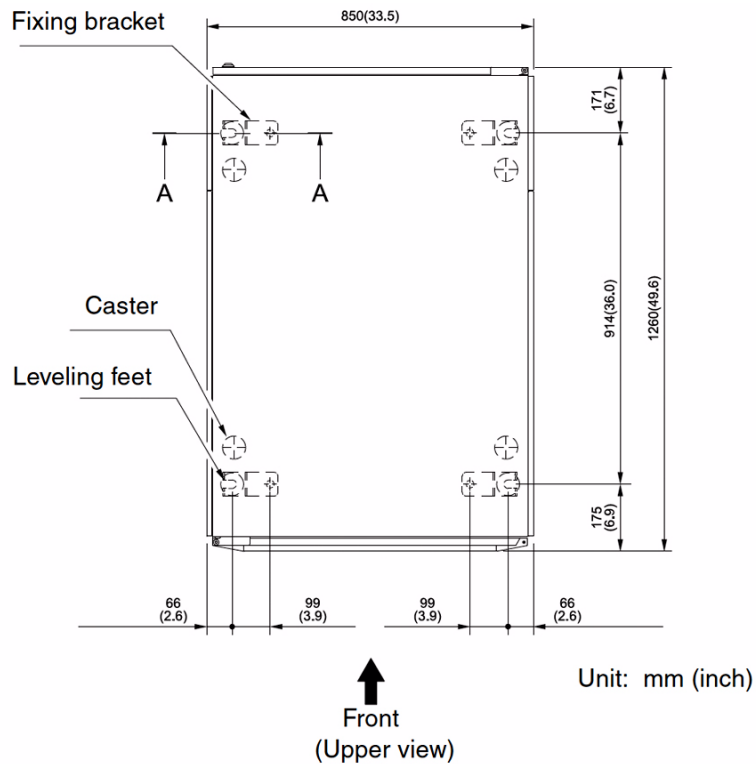
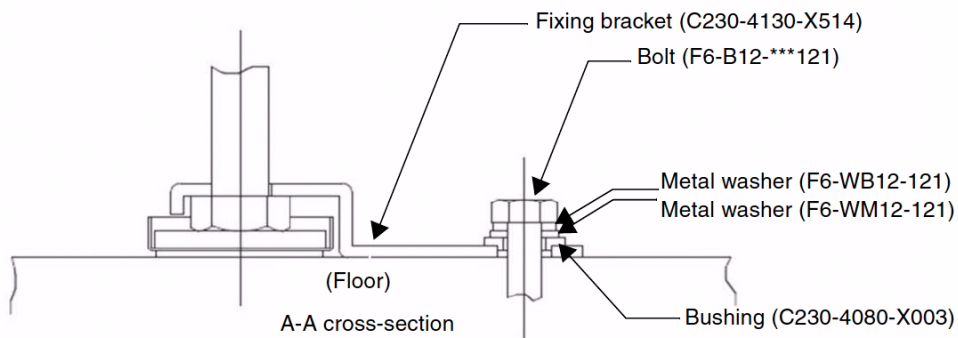
**FIGURE 6-1** Example of Securing the Cabinet to the Floor Surface Using the Fixing Bracket (M9000 Server)

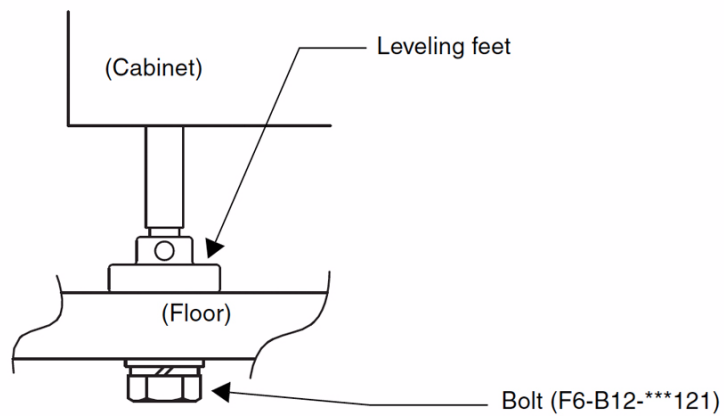
**FIGURE 6-2** Example of Securing the Cabinet Through a Hole in the Floor
