SPARC® Enterprise M4000/M5000 Servers Product Notes

For XCP Version 1081

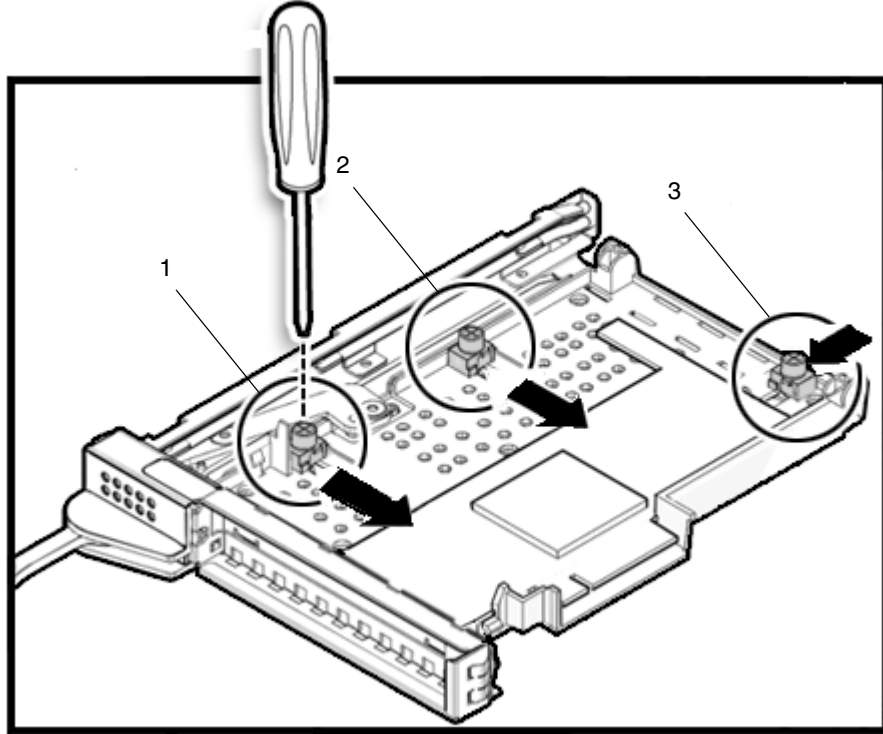
FIGURE 8-6 Sequence of Fixing the PCI Card in Position

Note – The adjustable stops should be snug against the card and securely tightened to ensure the card seats correctly. Also, fix the PCI card in position by following the 1-2-3 sequence in FIGURE 8-6.
