SPARC® Enterprise M8000/M9000 Servers Product Notes

For XCP version 1060

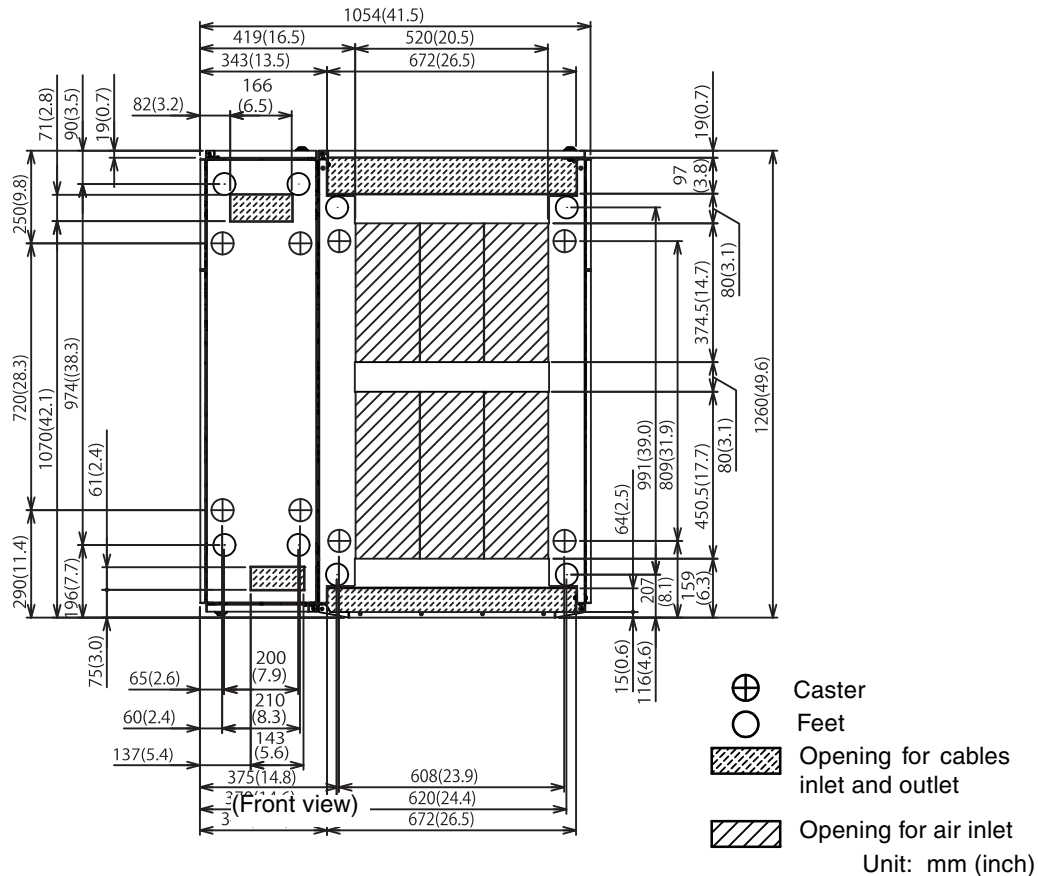
This is to correct the description in Section 1.2.2.2, "Bottom View of the Components", FIGURE 1-18 SPARC Enterprise M8000 Server + Power Cabinet Bottom View and FIGURE 1-20 SPARC Enterprise M9000 Server (Base Cabinet) + Power Cabinet Bottom View. The correct figures are as follows:
