SPARC® Enterprise M8000/M9000 Servers Product Notes

For XCP version 1070

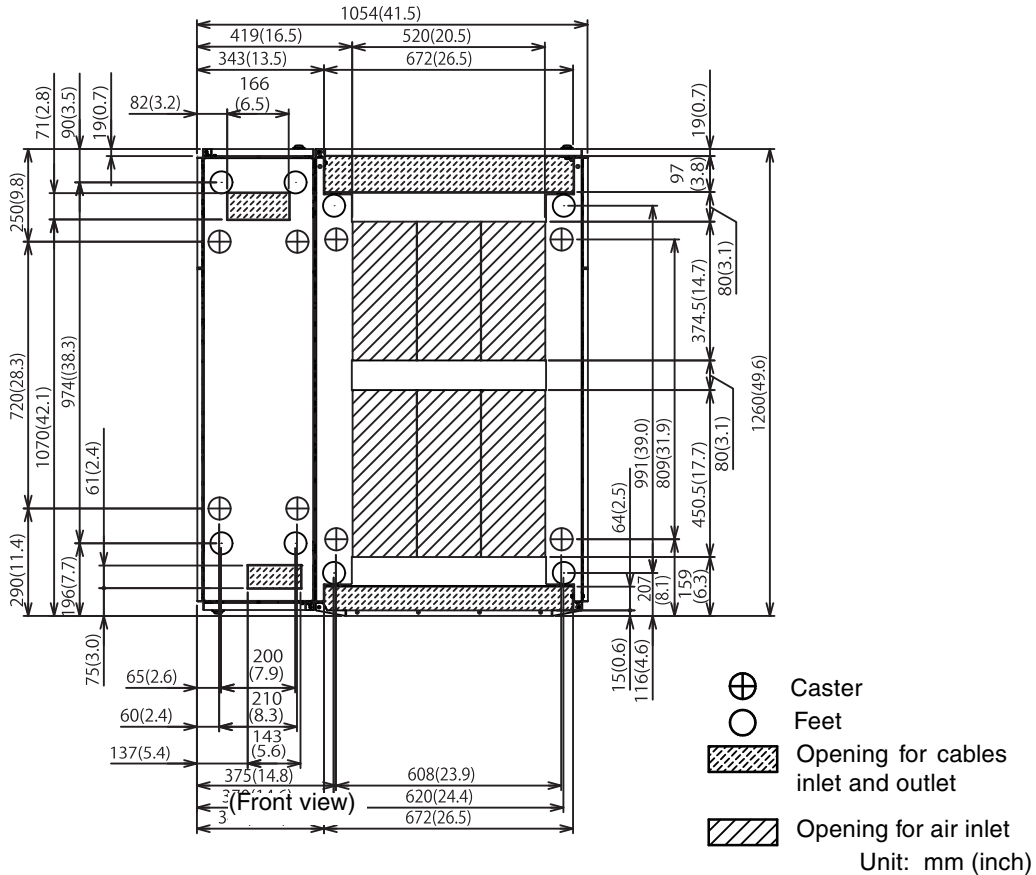
This is to correct the description in Section 1.2.2.2, "Bottom View of the Components", FIGURE 1-18 SPARC Enterprise M8000 Server + Power Cabinet Bottom View and FIGURE 1-20 SPARC Enterprise M9000 Server (Base Cabinet) + Power Cabinet Bottom View. The correct figures are as follows:

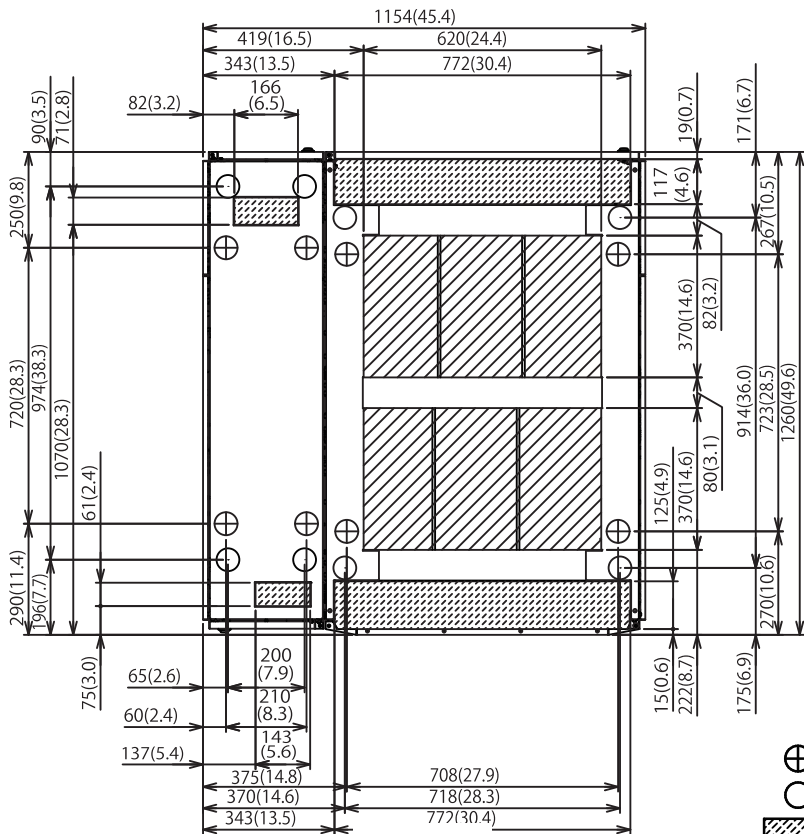
FIGURE1-18 SPARC Enterprise M9000 Server (Base Cabinet) + Power Cabinet Bottom View

(Front view)

Unit: mm (inch)
