SPARC® Enterprise M8000/M9000 Servers Product Notes

For XCP Version 1081

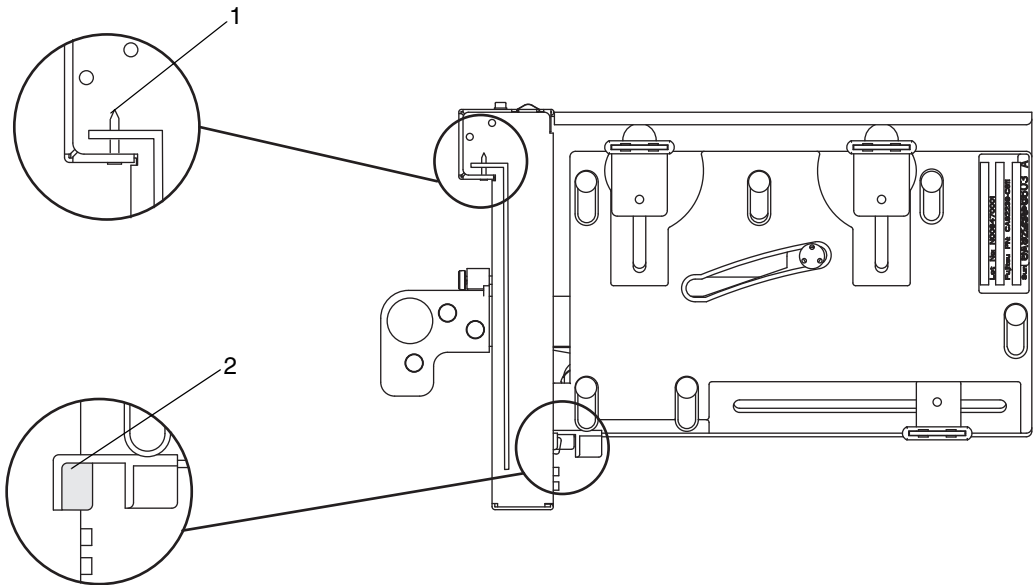
FIGURE 13-6 Card positioning post and card positioning tab

[FIGURE 13-6](#) shows card positioning post and card positioning tab.

Item	Description
1	Card positioning post
2	Card positioning tab

The post (item 1 in [FIGURE 13-6](#)) is seated in the notch of the bracket of the PCI card. If the post is not properly seated in the notch, the mounting bracket of the card may be bent and the card may end up being affixed in an inclined position on the PCI cassette. If a card is affixed in an inclined position, it will not be in proper electric contact with the socket on the IOU.

The tab (item 2 in [FIGURE 13-6](#)) fits in the notch on the lower part of the PCI card. This tab is helpful in positioning the card when it is mounted on the PCI cassette (however, some types of cards do not have the notch).

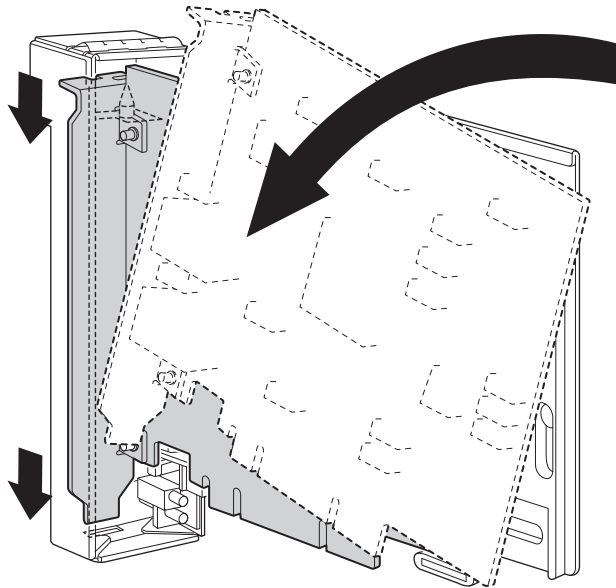
a. Mounting the PCI Card

- a. Move the PCI card in the direction of the arrow, and mount it on the PCI cassette by inserting the part projecting out at the bottom of the bracket of the PCI card into the hole at the bottom of the front panel of the PCI cassette and inserting the pin of the PCI cassette into the oval hole at the top of the bracket of the PCI card.

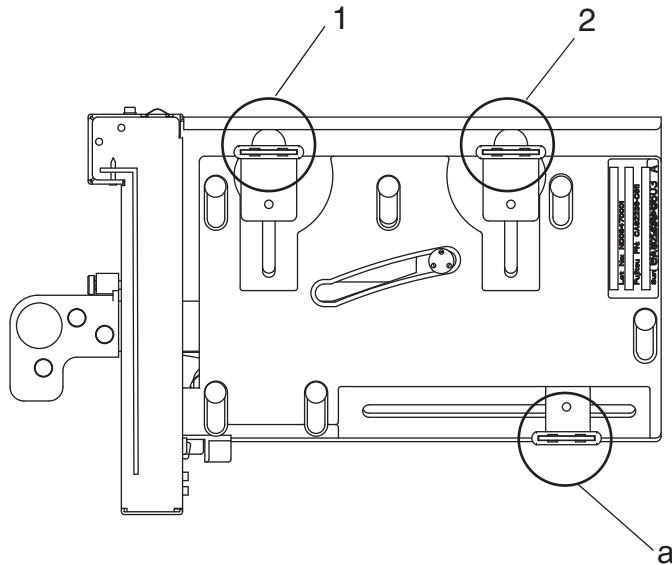
FIGURE 13-8 Sequence of Fixing the PCI Card in Position

- c. Align the PCI card with the center part of the lower latch of the cassette. Then, while pressing the PCI card against the center part of each of the upper latches of the cassette, tighten the fixing screws in the sequence shown in FIGURE 13-8 to fix the card in position.

Note – To ensure that the PCI card is properly mounted, you need to confirm that the PCI card base is properly centered at the latches and securely fastened in position.

Caution – If the card is short, move the screw at the bottom of the cassette as required. In such cases, place the latches as close as possible to the far end of the card (FIGURE 13-9 reference). To shift the location of the bottom screw for the PCI card, first secure the card at the lower latch (part a in FIGURE 13-8). Then, tighten the fixing screws in the sequence shown in FIGURE 13-8 to fix the card in position.
