SPARC Enterprise™ M8000/M9000 Servers Product Notes

For XCP Version 1082

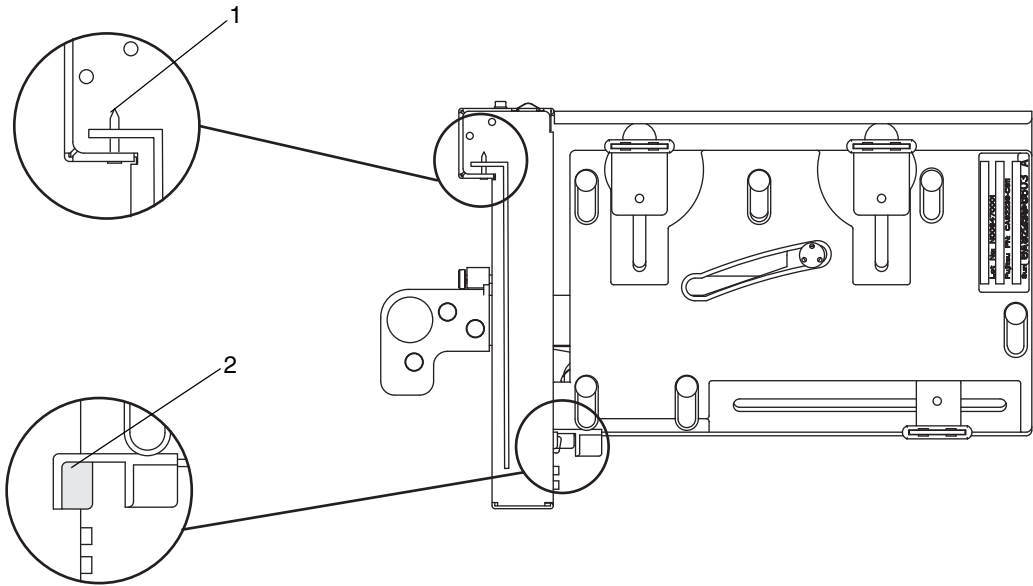
FIGURE 13-6 Card positioning post and card positioning tab

FIGURE 13-6 shows card positioning post and card positioning tab.

Item	Description
1	Card positioning post
2	Card positioning tab

The post (item 1 in [FIGURE 13-6](#)) is seated in the notch of the bracket of the PCI card. If the post is not properly seated in the notch, the mounting bracket of the card may be bent and the card may end up being affixed in an inclined position on the PCI cassette. If a card is affixed in an inclined position, it will not be in proper electric contact with the socket on the IOU.

The tab (item 2 in [FIGURE 13-6](#)) fits in the notch on the lower part of the PCI card. This tab is helpful in positioning the card when it is mounted on the PCI cassette (however, some types of cards do not have the notch).

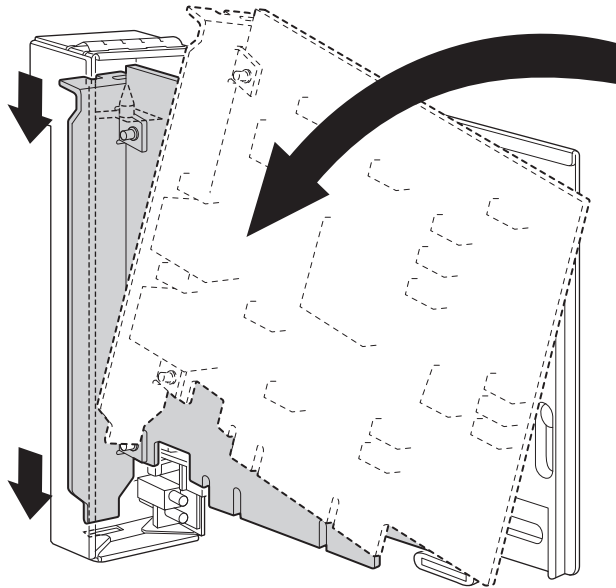
FIGURE 13-7 Mounting the PCI Card

- a. Move the PCI card in the direction of the arrow, and mount it on the PCI cassette by inserting the part projecting out at the bottom of the bracket of the PCI card into the hole at the bottom of the front panel of the PCI cassette and inserting the pin of the PCI cassette into the oval hole at the top of the bracket of the PCI card.

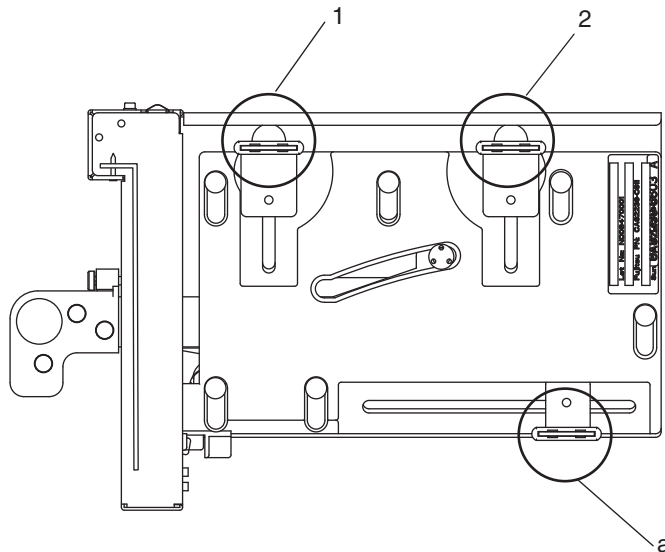
FIGURE 13-8 Sequence of Fixing the PCI Card in Position

- c. Align the PCI card with the center part of the lower latch of the cassette. Then, while pressing the PCI card against the center part of each of the upper latches of the cassette, tighten the fixing screws in the sequence shown in [FIGURE 13-8](#) to fix the card in position.

Caution – If the card is short, move the screw at the bottom of the cassette as required. In such cases, place the latches as close as possible to the far end of the card ([FIGURE 13-9](#) reference). To shift the location of the bottom screw for the PCI card, first secure the card at the lower latch (part a in [FIGURE 13-8](#)). Then, tighten the fixing screws in the sequence shown in [FIGURE 13-8](#) to fix the card in position.
