# SPARC Enterprise™ M8000/M9000 Servers Product Notes

For XCP Version 1090

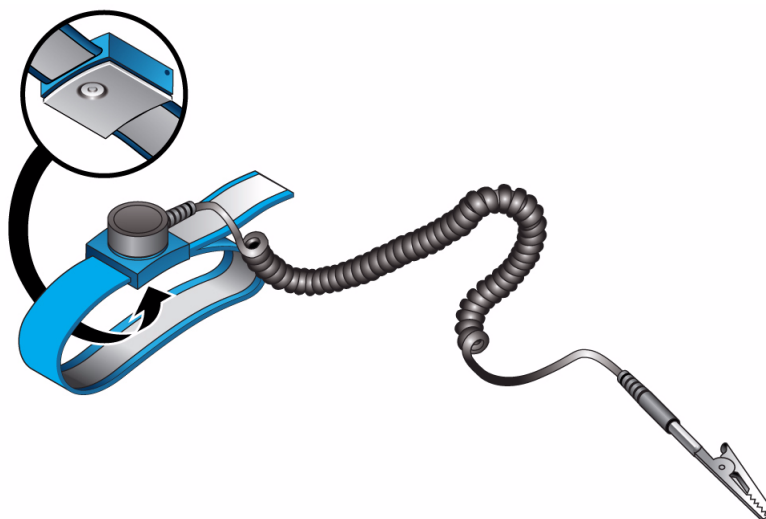
**FIGURE 1-1** Antistatic Wrist Strap Showing the Metallic Underside

**Caution** – When handling FRUs, be sure to connect an antistatic wrist strap clip to a cabinet grounding port and attach the band of the wrist strap to one of your wrists. Place the removed FRUs on an antistatic conductive mat. Failure to do so might result in serious damage.

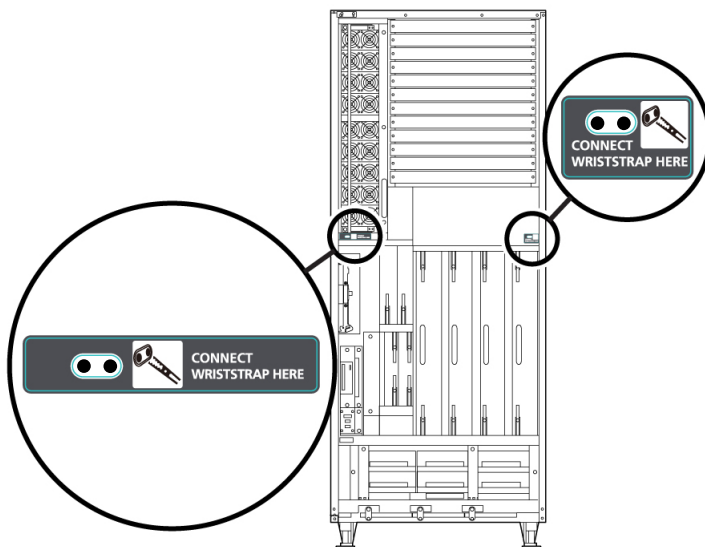
**FIGURE 1-2** M8000 Grounding Port Connection Locations for the Wrist Strap Clip (Front View)

**Note** – For the locations of the cabinet grounding port, see [FIGURE 1-2](#) to [FIGURE 1-5](#).

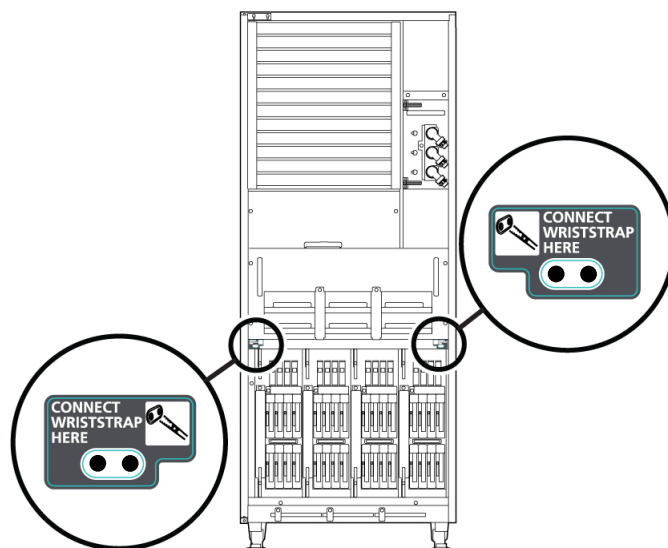
**FIGURE 1-3** M8000 Grounding Port Connection Locations for the Wrist Strap Clip (Rear View)

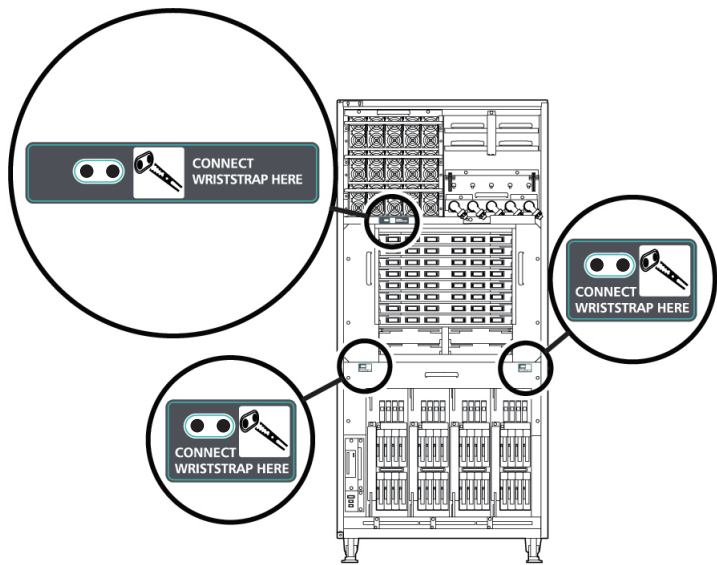
**FIGURE 1-4** M9000 Grounding Port Connection Locations for the Wrist Strap Clip (Front View)

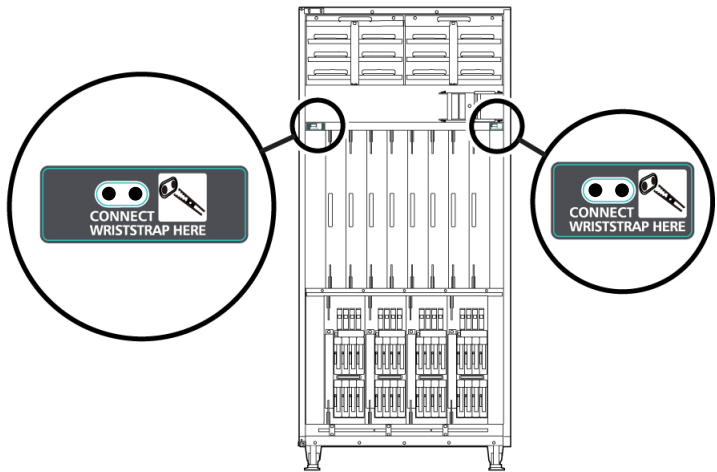
**FIGURE 1-5** M9000 Grounding Port Connection Locations for the Wrist Strap Clip (Rear View)
