SPARC Enterprise™ M8000/M9000 Servers Product Notes

For XCP Version 1091

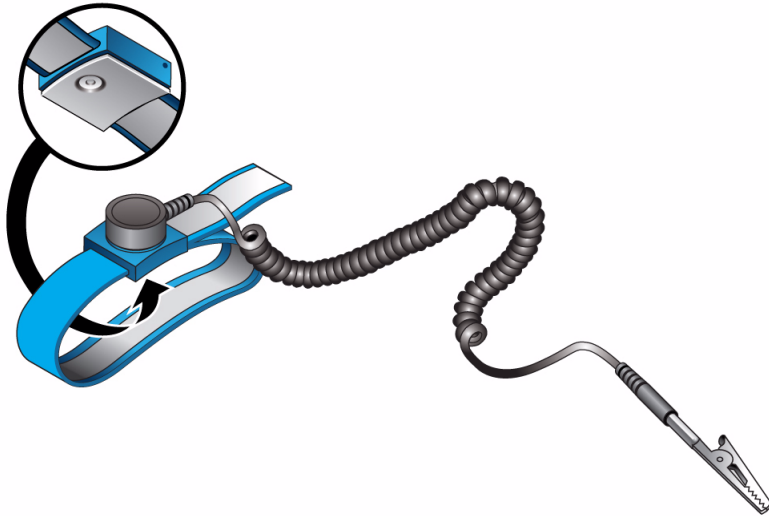
The wrist strap should be snug around the wrist so that it does not rotate.

FIGURE 1-1 Antistatic Wrist Strap Showing the Metallic Underside

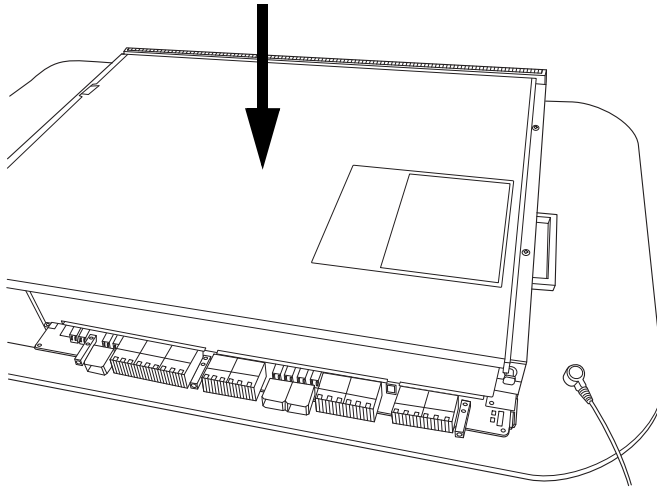
FIGURE 1-2 Metallic Chassis (CMU)

Touch for 5 or more seconds.

- b. Touch the metallic chassis for 5 or more seconds with your bare hand wearing the antistatic wrist strap. (See [FIGURE 1-2](#) or [FIGURE 1-3](#))

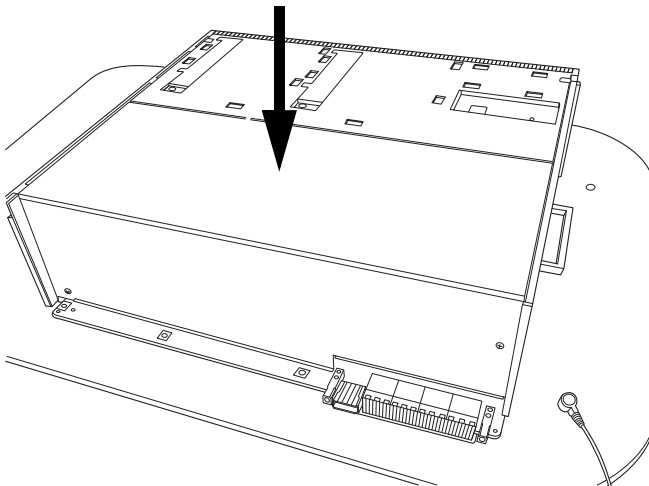
FIGURE 1-3 Metallic Chassis (IOU)

Touch for 5 or more seconds.

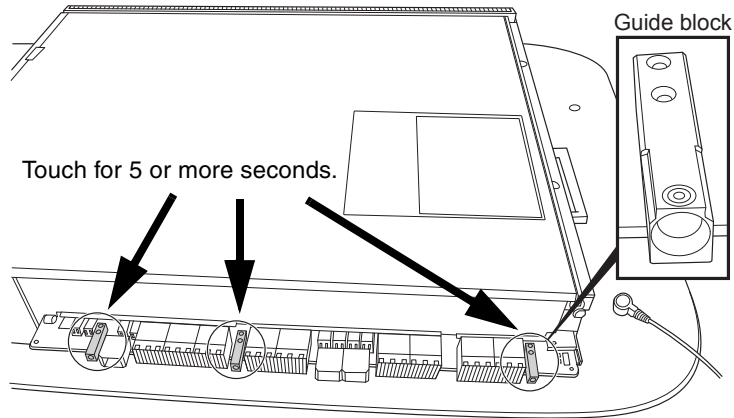
FIGURE 1-4 Guide Block (CMU)

- c. Touch each of the designated points on the guide blocks for 5 or more seconds with your bare hand wearing the antistatic wrist strap. (See [FIGURE 1-4](#) or [FIGURE 1-5](#))

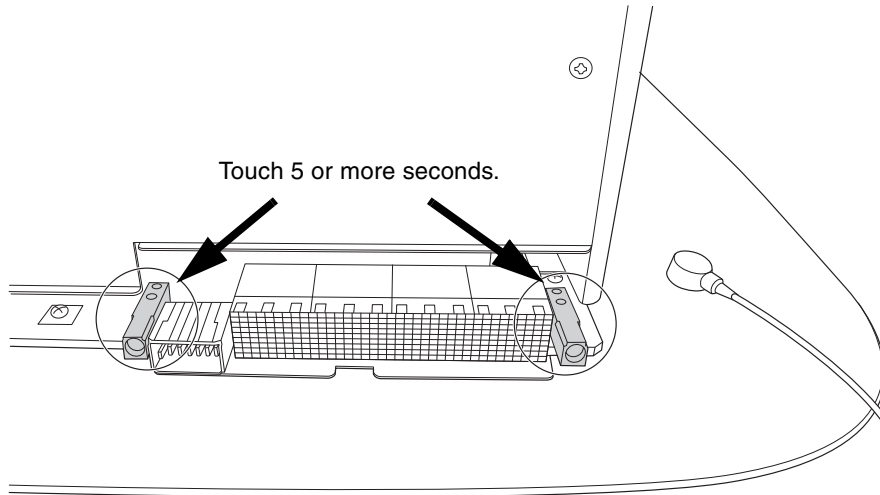
FIGURE 1-5 Guide Block (IOU)

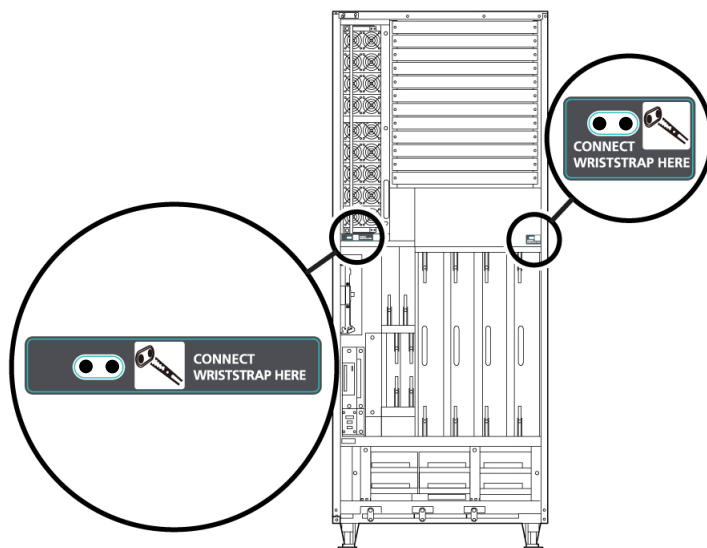
FIGURE 1-6 M8000 Grounding Port Connection Locations for the Wrist Strap Clip and the Antistatic Conductive Mat (Front View)

The grounding port can be used to connect the clip of the antistatic wrist strap and the antistatic conductive mat.

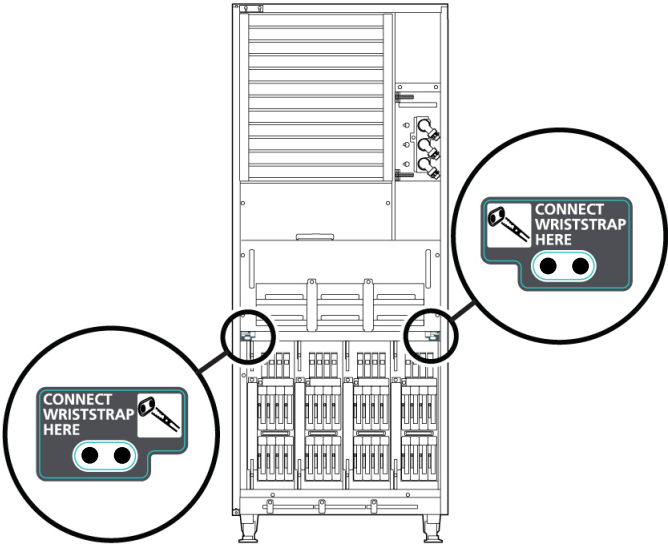
FIGURE 1-7 M8000 Grounding Port Connection Locations for the Wrist Strap Clip and the Antistatic Conductive Mat (Rear View)

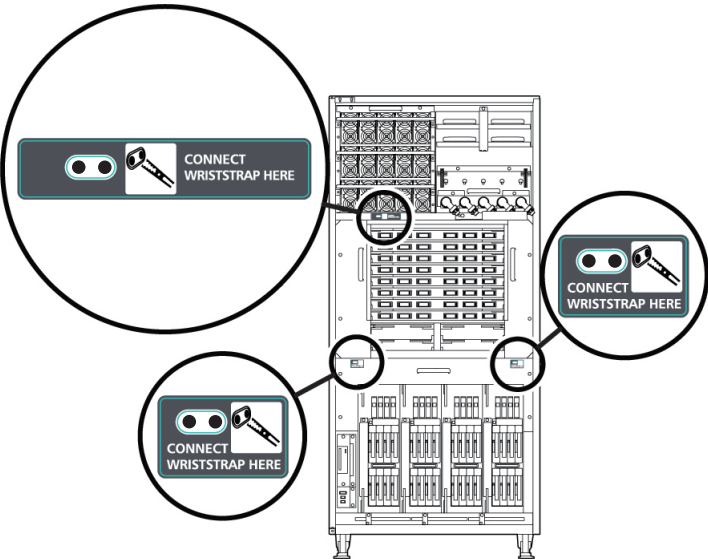
FIGURE 1-8 M9000 Grounding Port Connection Locations for the Wrist Strap Clip and the Antistatic Conductive Mat (Front View)

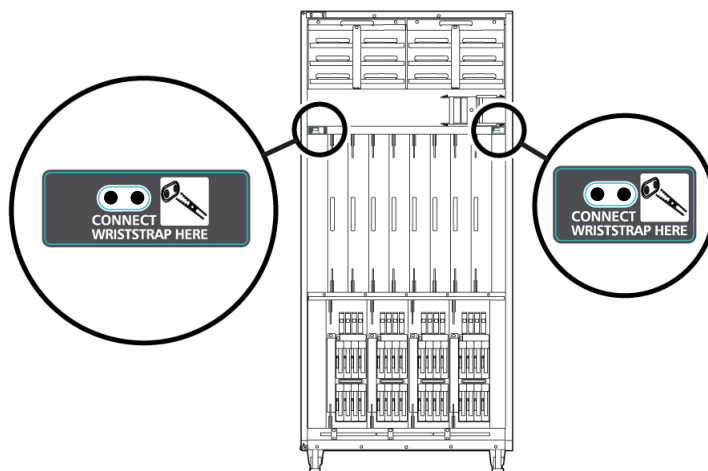
FIGURE 1-9 M9000 Grounding Port Connection Locations for the Wrist Strap Clip and the Antistatic Conductive Mat (Rear View)
