SPARC Enterprise™ M8000/M9000 Servers Product Notes

For XCP Version 1093

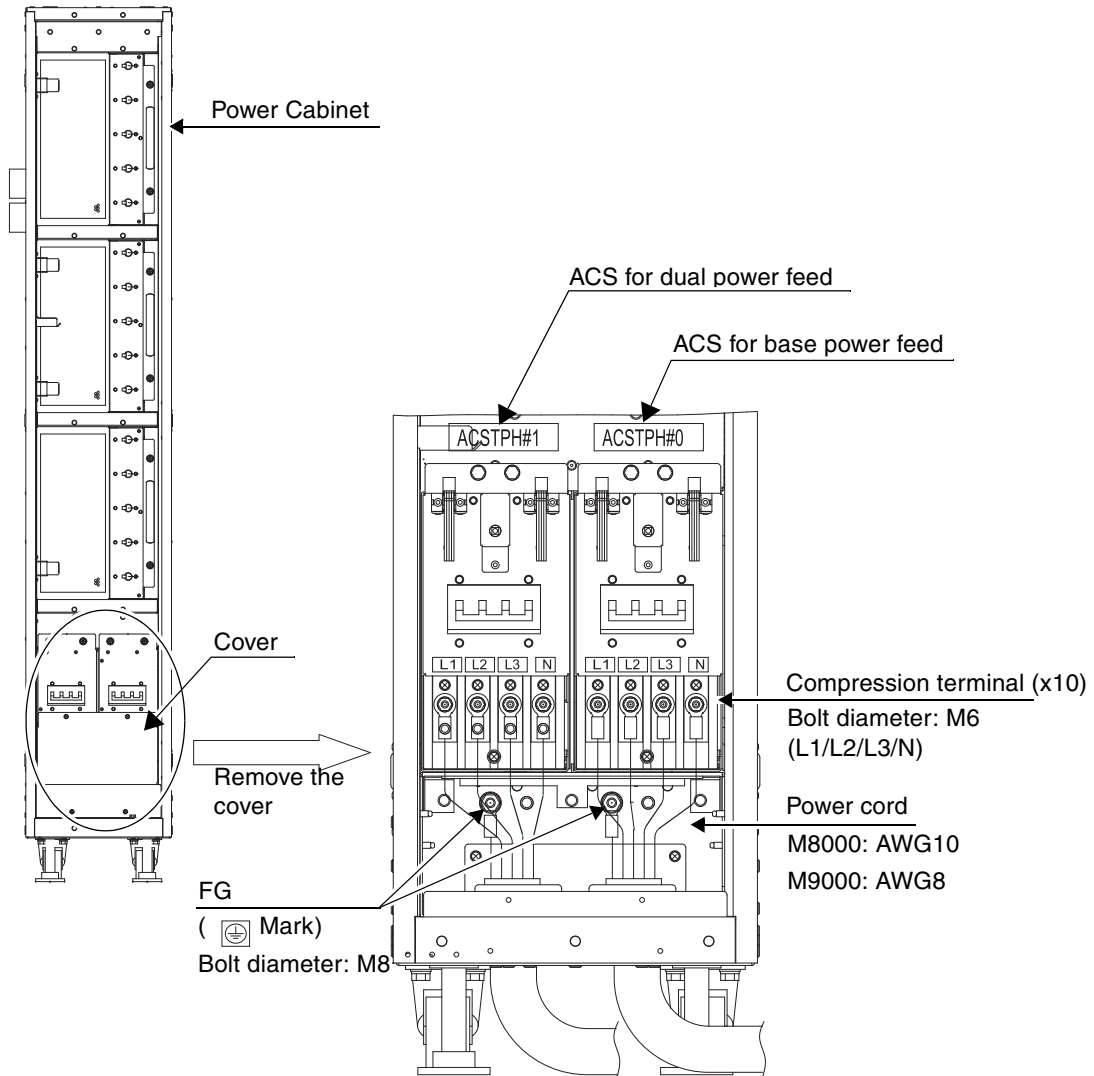
FIGURE 3-9 Three-Phase Star Power Supply Connections

Make sure that the facility administrator or a qualified electrician performs the electrical work.

3-22	FIGURE 3-9, "Three-Phase Star Power Supply Connections" in Section 3.3.3 will be changed. See “Power Cord Connection Specifications” on page 21 for detail.
	3-24	Circuit breaker capacity of customer panel board (Europe) for 3 phase-star power supplies in Table 3-9 will be corrected. The value for SPARC Enterprise M8000 server should be 32A, not 30A.
