SPARC Enterprise M3000/M4000/M5000/ M8000/M9000 Servers

Product Notes for XCP Version 1118

Manual Code: C120-0004-01EN
October 2014, Revision A

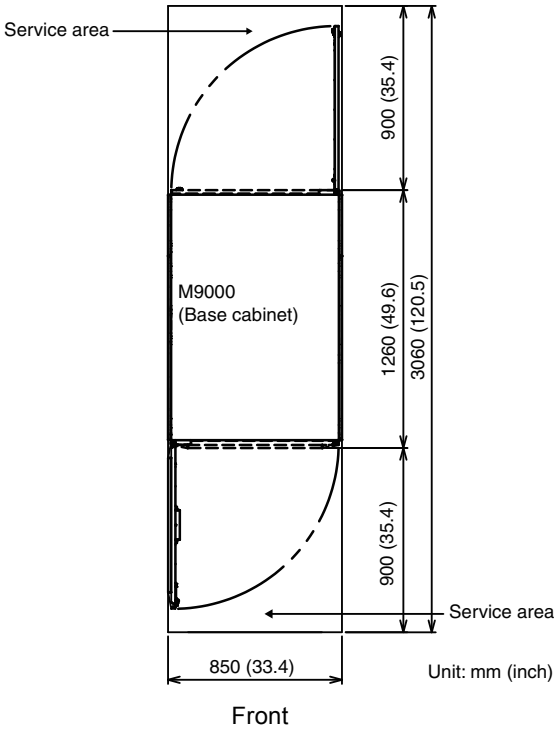
FIGURE 1-13 M9000 Server (Base Cabinet) Installation Area

SPARC Enterprise M8000/M9000 Servers Site Planning Guide	1-18	A part of values in inches on FIGURE 1-13 to FIGURE 1-16 will be corrected. For detail, see “M9000 Servers Installation Area” on page 119 .
	1-35	For the order number of Vibration-proof bracket and Vibration-proof feet, see “Miscellaneous Information” on page 123 .
SPARC Enterprise M8000/M9000 Servers Service Manual	7-8	The mounting location of I/O Unit (IOU) indicated on FIGURE 7-4 will be corrected. For detail, see “I/O Unit (IOU) Mounting Locations” on page 122 ."

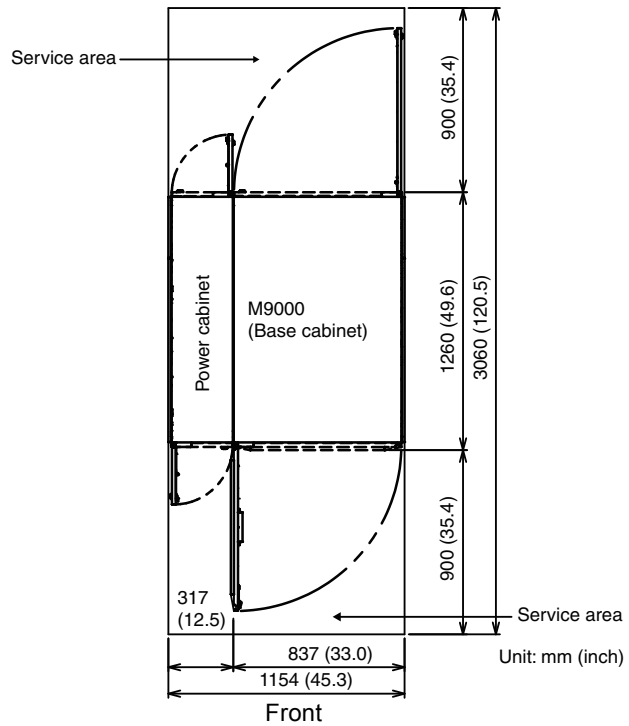
FIGURE 1-14 M9000 Server (Base Cabinet) + Power Cabinet Installation Area

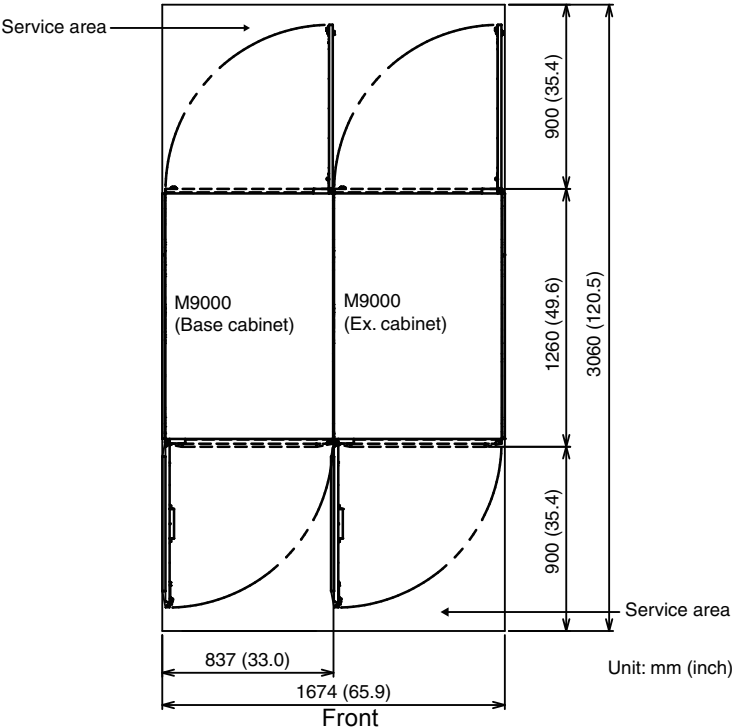
FIGURE 1-15 M9000 Server (Base Cabinet + Expansion Cabinet) Installation Area

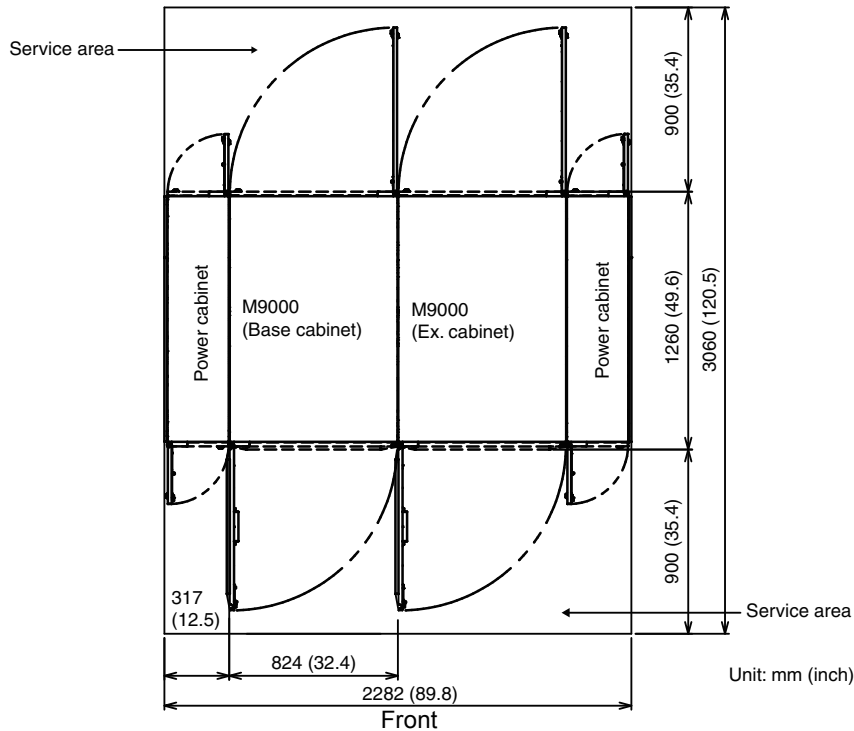
FIGURE 1-16 M9000 Server (Base Cabinet + Expansion Cabinet) + Power Cabinet Installation Are

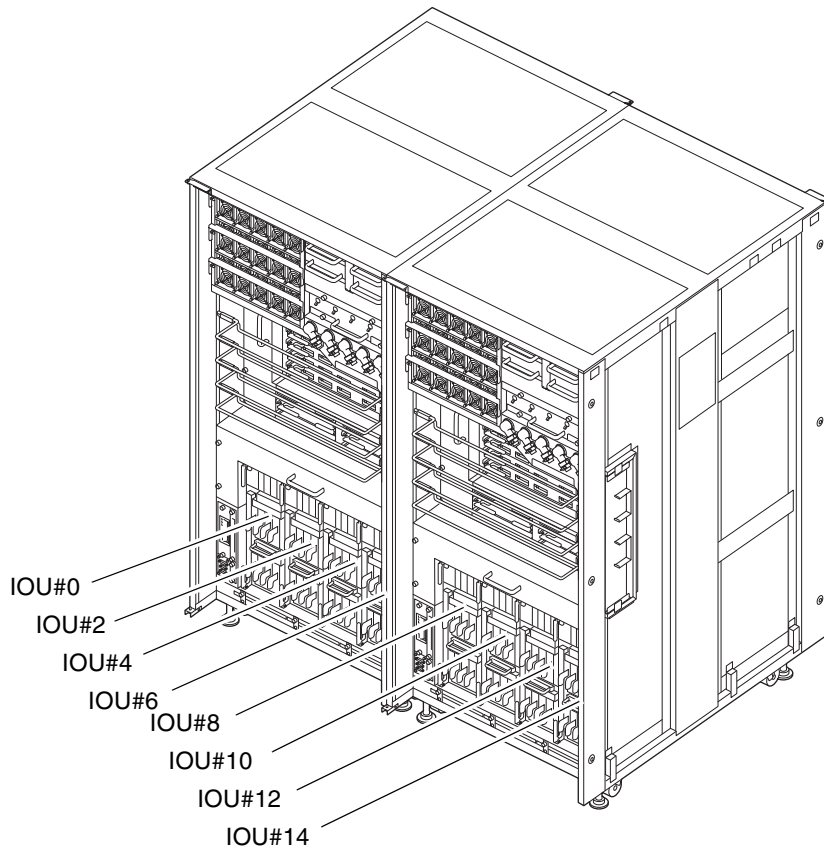
FIGURE 7-4 shows the mounting locations of IOUs in the M9000 server (with the expansion cabinet).

FIGURE 7-4 IOU Mounting Locations (Front of M9000 with the Expansion Cabinet)
