**SPARC Enterprise M3000/M4000/M5000/
M8000/M9000 Servers**

Product Notes for XCP Version 1110

Manual Code: C120-E669-01EN
January 2012, Revision A

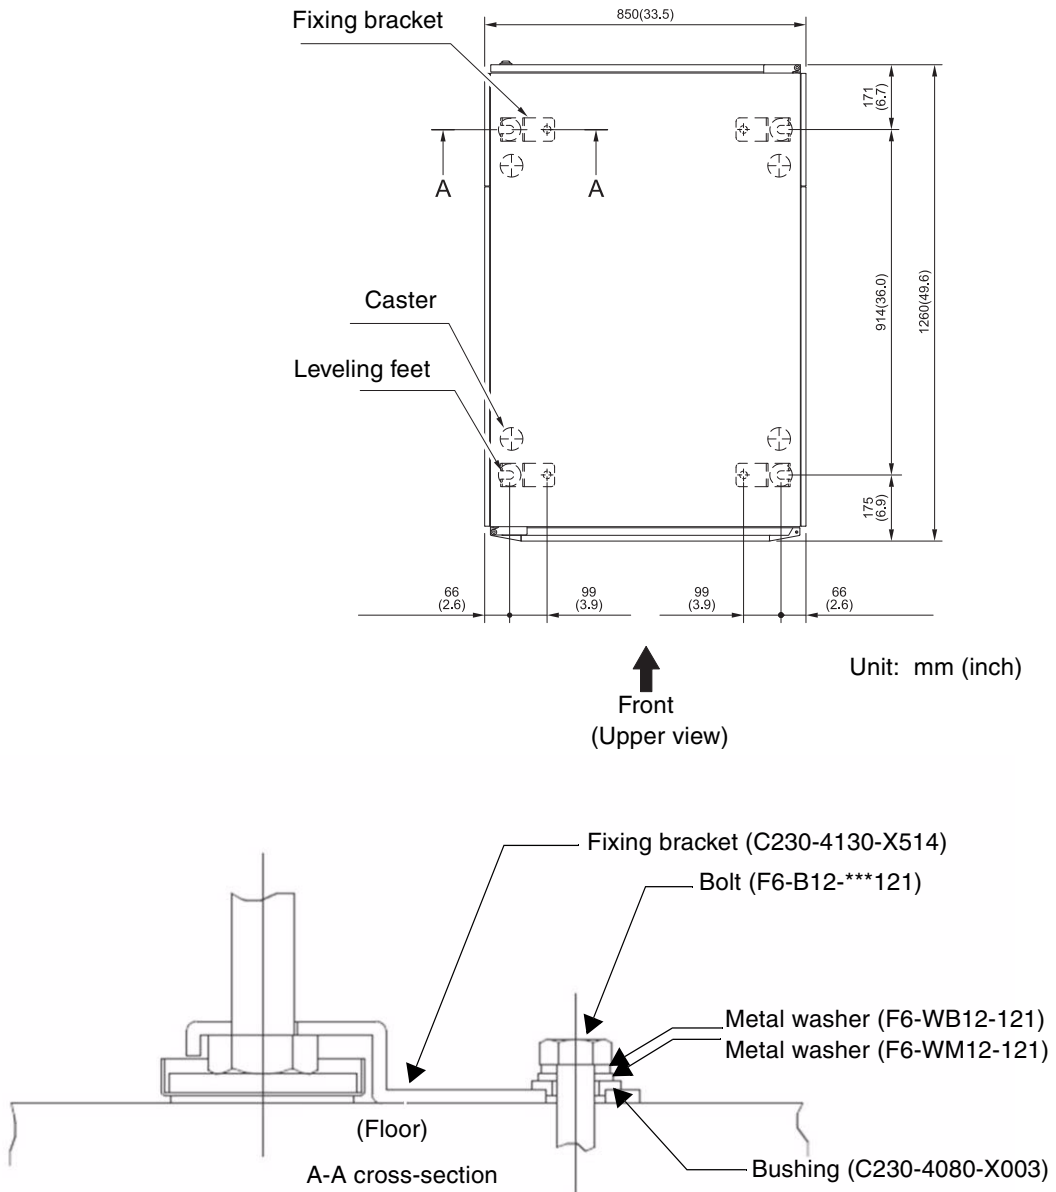
FIGURE 6-1 Example of Securing the Cabinet to the Floor Surface Using the Fixing Bracket (M9000 Server)

Note – Consult with the company that constructed the building because the length depends on the structure of the building.

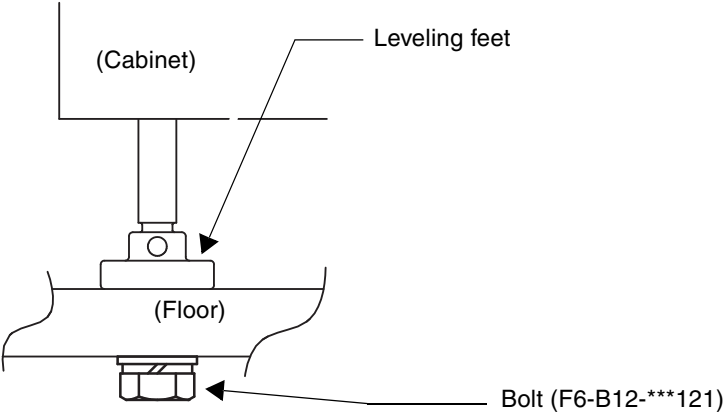
FIGURE 6-2 Example of Securing the Cabinet Through a Hole in the Floor
