**SPARC Enterprise M3000/M4000/M5000/
M8000/M9000 Servers**

Product Notes for XCP Version 1111

Manual Code: C120-E672-01EN
April 2012, Revision A

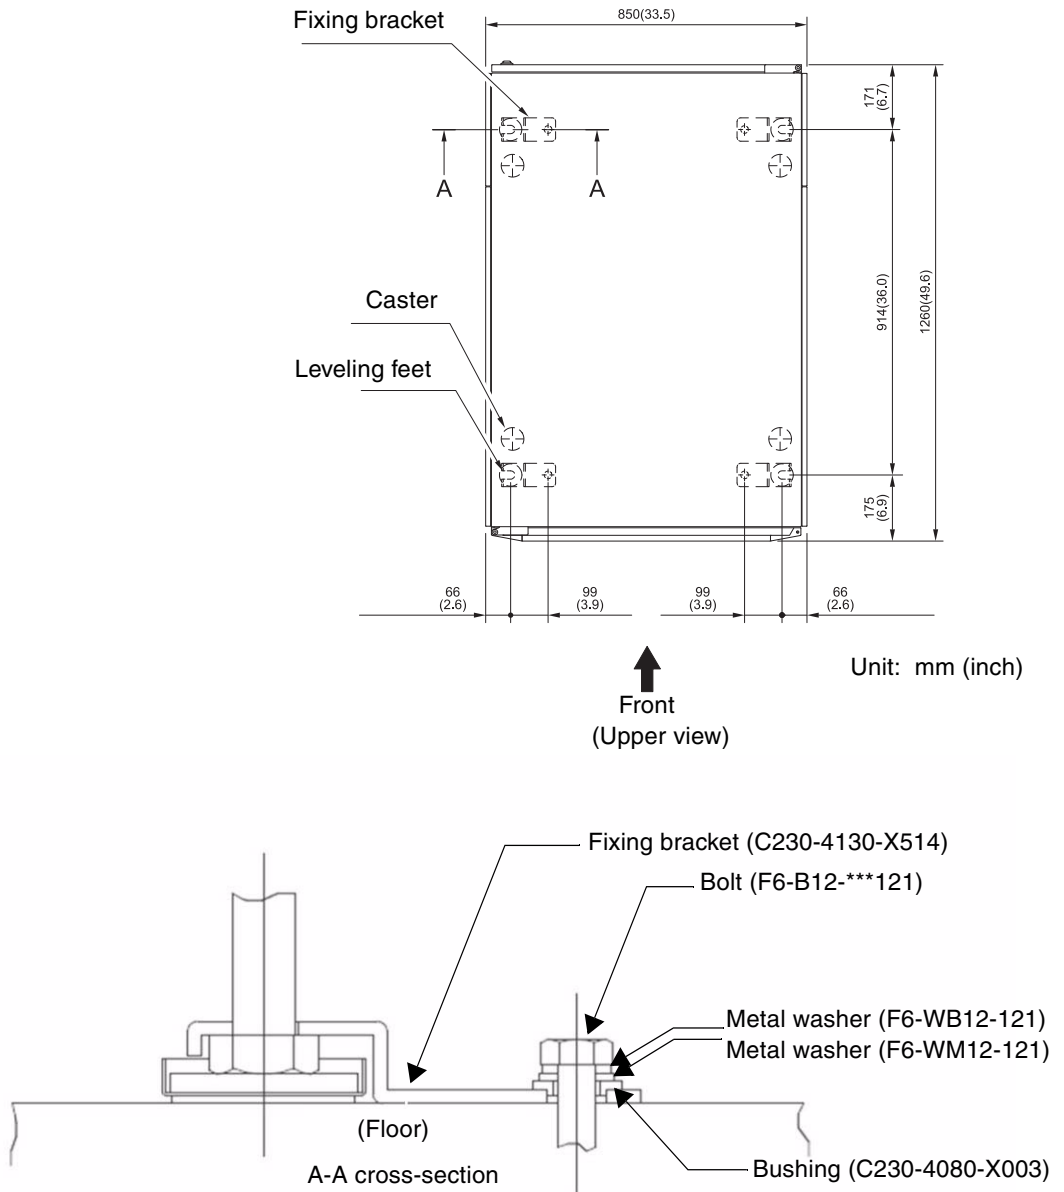
FIGURE 6-1 Example of Securing the Cabinet to the Floor Surface Using the Fixing Bracket (M9000 Server)

Note – Consult with the company that constructed the building because the length depends on the structure of the building.

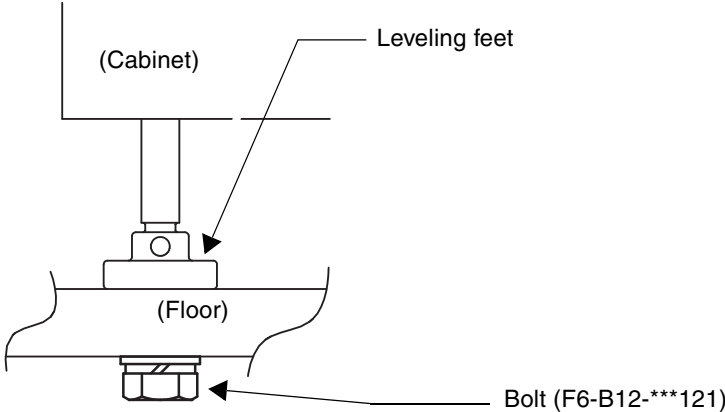
FIGURE 6-2 Example of Securing the Cabinet Through a Hole in the Floor
