**SPARC Enterprise M3000/M4000/M5000/
M8000/M9000 Servers**

Product Notes for XCP Version 1112

Manual Code: C120-E673-02EN
June 2012, Revision B

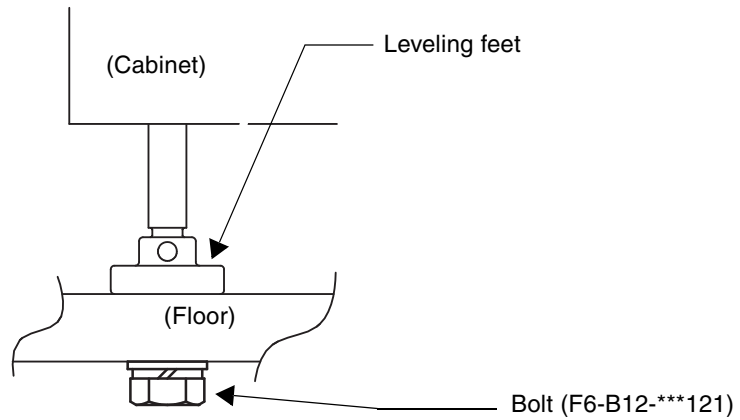
FIGURE 6-2 Example of Securing the Cabinet Through a Hole in the Floor
