SPARC Enterprise M3000/M4000/M5000/ M8000/M9000 Servers

Product Notes for XCP Version 1123

Manual Code: C120-0062-02EN
December 2017, Revision A

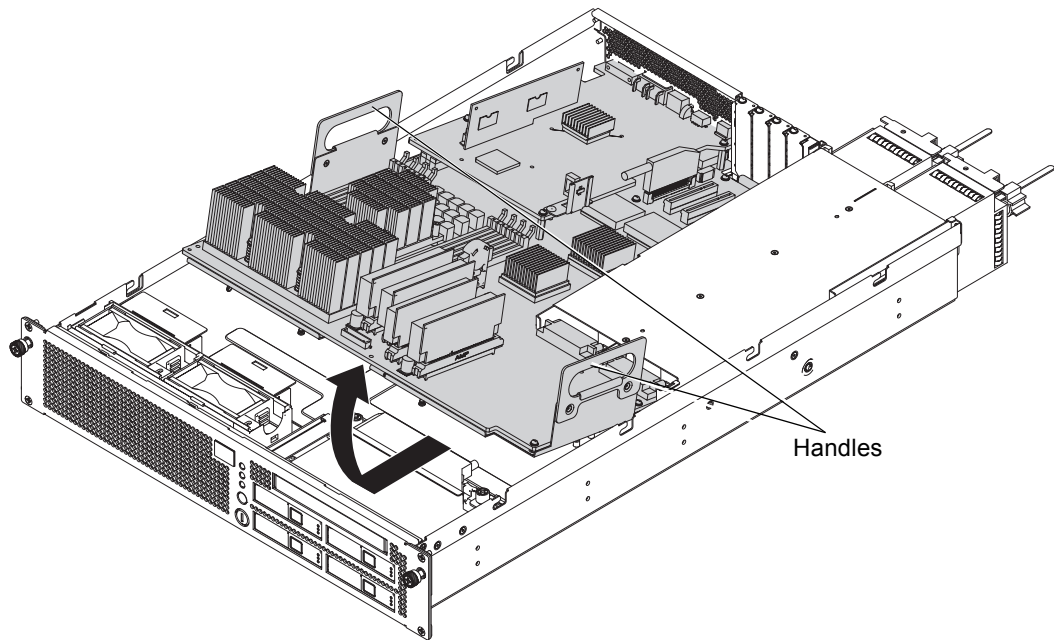
FIGURE 6-5 Removing the Motherboard Unit

2. Hold the two opaque handles on both sides of the motherboard unit and lift the motherboard unit while sliding it out.

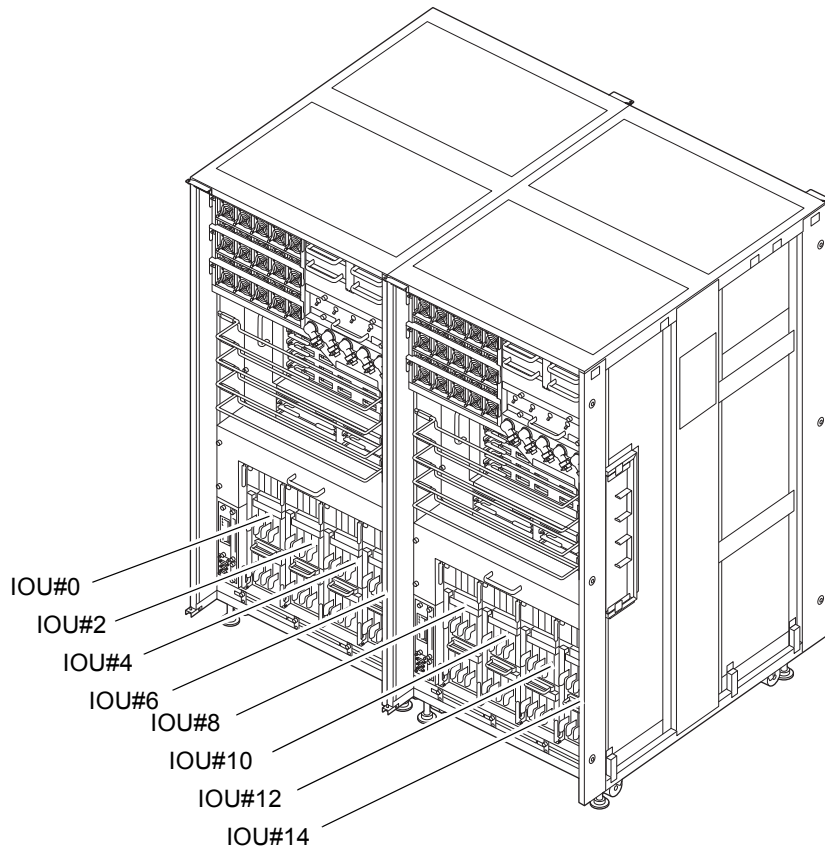
FIGURE 7-4 IOU Mounting Locations (Front of M9000 with the Expansion Cabinet)

FIGURE 7-4 shows the mounting locations of IOUs in the M9000 server (with the expansion cabinet).

SPARC Enterprise M8000/M9000 Servers Site Planning Guide	1-18	A part of values in inches on FIGURE 1-13 to FIGURE 1-16 will be corrected. For detail, see “M9000 Servers Installation Area” on page 123.
	1-35	For the order number of Vibration-proof bracket and Vibration-proof feet, see “Miscellaneous Information” on page 127.
SPARC Enterprise M8000/M9000 Servers Service Manual	7-8	The mounting location of I/O Unit (IOU) indicated on FIGURE 7-4 will be corrected. For detail, see “I/O Unit (IOU) Mounting Locations” on page 126.”

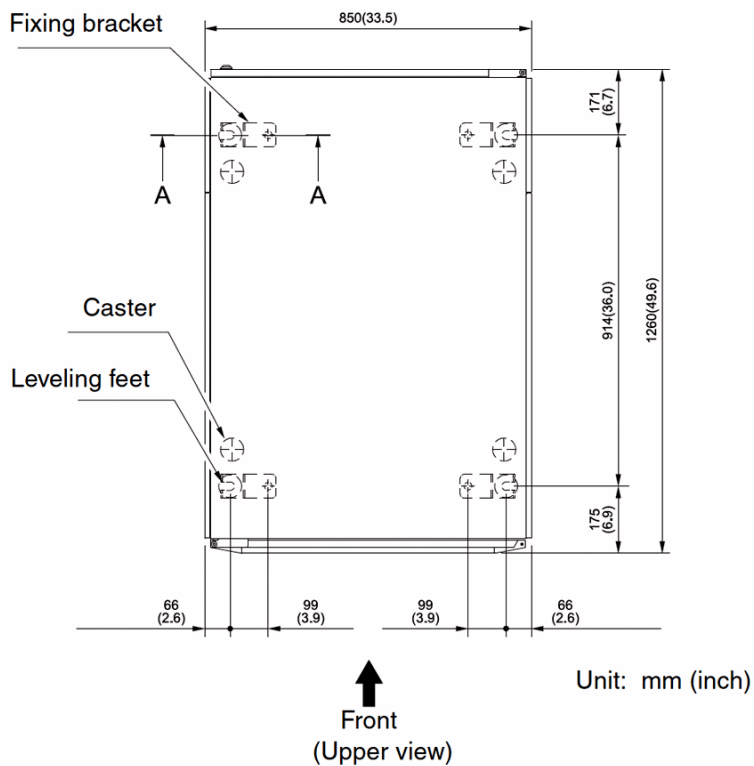
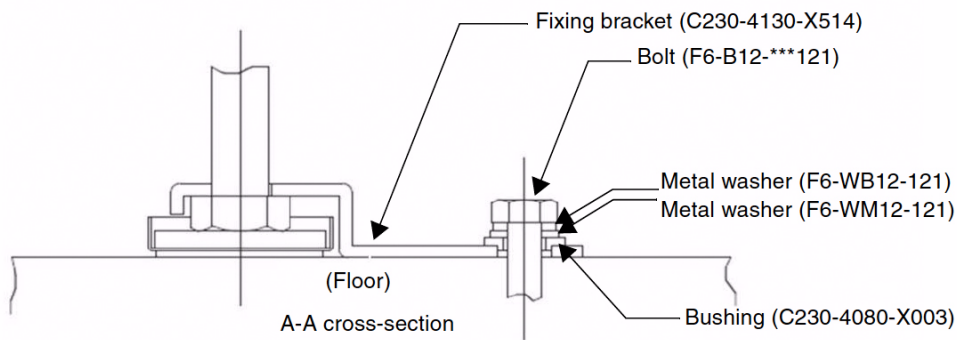
FIGURE 6-1 Example of Securing the Cabinet to the Floor Surface Using the Fixing Bracket (M9000 Server)

Note – Consult with the company that constructed the building because the length depends on the structure of the building.
