Fujitsu M10/SPARC M10 Systems

Product Notes for XCP Version 2050

Manual Code: C120-E703-03EN
April 2014

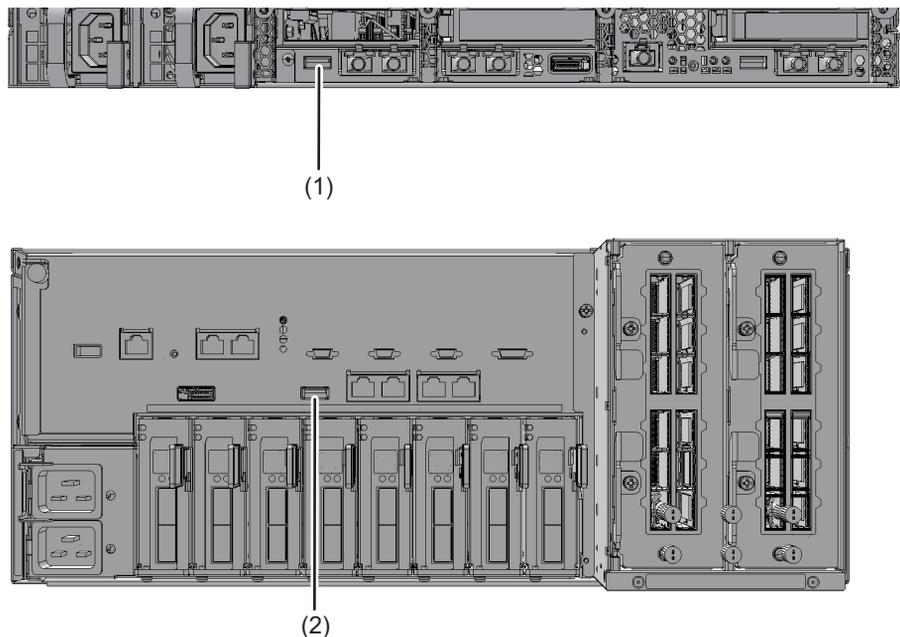
Figure 8-1 USB ports for DVD drive connection on SPARC M10 Systems (rear)

DVD-connectable USB port (rear)

No.	Component
1	USB port for connecting a DVD drive (SPARC M10-1)
2	USB port for connecting a DVD drive (SPARC M10-4/M10-4S)
