Fujitsu M10/SPARC M10 Systems

Product Notes for XCP Version 2041

Manual Code: C120-E698-03EN
October 2013

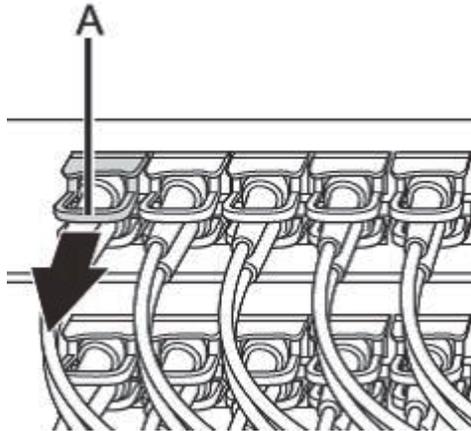
Figure 8-1 Tabs and pull-out directions of crossbar cables

Hold the tab (A in Figure 8-1) of the crossbar cable (optical), and pull it straight in the arrow direction to remove it. At this time, do not hold the cable part when pulling it out. If you pull the cable part, the connector is not unlocked completely, which may cause a damage.
 - b. Reattach labels of the removed cables.

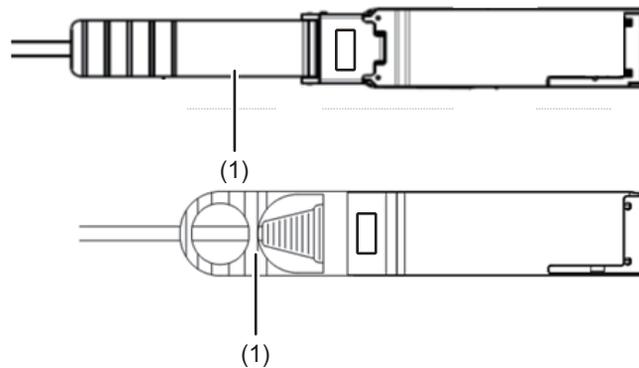
Figure 8-2 Shape and tab of crossbar cable (optical)

Note – There are two types of crossbar cables (optical). Connect cables of the same type to the same port number. Cables can be distinguished by tab shape. For tab shape, see Figure 8-2.

Number in figure	Description
1	Tab

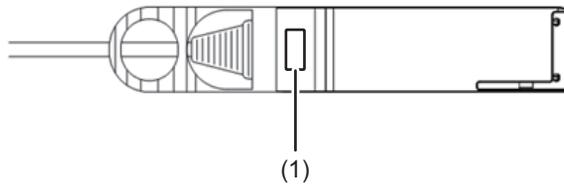
Figure 8-3 Shape and tab of link cable (optical)

Note - The two link cables are the same. Each cable has the same indication labels on the both ends. When connecting cables, ensure that cable ends having the same label are connected to the corresponding positions of the link card and link board.

Number in figure	Description
1	Tab

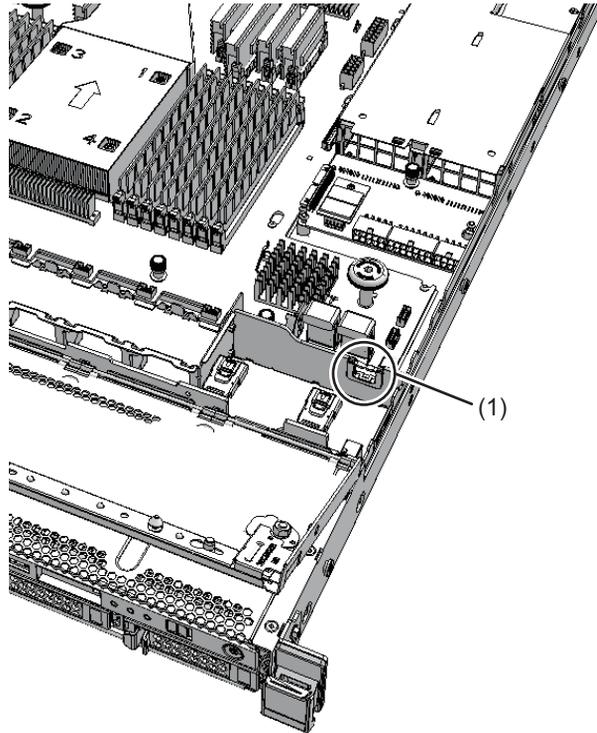
Figure 8-4 Location of cable guide

6. Store cables of the motherboard unit in the cable guide.

Location number	Component
1	Cable guide

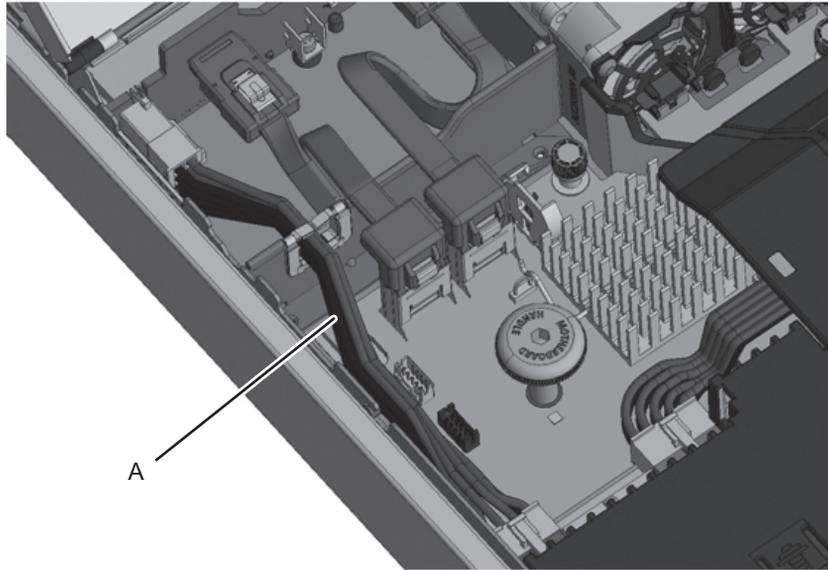
Figure 8-5 Storing cable (red/black)

- a. Store the cable (red/black) (A in the figure) connecting the HDD backplane to the PSU backplane in the cable guide from the middle of the clamp.

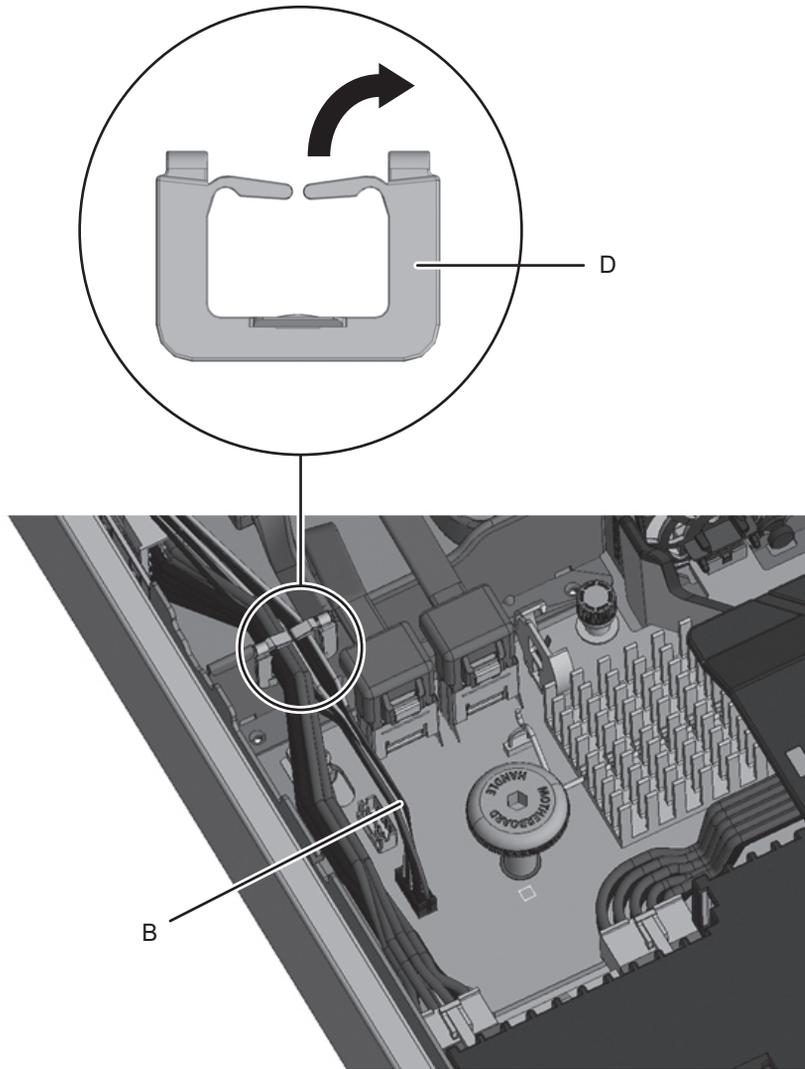
Figure 8-6 Storing cables (black/yellow/white)

- b. Push up one side of the clamp at upper part of the cable guide from the middle to open it (D in the figure). Then, store the cables (black/yellow/white) (B in the figure) connecting the operation panel to the motherboard unit in the cable guide.

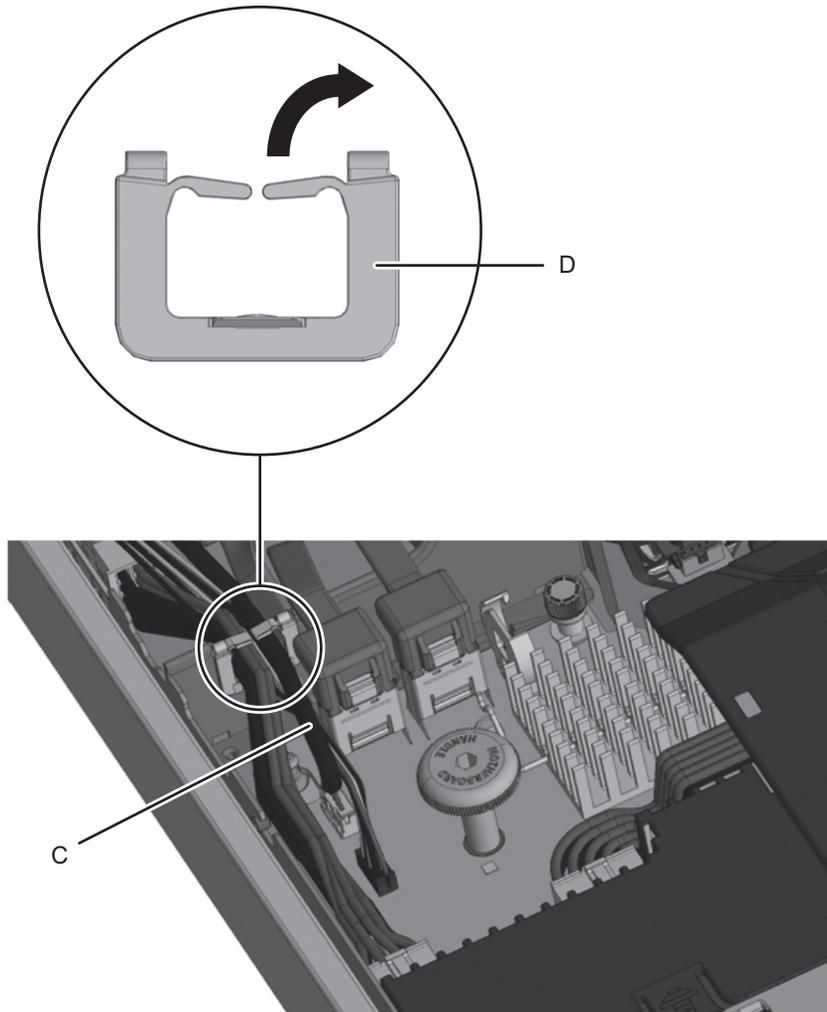
Figure 8-7 Storing cable (black)

- c. Push up one side of the clamp at upper part of the cable guide from the middle to open it (D in the figure). Then, store the cable (black) (C in the figure) connecting the operation panel to the motherboard unit in the cable guide.

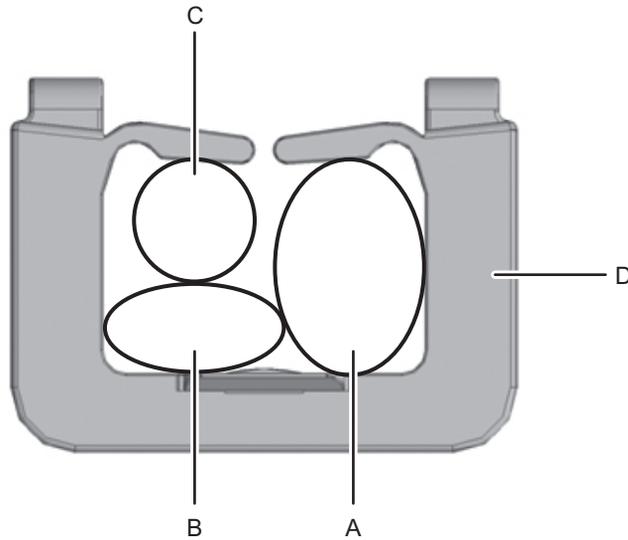
Figure 8-8 Cross section of the guide viewed from the front, after storage of the cables

d. Confirm that each cable is stored in the cable guide, as shown in Figure 8-8.

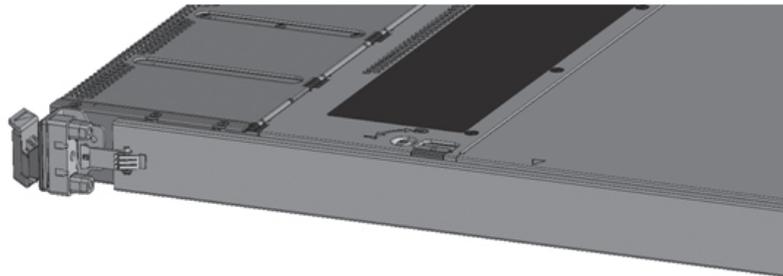
Figure 8-9 Attaching fan unit cover

- e. Confirm that each laid-out cable will not interfere with the fan unit cover, and attach the fan unit cover.

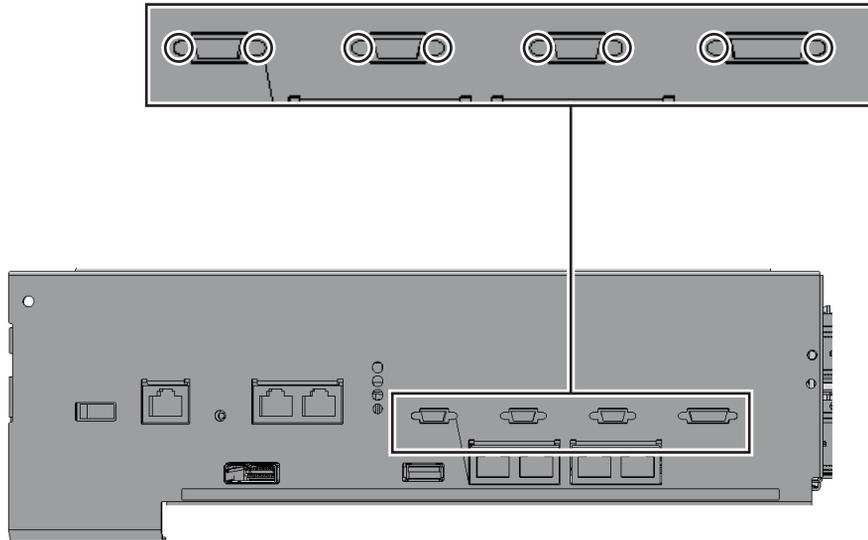
Figure 8-10 Screw positions at both ends of XSCF cable connection port (for SPARC M10-4S)

For SPARC M10-4, this procedure is not necessary.

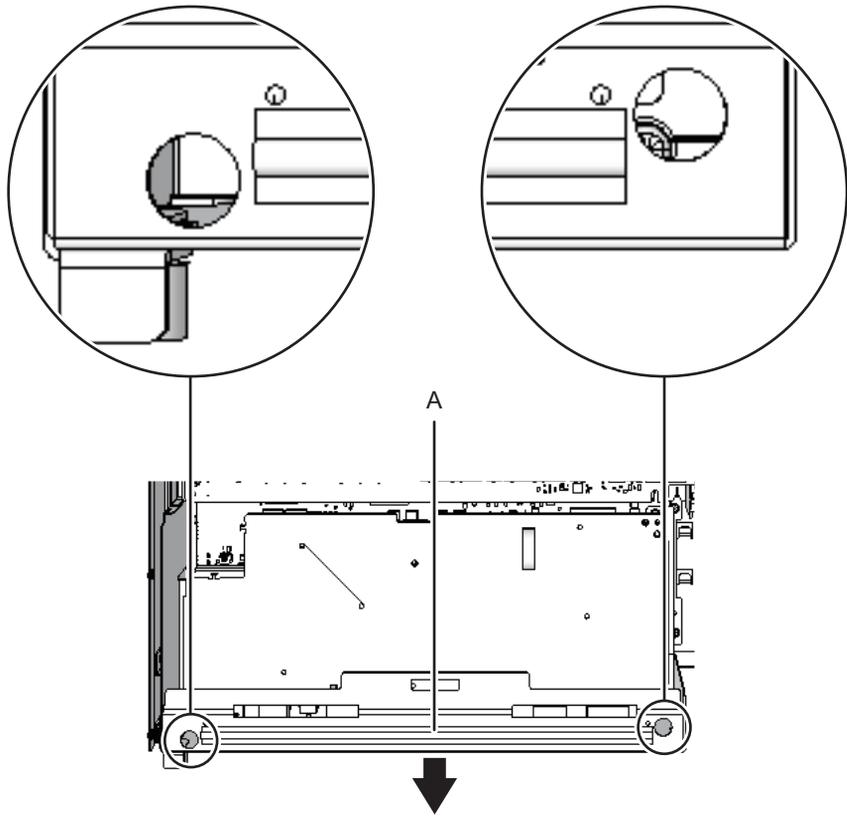
Figure 8-11 Removing rear cover

2. **Loosen the two screws from the upper part of the rear side of the CPU memory unit lower. Then, remove the rear cover (A in the figure) by pulling it to the direction of arrow.**

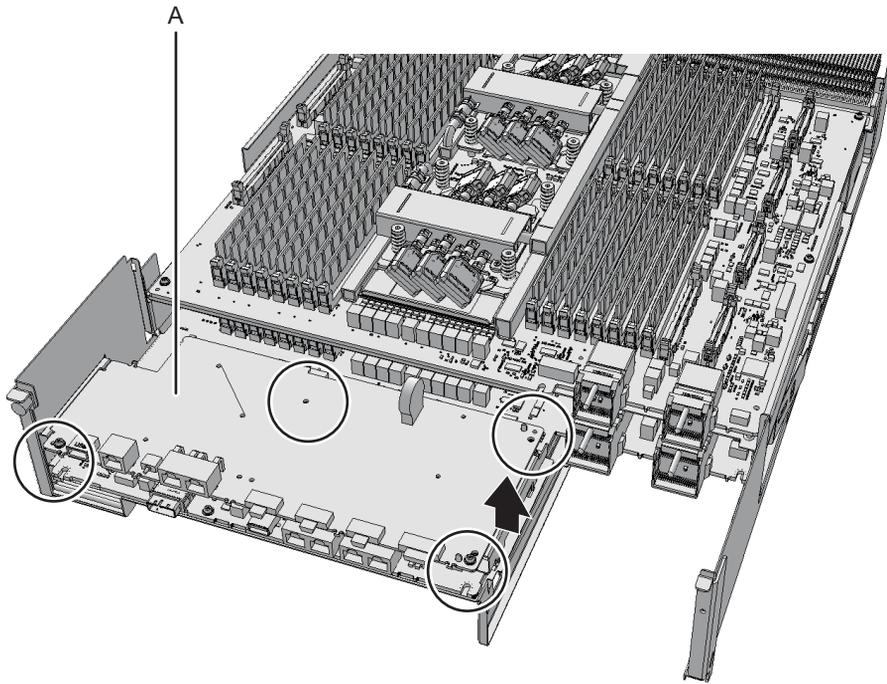
Figure 8-12 Releasing connected XSCF board

3. **Remove the XSCF board.**
 - For SPARC M10-4S, remove the four screws fixing the XSCF board (A in the figure). Then, lift the right side of the XSCF board to release connection of the connector.

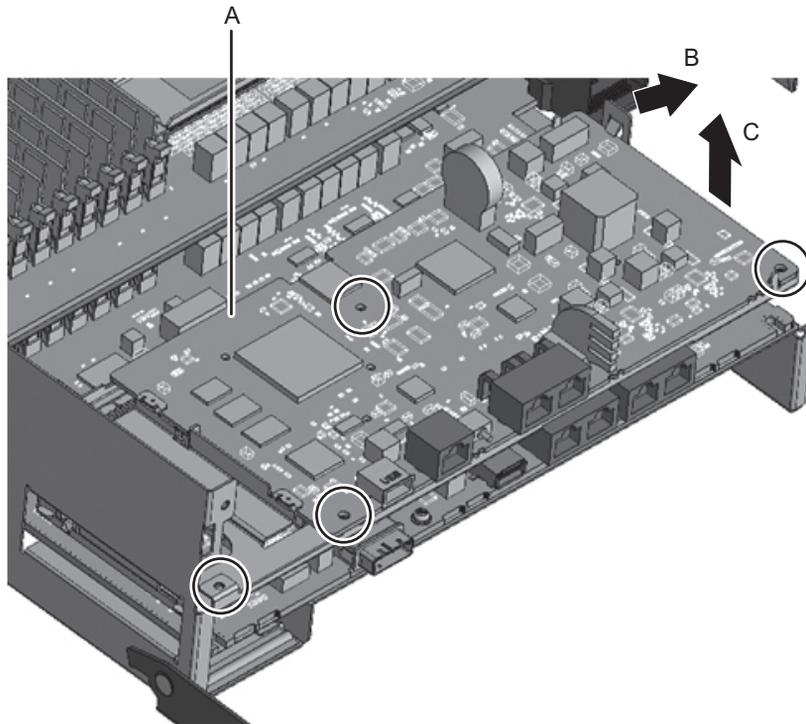
Figure 8-13 Releasing connection of XSCF board (for SPARC M10-4)

- For SPARC M10-4, remove the four screws fixing the XSCF board (A in the figure) and rear cover. Tilt the right lever of the XSCF mount by fingers about 5 mm (0.2 in.) to the right (B in the figure). Lift up the right side of the XSCF board and release connection of the connector (C in the figure).

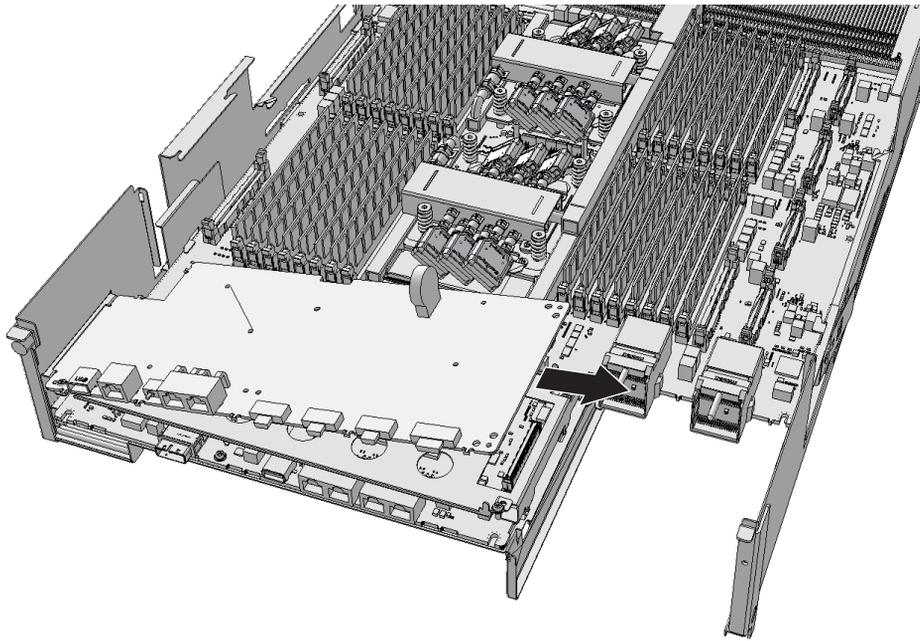
Figure 8-14 Pulling out XSCF board (for SPARC M10-4S)

4. Pull out the XSCF board obliquely to the right direction (arrow).

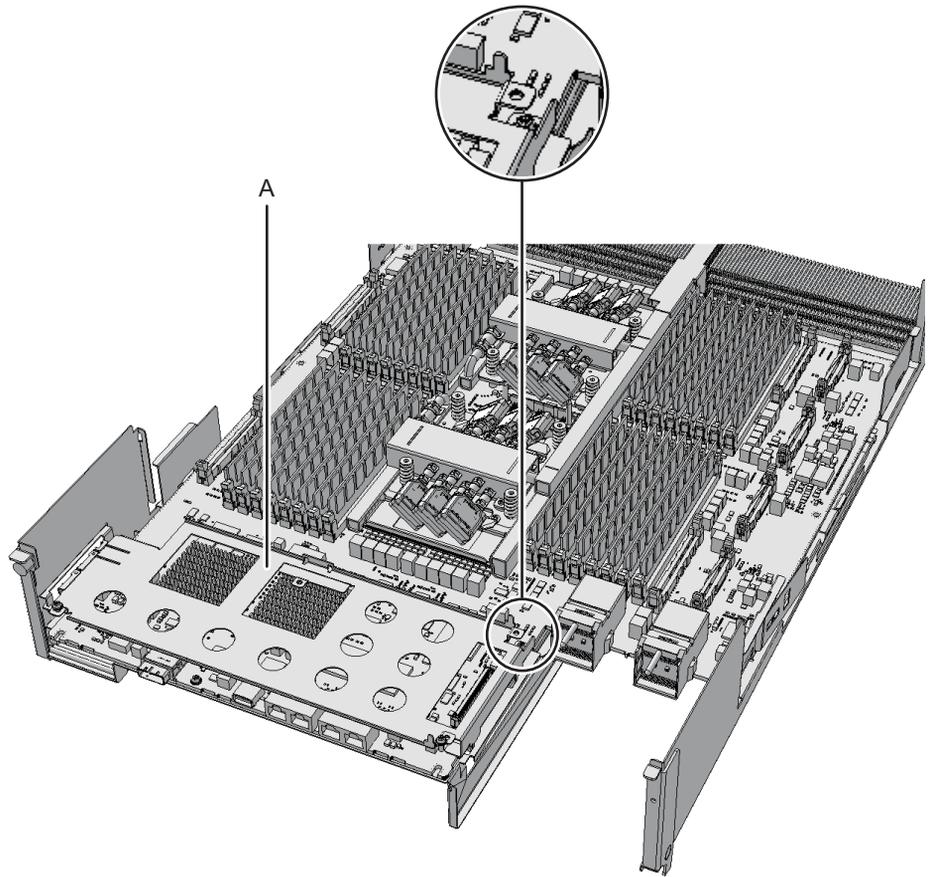
Figure 8-16 Screw fixing XSCF mount (for SPARC M10-4S)

5. Remove the one screw fixing the XSCF mount (A in the figure).

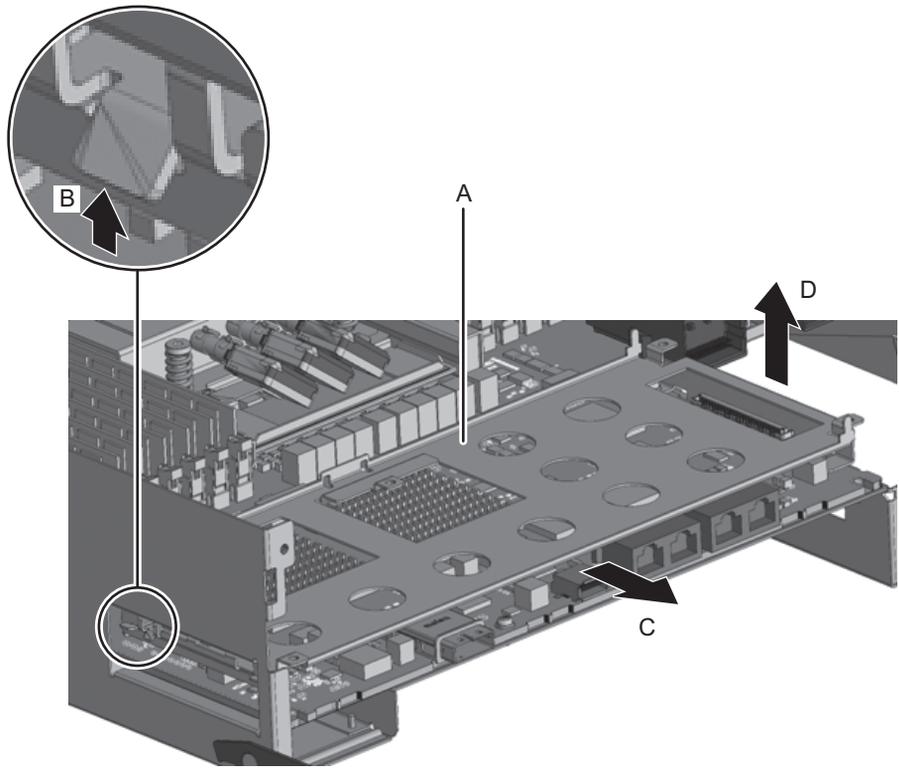
Figure 8-18 Removing XSCF mount (for SPARC M10-4S)

6. Lift up the left projecting lever of the XSCF mount (A in the figure) by fingers about 2 mm (0.1 in.) (B in the figure) and slide it to the front about 8 mm (0.4 in.) (C in the figure). Then, remove it upward (D in the figure).

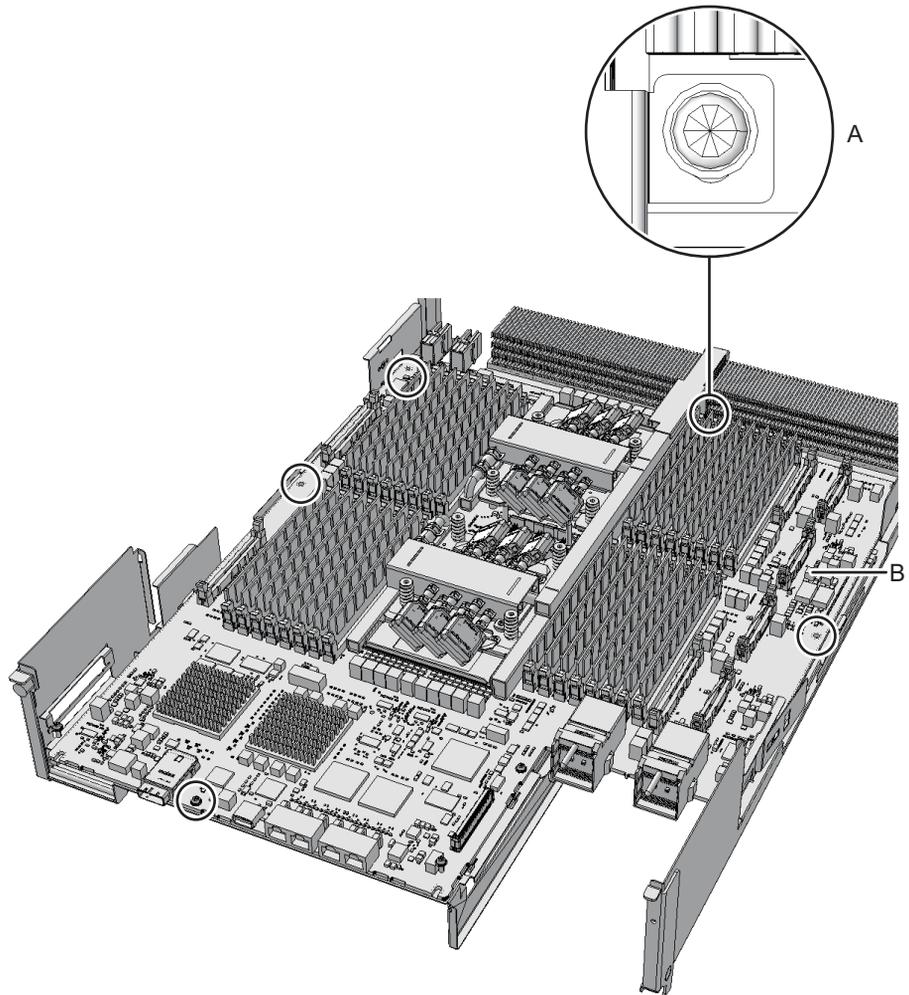
Figure 8-20 Positions of of screws fixing CPU memory unit board

7. Remove the one black screw (A in the figure) fixing the center part of the radiator on the front side and the four screws fixing the CPU memory unit board (B in the figure).

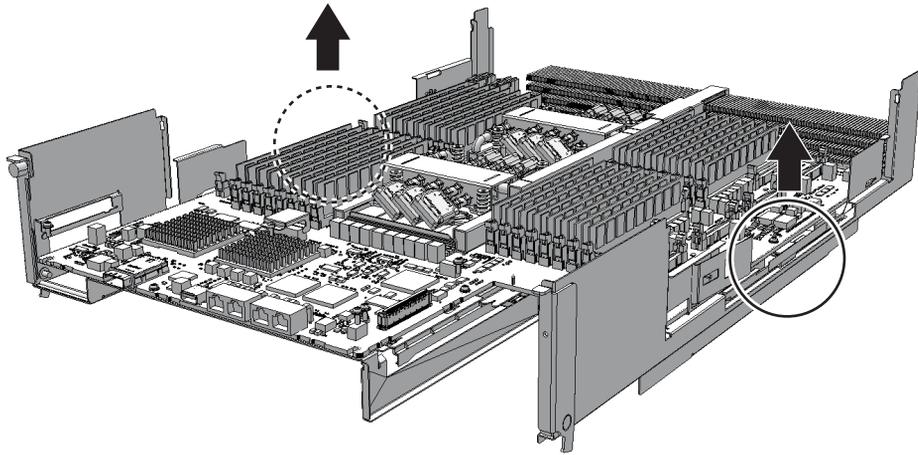
Figure 8-21 Removing CPU memory unit board

8. **Insert your fingers under the board of the connector unit located at the center of the right and left sides of the CPU memory unit board. Lift the CPU memory unit board, and disconnect and remove the connector.**

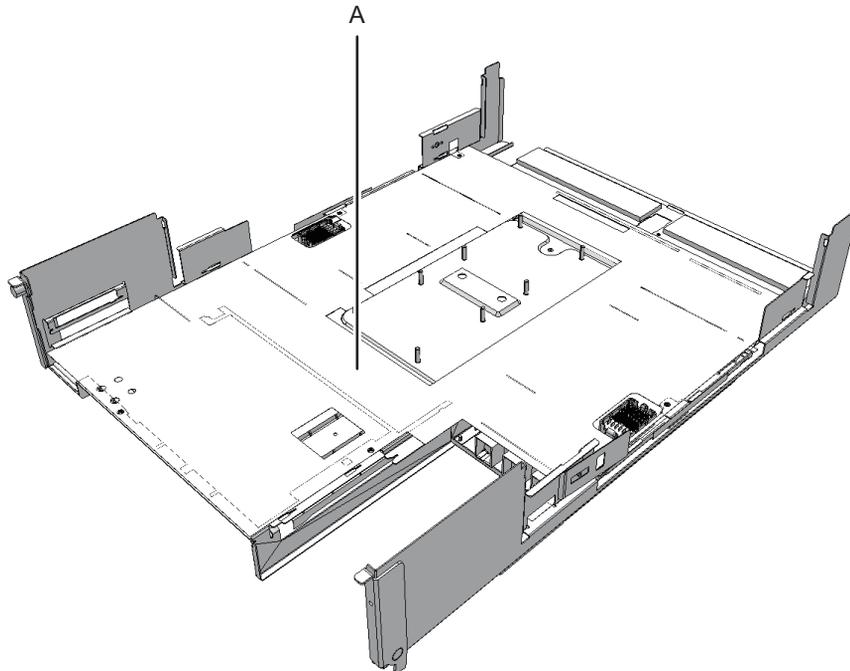
Figure 8-22 Removing sheet

9. **Remove the sheet (A in the figure).**
You can expand the CPU memory unit upper with the operations you have done so far. You do not have to perform Step 10.

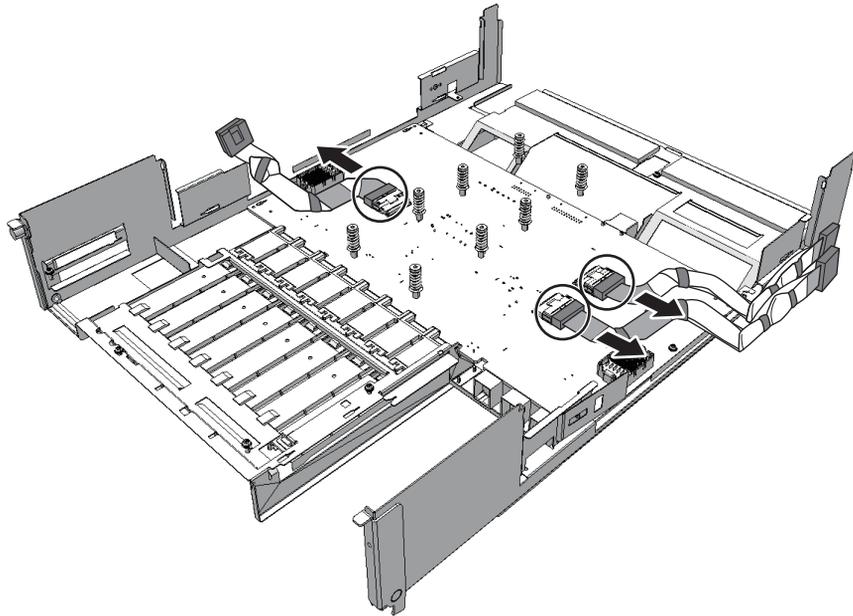
Figure 8-23 Removing PCIe cable

10. **Remove the three PCIe cables.**

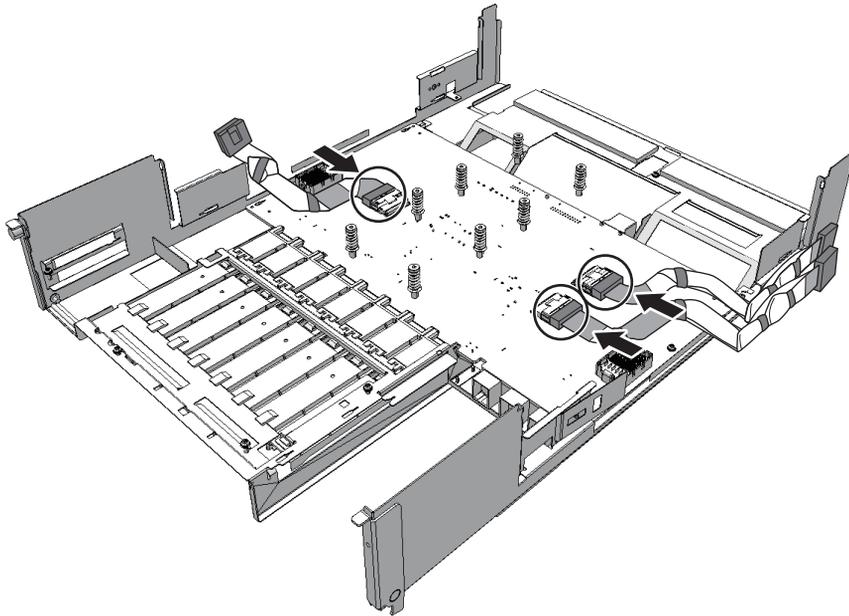
Figure 8-24 Installing PCIe cable

Note - Ensure that the PCIe cables are firmly attached and fixed.

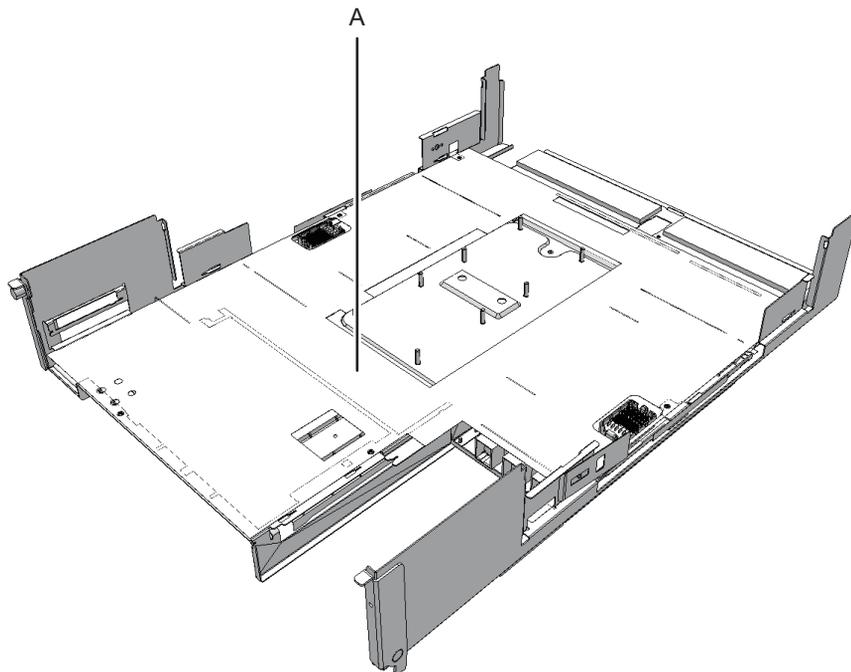
Figure 8-25 Installing sheet

2. Install a sheet (A in the figure).

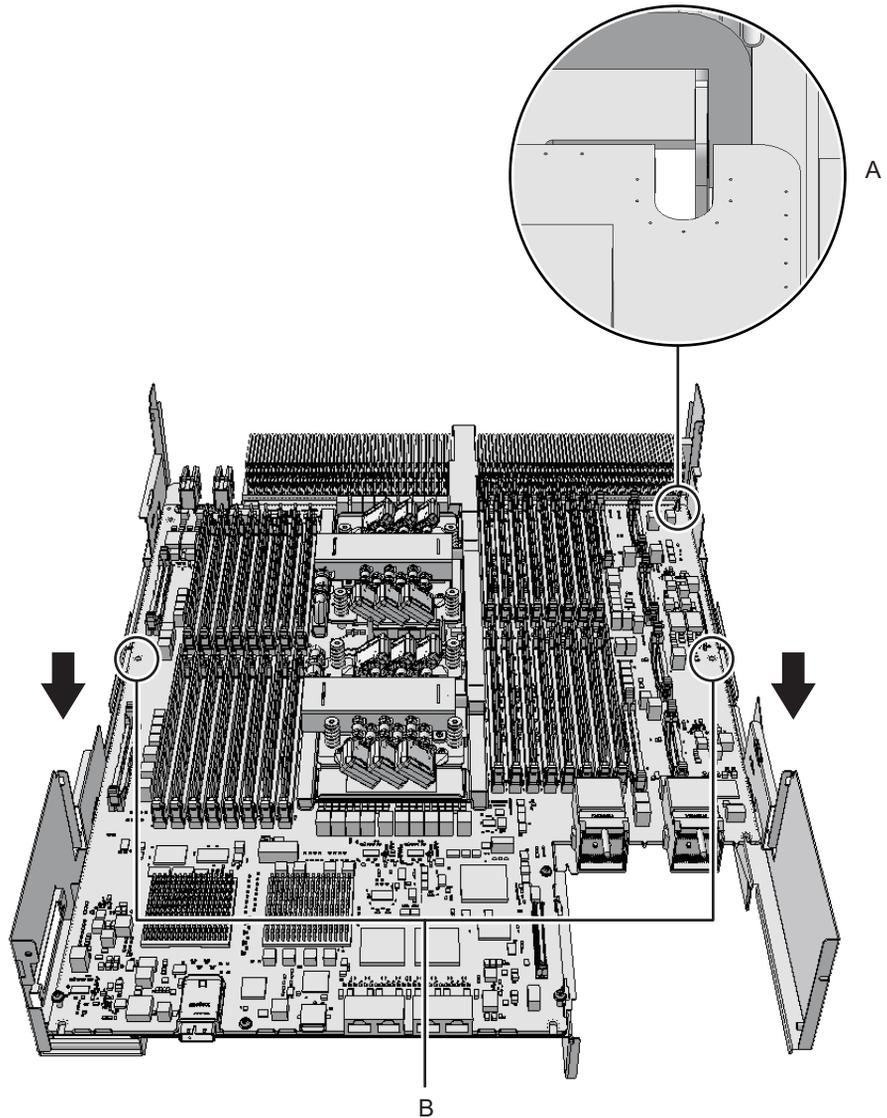
Figure 8-26 Installing CPU memory unit board

3. **Install the CPU memory unit board with the right guide (A in the figure) on the front side of the board as a guide. Press the connector unit (B in the figure) at the center of right and left sides of the CPU memory unit board to connect the connector.**

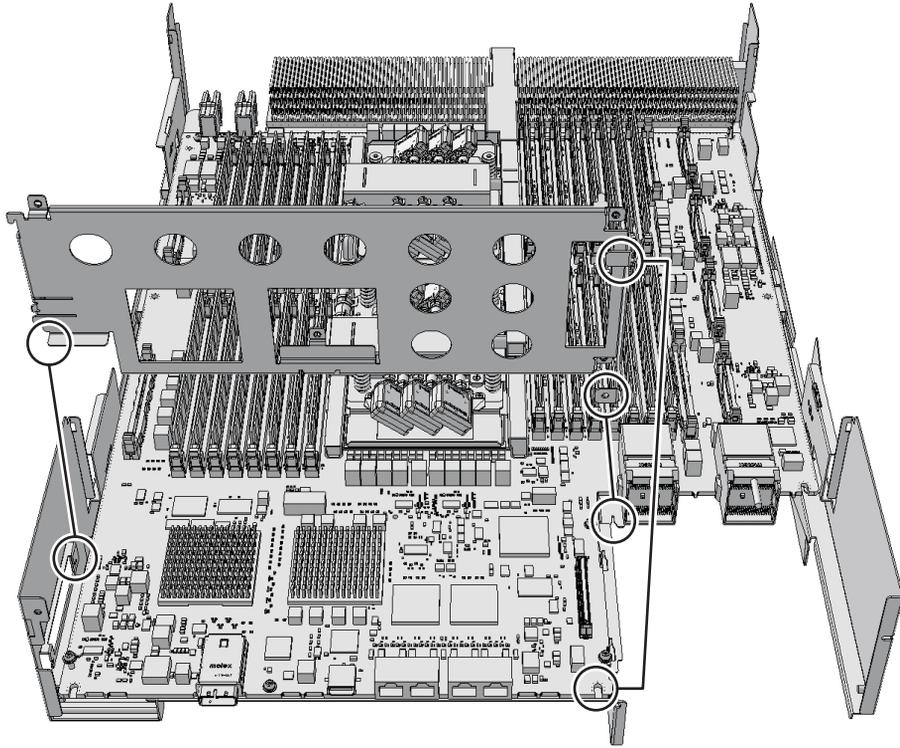
Figure 8-27 Installing XSCF mount

4. **Fix the CPU memory unit board with four screws and center part of the radiator on the front side with one black screw.**
5. **install the XSCF mount by sliding it to the front side, and fix it with one screw.** Align the guide on one part of the left side and the guides on two parts on the lower right side to install the XSCF mount.

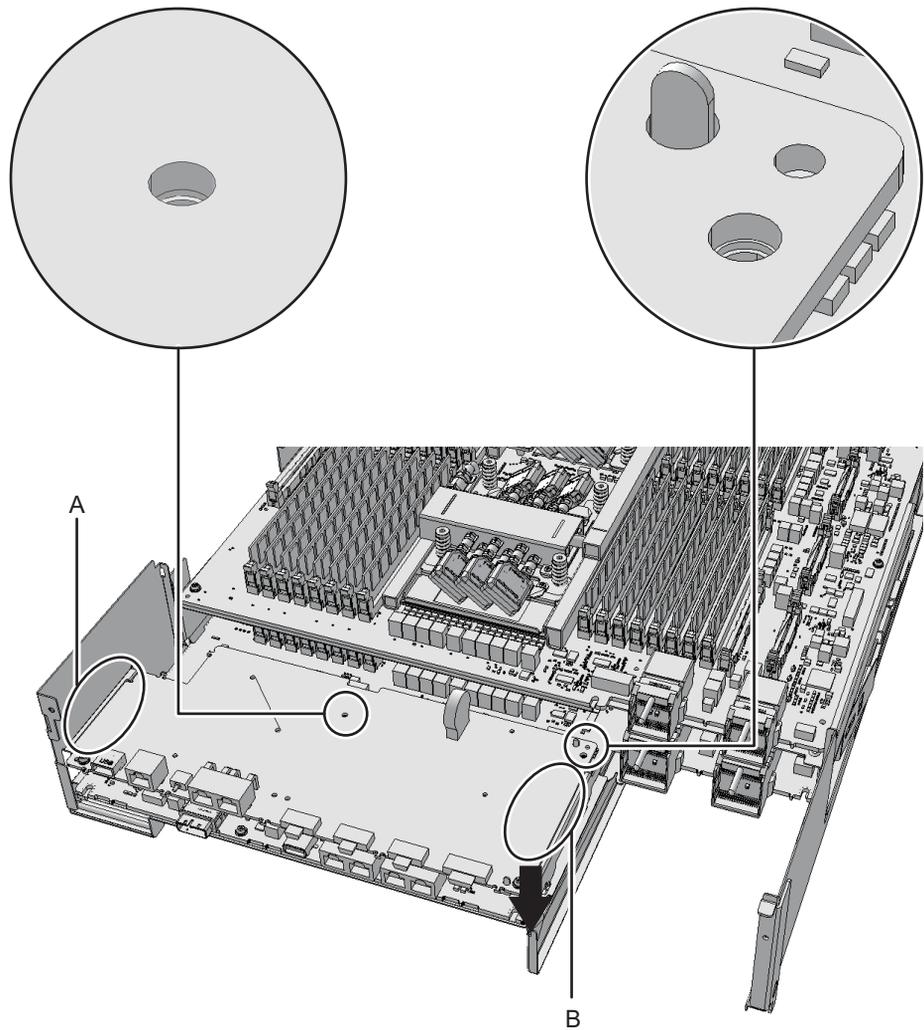
Figure 8-28 Installing XSCF board

6. **Install the XSCF board.**
 - For SPARC 10-4S, insert the XSCF board into the left guide (A in the figure), and press down the right connector unit (B in the figure) to connect the connector. Then, fix it with two screws.

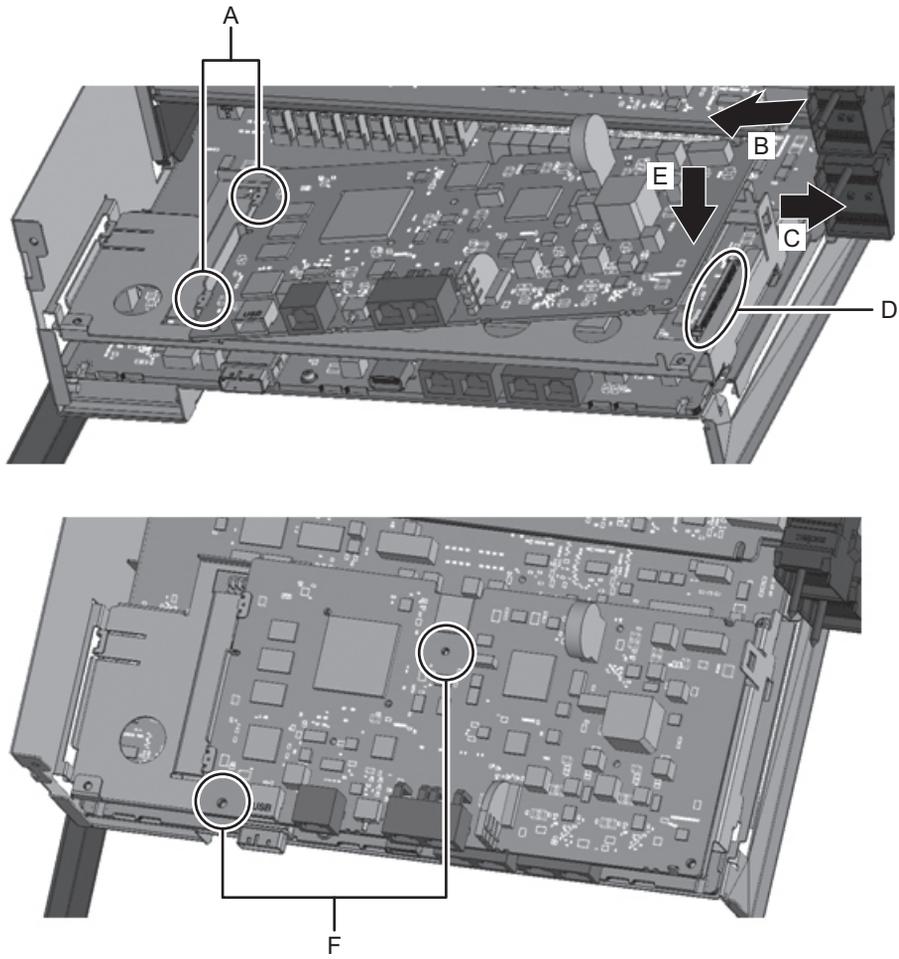
Figure 8-29 Installing XSCF board (for SPARC M10-4)

- For SPARC M10-4, insert the XSCF board into two positions (A in the figure) on the guide of the mount (B in the figure), and press the right lever of the mount about 5 mm (0.2 in.) to the right (C in the figure) to connect the connector unit (D in the figure). Then, fix it with two screws (F in the figure).

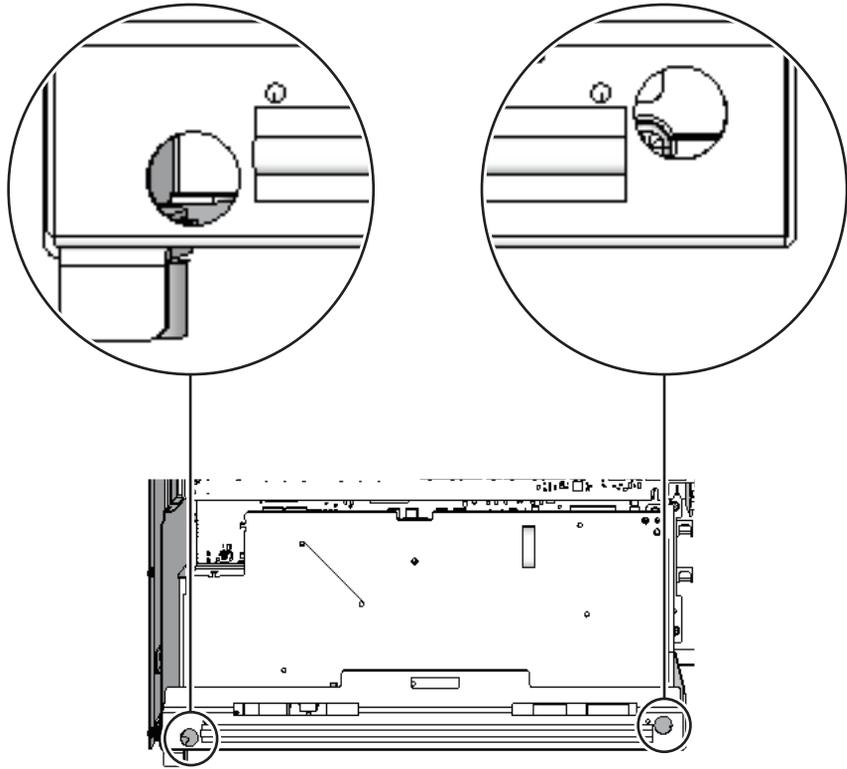
Figure 8-30 Screws for rear cover

7. **Attach the rear cover with two screws from the upper part of the rear side of the CPU memory unit lower.**

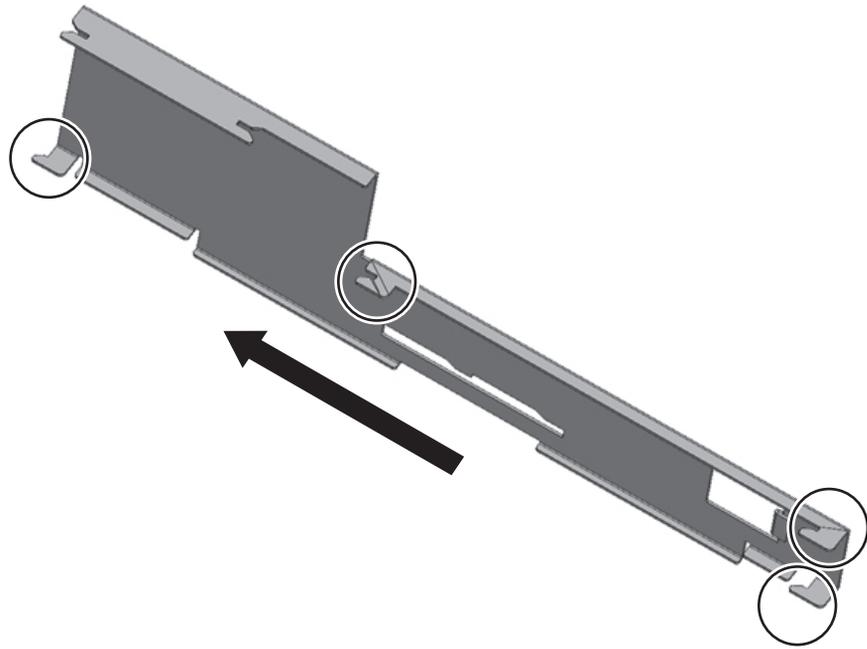
Figure 8-32 Clip positions of right and left side guides

Note—Be careful not to damage the PCIe cable when installing the right and left side guides.

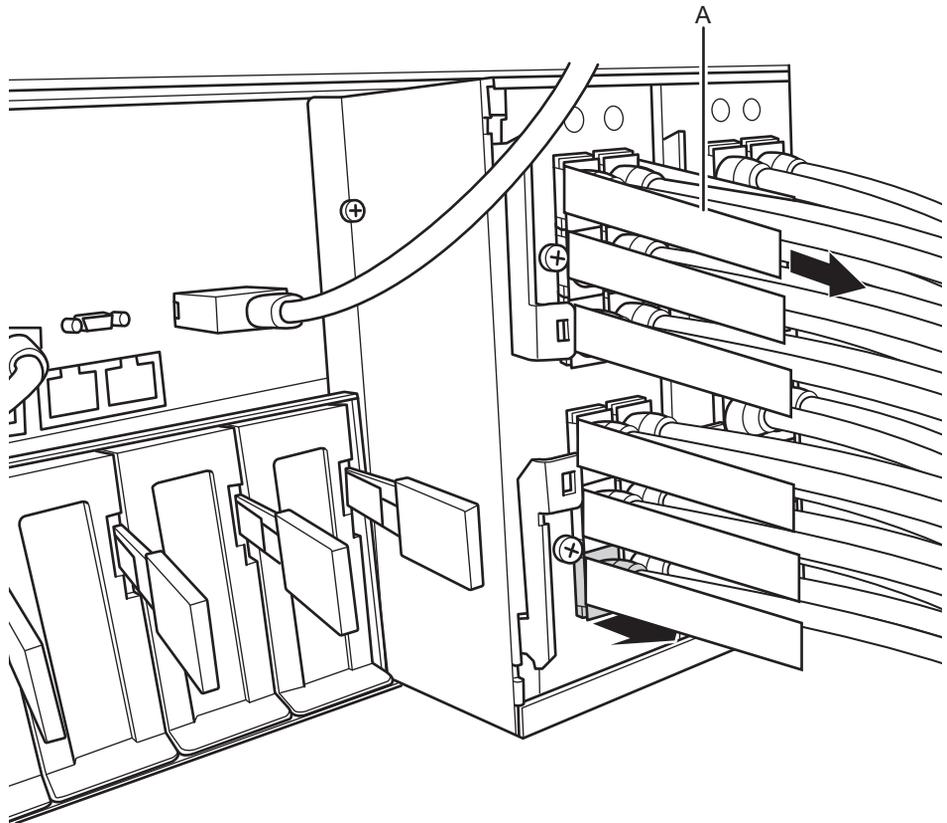
Figure 8-34 Removing crossbar cable (electrical)

1. **Remove two crossbar cables (electrical) from SPARC M10-4S.**
Hold the tab (A in the figure) of the crossbar cable (electrical), and pull it straight in the arrow direction to remove it. At this time, do not pull out the crossbar cable by holding the cable part. If you pull the cable part, the connector is not unlocked completely, which may cause a damage.
2. **Remove two crossbar cables (electrical) from the other cabinet.**
Hold the tab (A in the figure) of the crossbar cable (electrical), and pull it straight

in the arrow direction to remove it. At this time, do not pull out the crossbar cable by holding the cable part. If you pull the cable part, the connector is not unlocked completely, which may cause a damage.

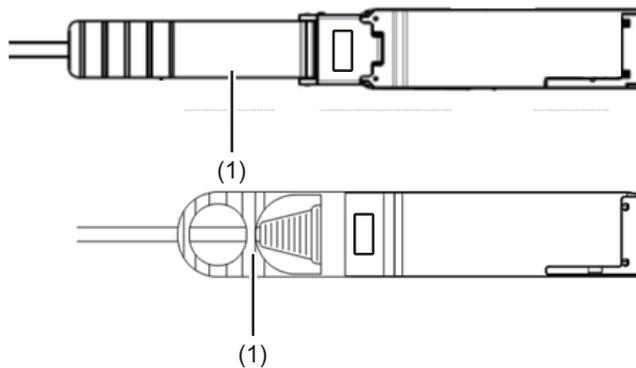
Figure 8-35 Shape and tab of crossbar cable (optical)

There are two types of crossbar cables (optical). Connect cables of a same type to a same port number. Cables can be distinguished by tab shape. For tab shape, see Figure 8-7.

Number in figure	Description
1	Tab

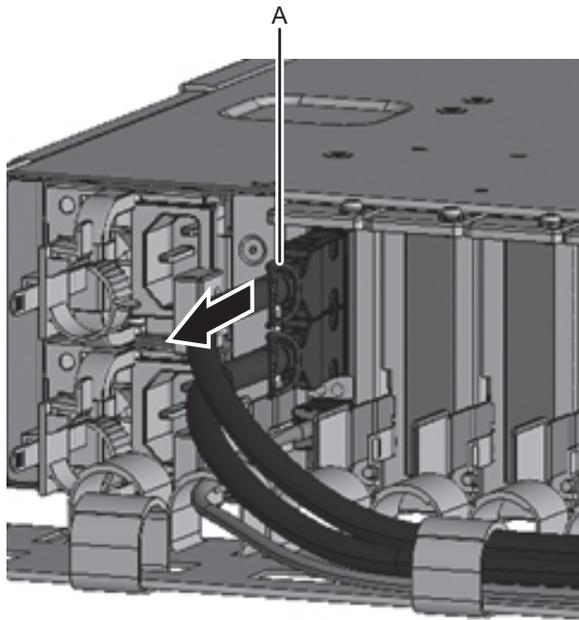
Figure 8-36 Removing link cable

Hold the tab (A in the figure) for the link cable (electrical) or link cable (optical), and pull it straight to the cable side to remove it. At this time, do not pull out the crossbar cable by holding the cable part. If you pull the cable part, the connector is not unlocked completely, which may cause a damage.

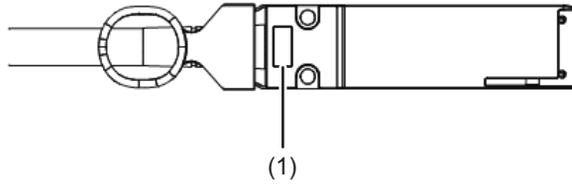
Figure 8-38 Label position of link cable (electrical)

Number in figure	Description
1	Label

- Before using the link cable, confirm that labels of a same number (0 or 1) are attached to the connectors at both ends.
If no label is attached, attach labels supplied with the link cable so that the same number is displayed on the connectors at both ends. For state of the labels correctly attached, see Figure 8-37. For attachment positions, see Figure 8-38 and Figure 8-39.

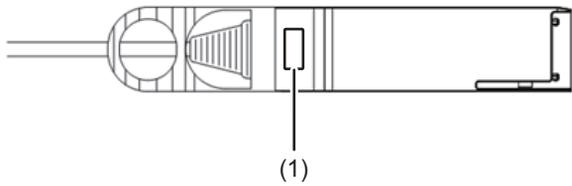
Figure 8-39 Label position of link cable (optical)

Number in figure	Description
1	Label

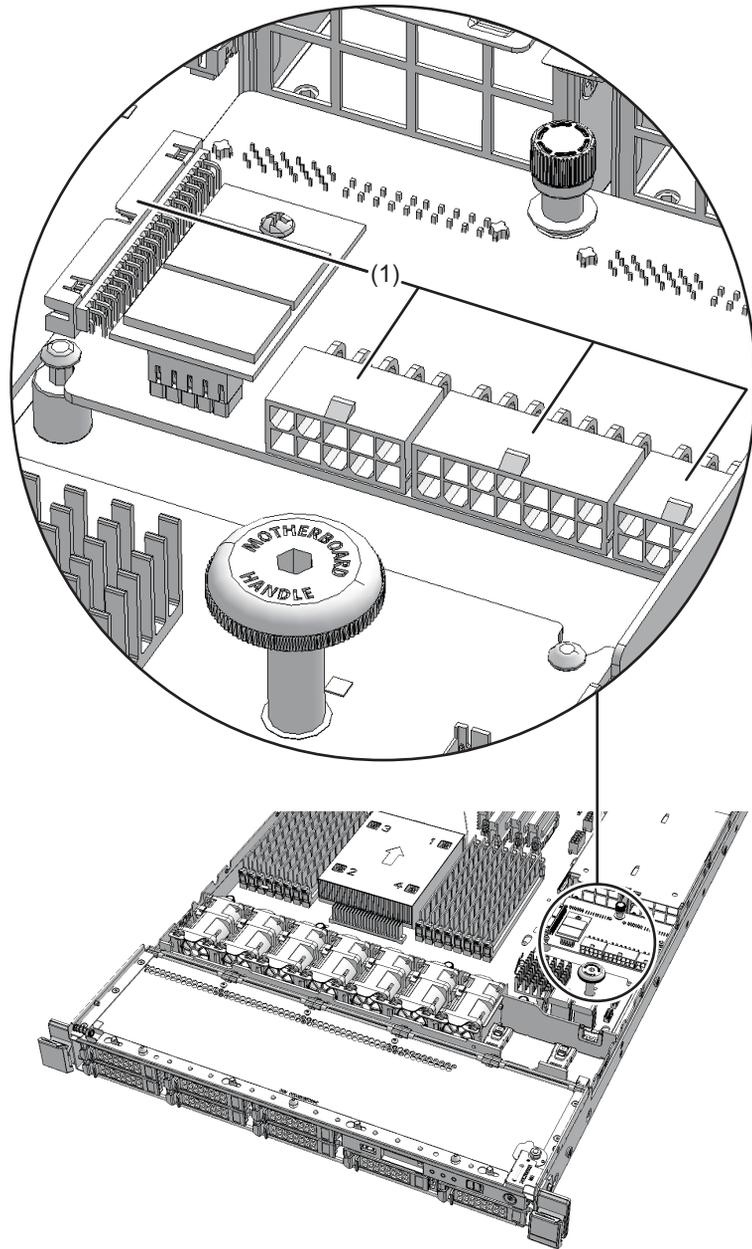
Figure A-1 Location of Cable Kit

The cable kit consists of four cables connecting the motherboard unit with the PSU backplane.

Location number	Component
1	Cable kit

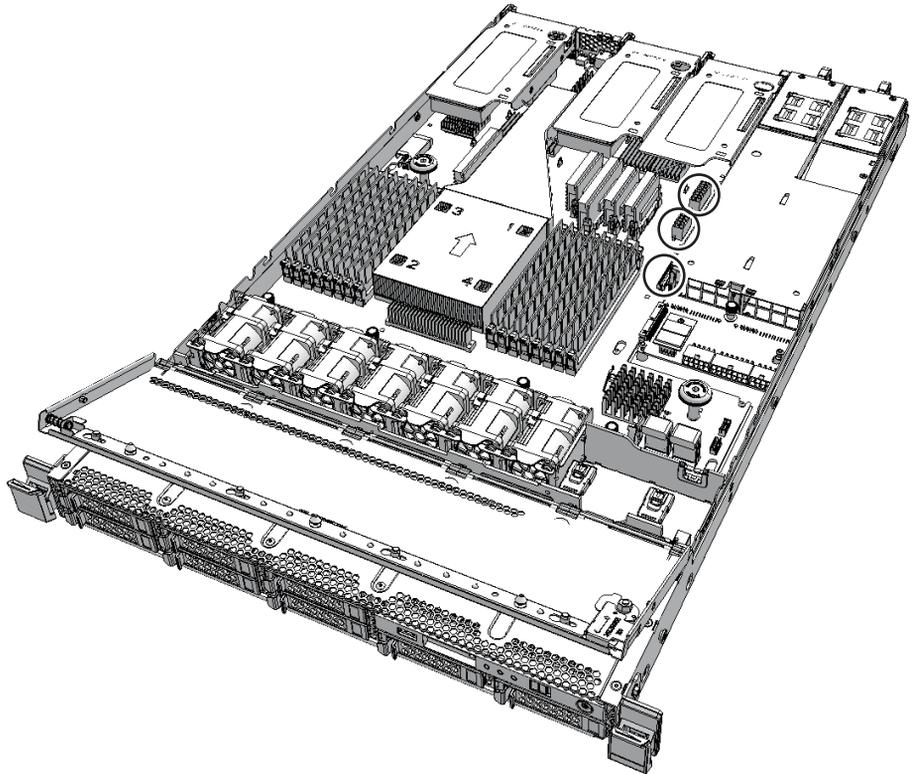
Figure A-2 Cables of motherboard unit

Note - Write down the connection positions for the cables before removing them to restore them correctly.
