Fujitsu M10/SPARC M10 Systems

Product Notes for XCP Version 2041

Manual Code: C120-E698-03EN
October 2013

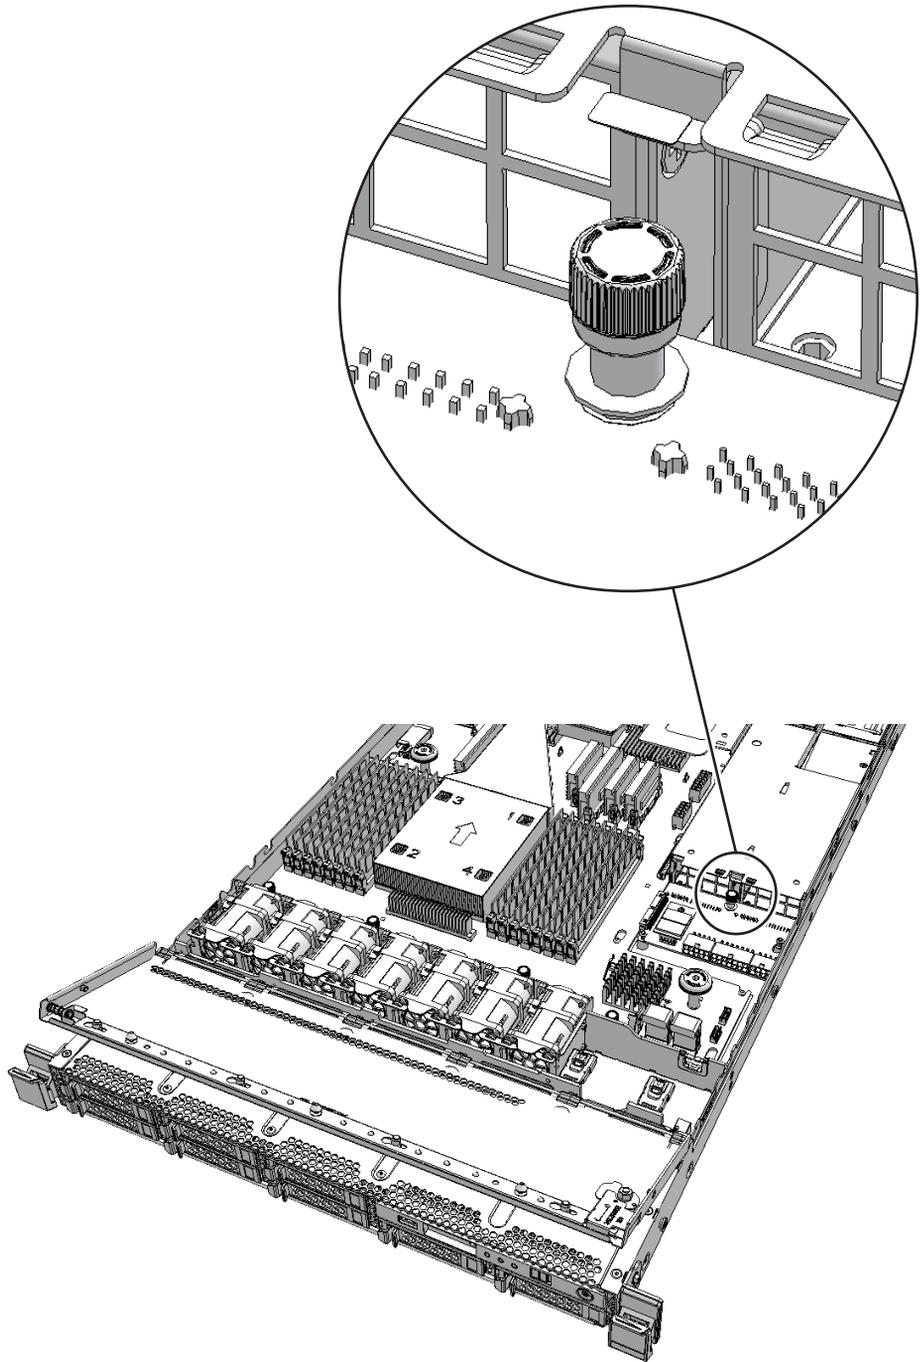
Figure A-3 Screws for PSU backplane

2. **Loosen one screw that fixes the PSU backplane.**

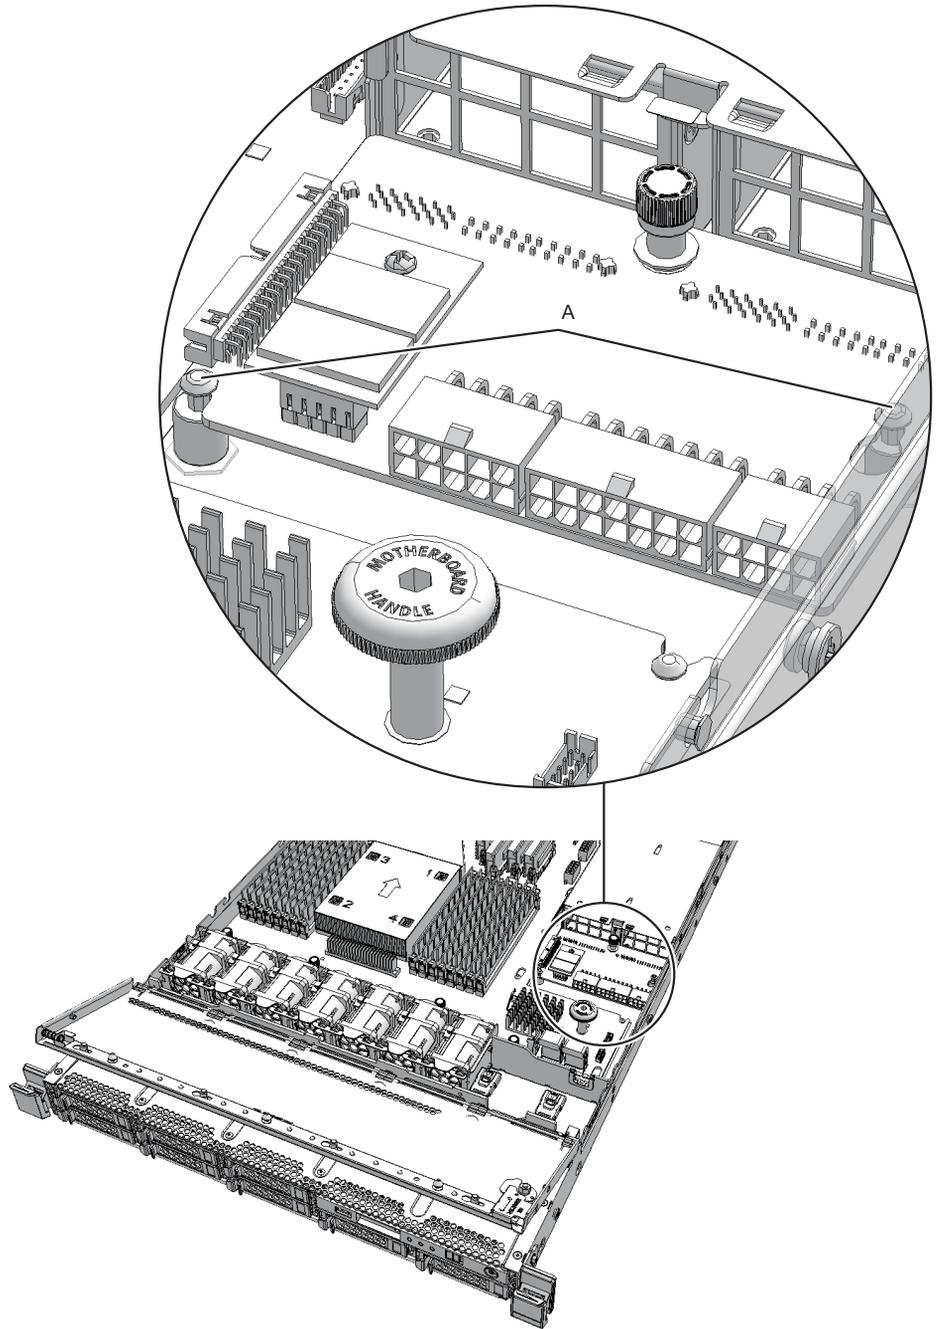
Figure A-4 Fixing screws for PSU backplane

3. **Slide the PSU backplane to the rear side of the cabinet and remove it from the two fixing pins (A in the figure).**

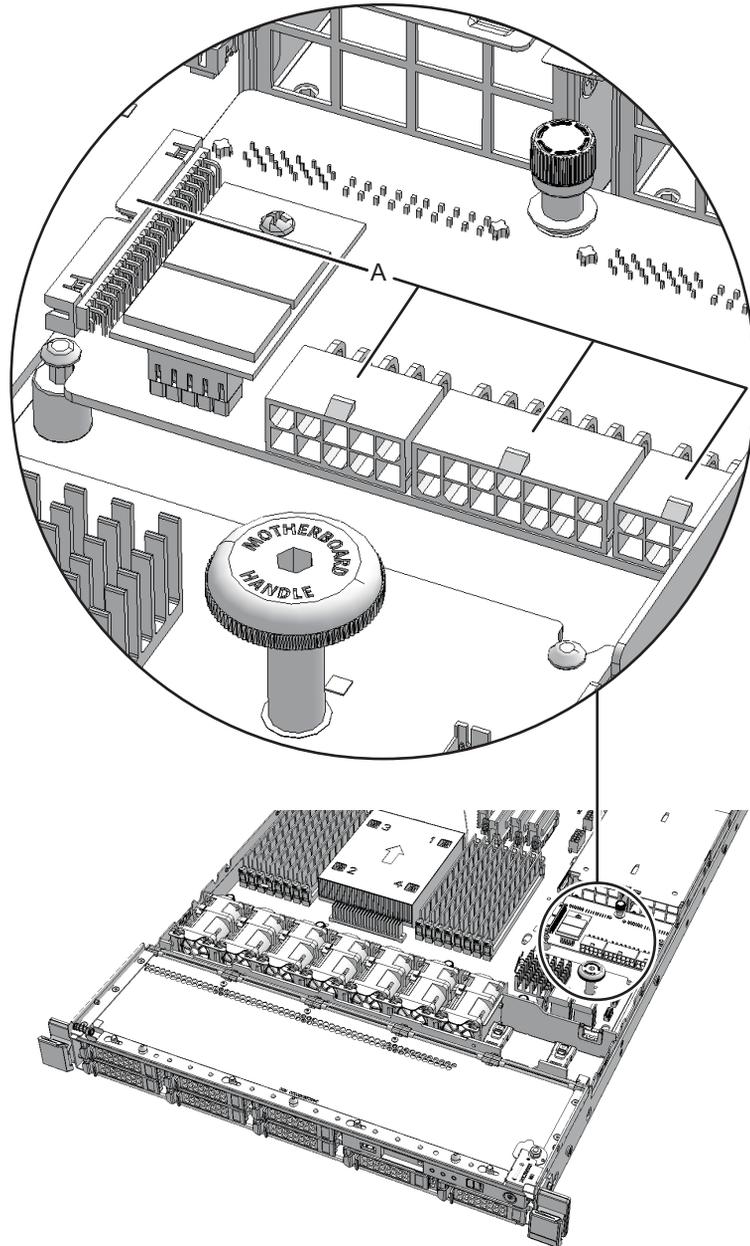
Figure A-5 Cable for PSU backplane

4. Lift the PSU backplane and remove the four cables (A in the figure).

Note - Write down the connection positions for the cables before removing them to restore them correctly.

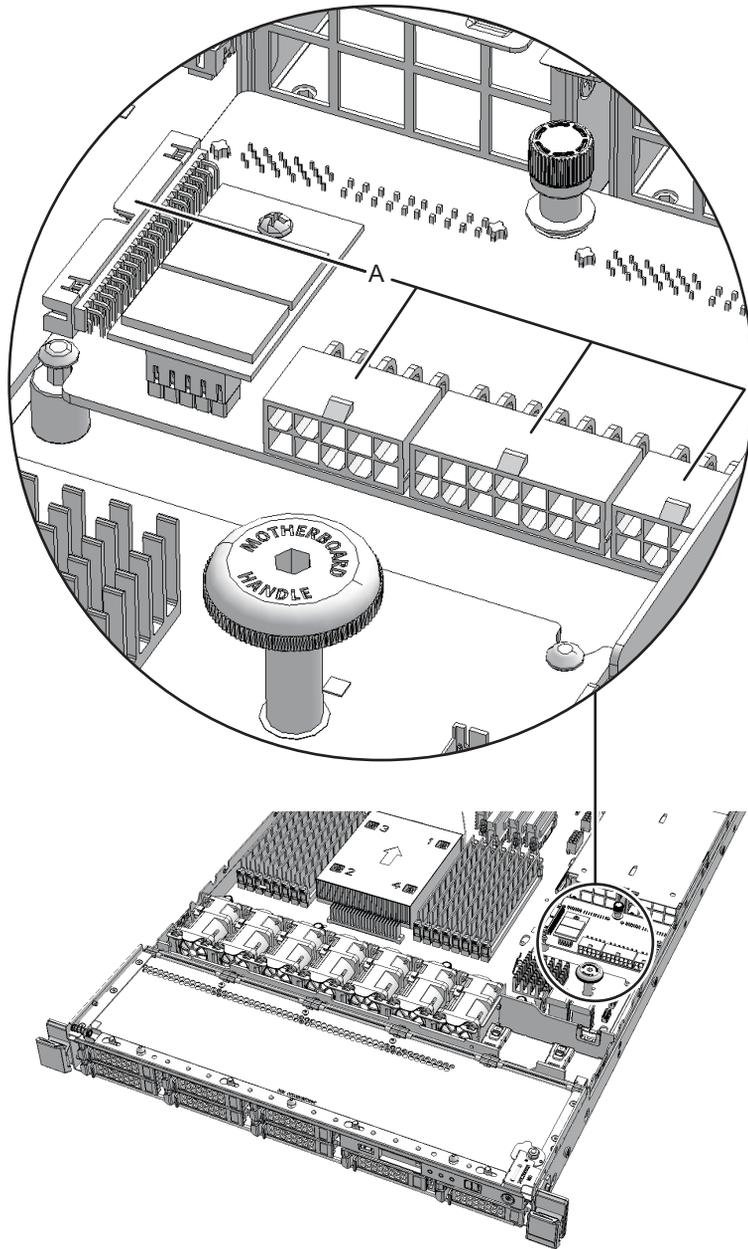
Figure A-6 Cable for PSU backplane

1. **Hold the PSU backplane and connect the four cables (A in the figure).**

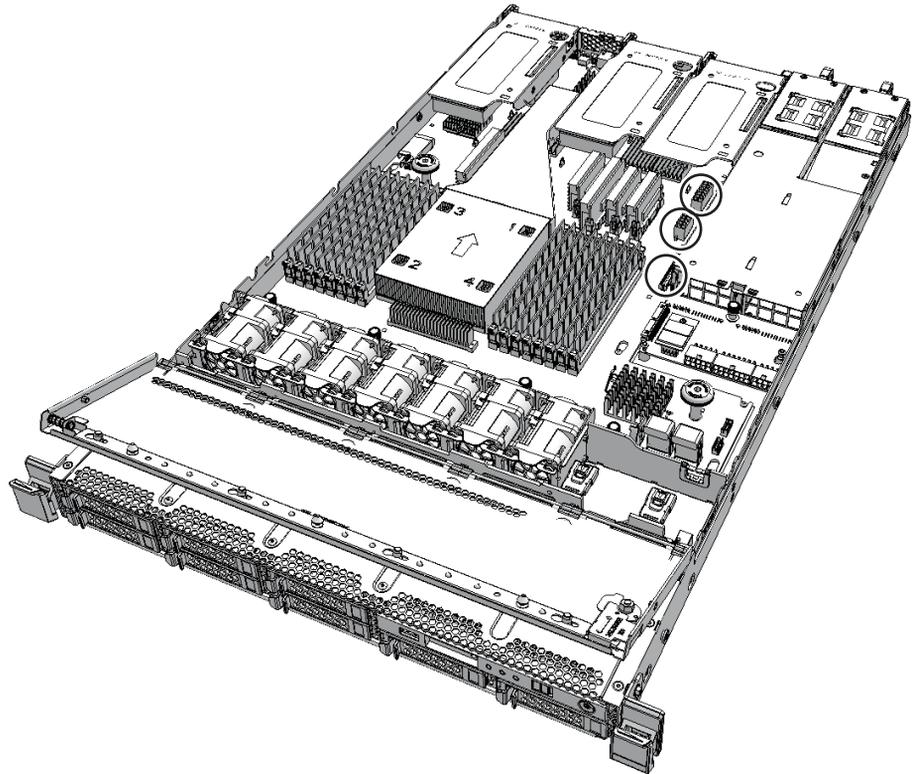
Figure A-7 Cables of motherboard unit

2. **Install the PSU backplane.**
3. **Confirm that the two fixing pins are inserted into the PSU backplane. Then, slide the PSU backplane to the rear side of the cabinet.**
4. **Tighten the one screw that fixes the PSU backplane.**
5. **Connect the three cables connecting the PSU backplane with the motherboard unit.**

Note - Connect the cables correctly to the original positions according to the record before maintenance.

Note - Ensure that the cables are firmly inserted.

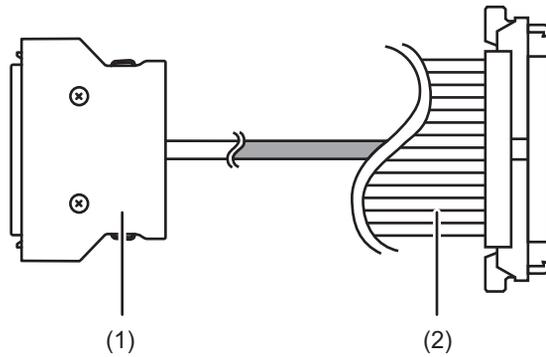
Figure B-1 Cable (SIG) (Between crossbar backplane unit and terminal board)

- Cable (SIG)
Cable for connecting the crossbar backplane unit and terminal board (SIG)

Location number	Component
1	Connector (terminal board (SIG) side)
2	Connector (crossbar backplane unit side)

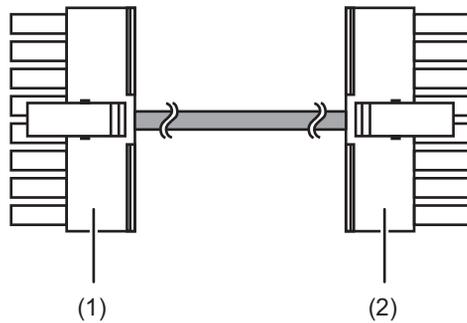
Figure B-2 Cable (PWR) (Between crossbar backplane unit and terminal board)

- Cable (PWR)
Cable for connecting the crossbar backplane unit and terminal board (PWR)

Location number	Component
1	Connector (terminal board (PWR) side)
2	Connector (crossbar backplane unit side)

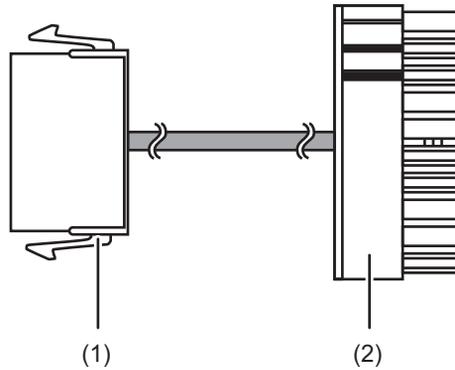
Figure B-3 Cable (PWR) (Between terminal board and fan backplane)

- Cable (PWR)
Cable for connecting the terminal board and fan backplane (PWR)

Location number	Component
1	Connector (terminal board side)
2	Connector (fan backplane (PWR) side)

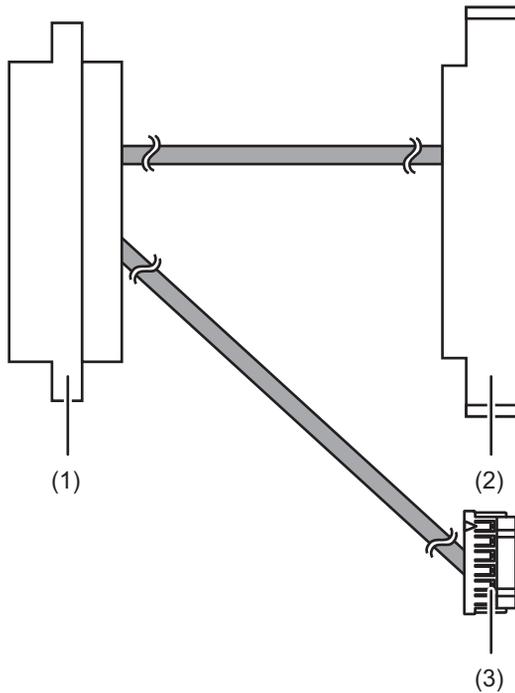
Figure B-4 Cable (SIG) (Between terminal board-fan backplane and operation panel)

- Cable (SIG)
Cable for connecting the terminal board and fan backplane (SIG) and operation panel

Location number	Component
1	Connector (terminal board side)
2	Connector (fan backplane (SIG) side)
3	Connector (operation panel side)

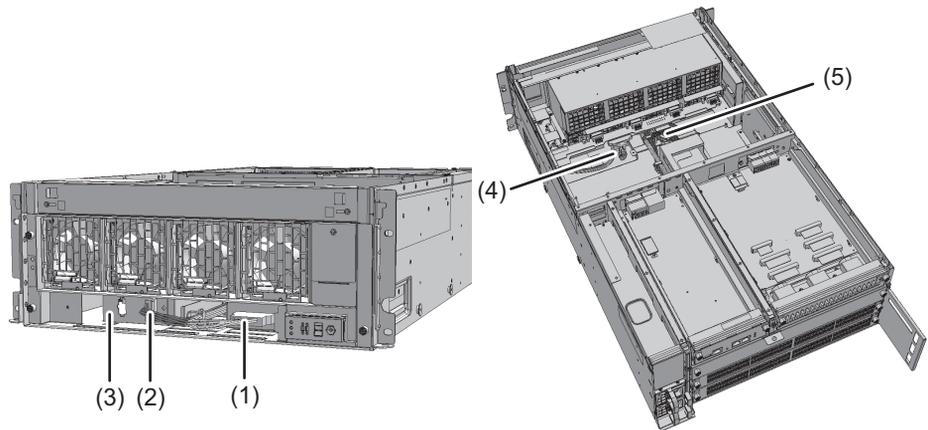
Figure B-5 Location of cable kit

The connection positions of the cable kit are as follows.

Location number	Component	Connection
1	Cable (PWR)	Crossbar backplane unit and terminal board (PWR)
2	Cable (SIG)	Crossbar backplane unit and terminal board (SIG)
3	Terminal board	
4	Cable (PWR)	Terminal board (PWR) and fan backplane
5	Cable (SIG)	Terminal board (SIG) and fan backplane

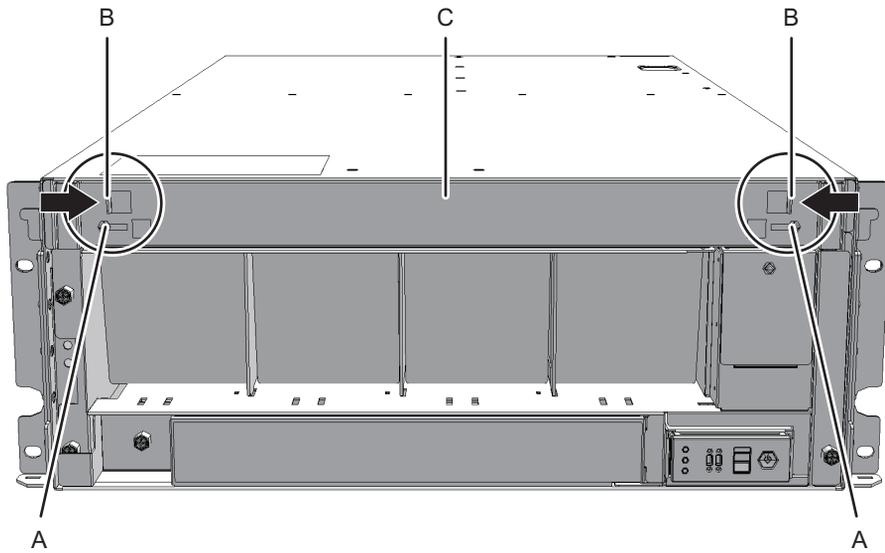
Figure B-6 Removing upper cover

1. **Remove the front cover.**
For details, see "5.4.3 Removing front cover."
2. **Remove all the fan units.**
For details, see "19.4 Removing Fan Unit."
3. **Loosen two screws (A in the figure) of the upper cover and slide the right and left stoppers (B in the figure) inward. Then, remove the upper cover (C in the figure).**

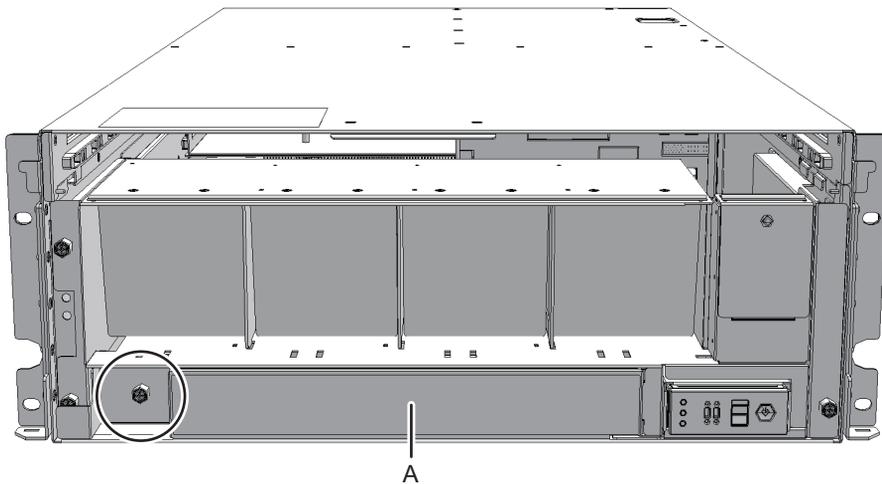
Figure B-7 Removing lower cover

4. Loosen one screw (A in the figure) of the lower cover and slide the lower cover to the left to remove it.

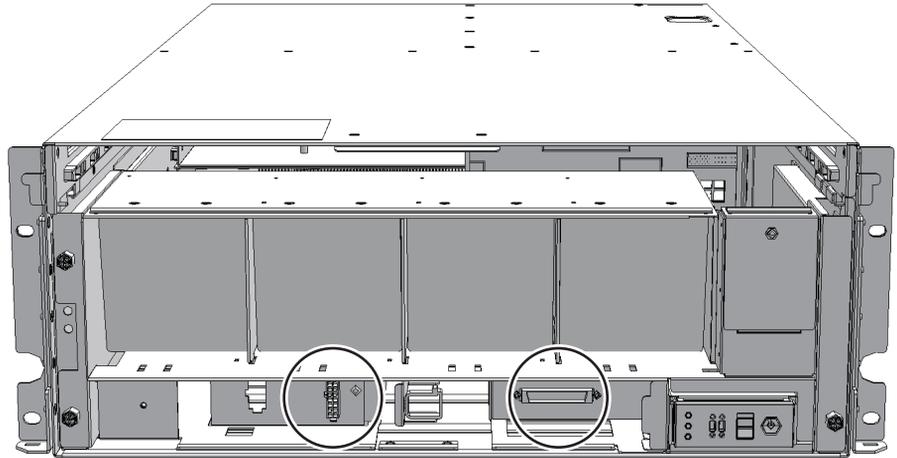
Figure B-8 Removing cables

5. Remove the two cables connected to the fan shelf from the connectors. Arrange the removed cables in the center.

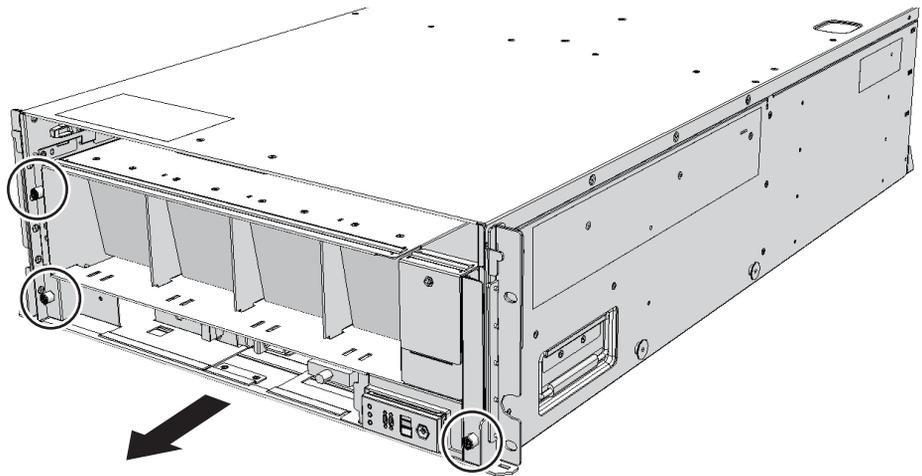
Figure B-9 Removing fan shelf

6. Loosen three screws of the fan shelf and partially pull out the fan shelf.

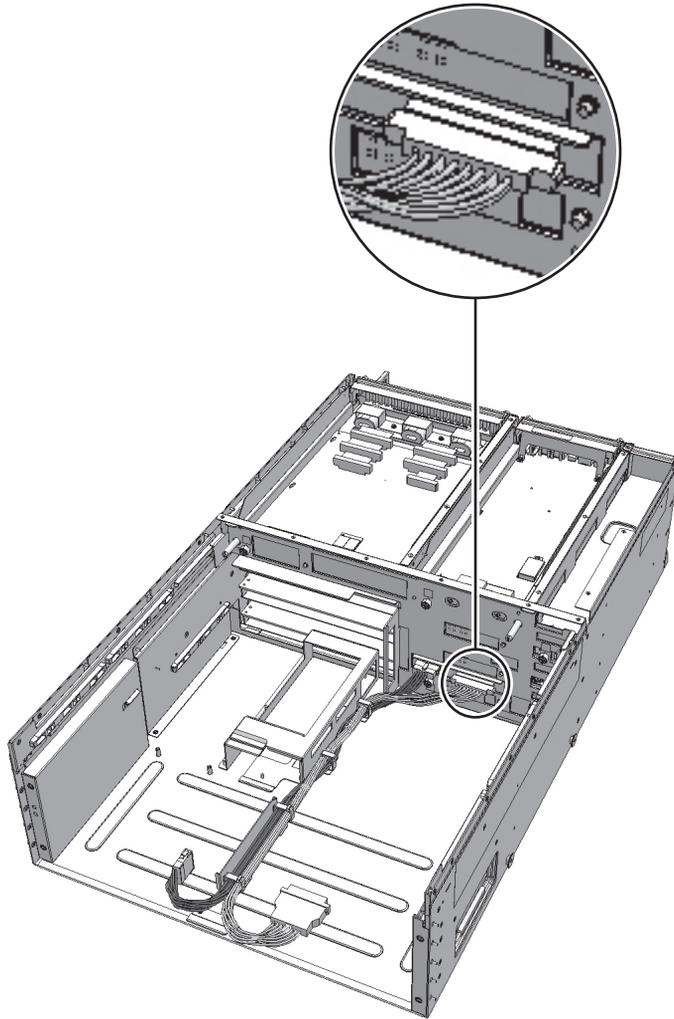
Figure B-10 Removing cable (cable (SIG))

8. Remove the cable connected to the crossbar backplane unit from the connector.

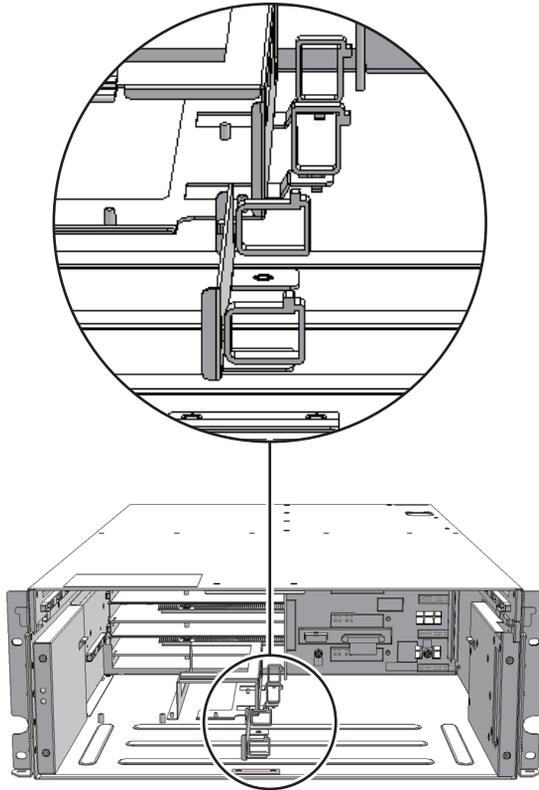
Figure B-12 Removing cables

9. **Remove the cable from the clamps.**

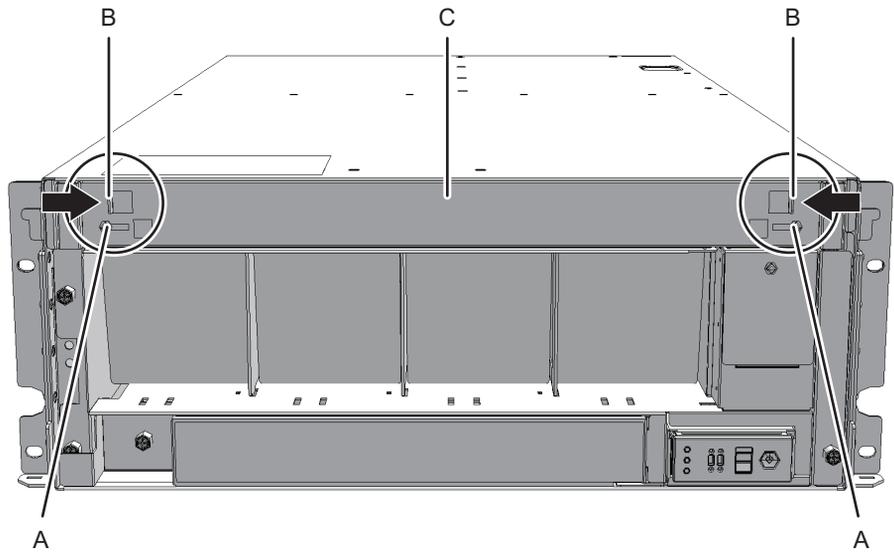
Figure B-13 Removing upper cover

1. **Remove the front cover.**
For details, see "5.4.3 Removing front cover."
2. **Remove all the fan units.**
For details, see "19.4 Removing Fan Unit."
3. **Loosen two screws (A in the figure) of the upper cover and slide the right and left stoppers (B in the figure) inward. Then, remove the upper cover (C in the figure).**

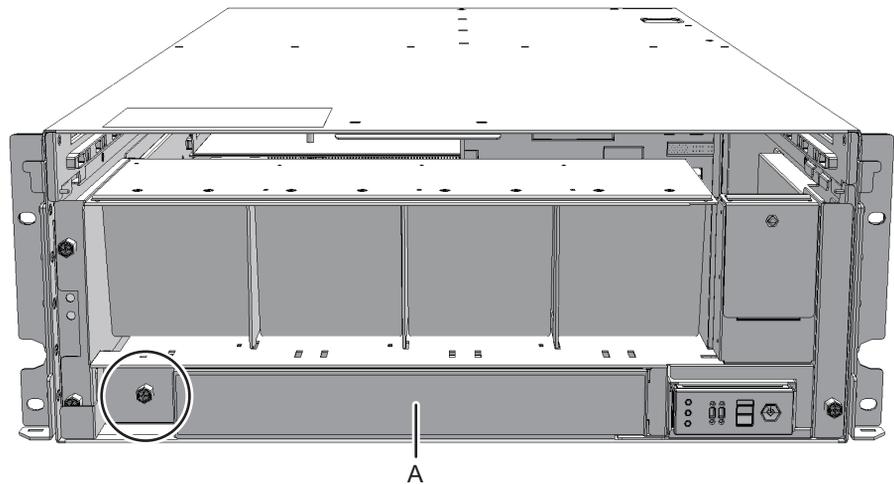
Figure B-14 Removing lower cover

4. **Loosen one screw (A in the figure) of the lower cover and slide the lower cover to the left to remove it.**

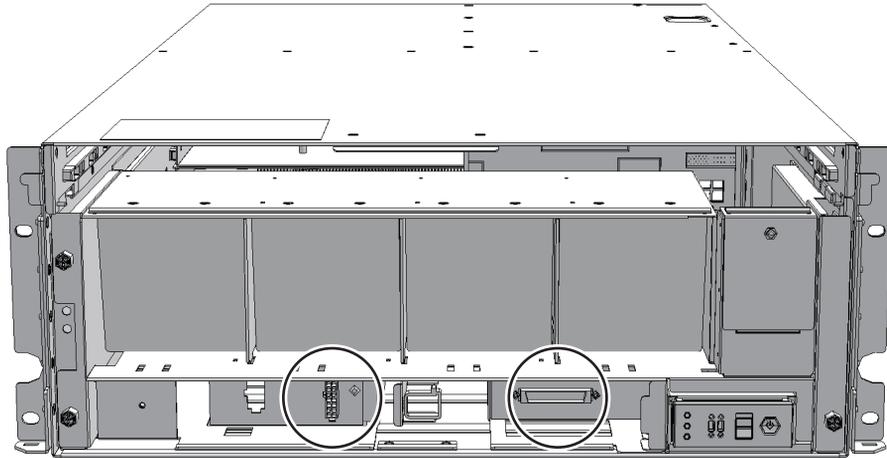
Figure B-15 Removing cables

5. **Remove the two cables connected to the fan shelf from the connectors. Arrange the removed cables in the center.**

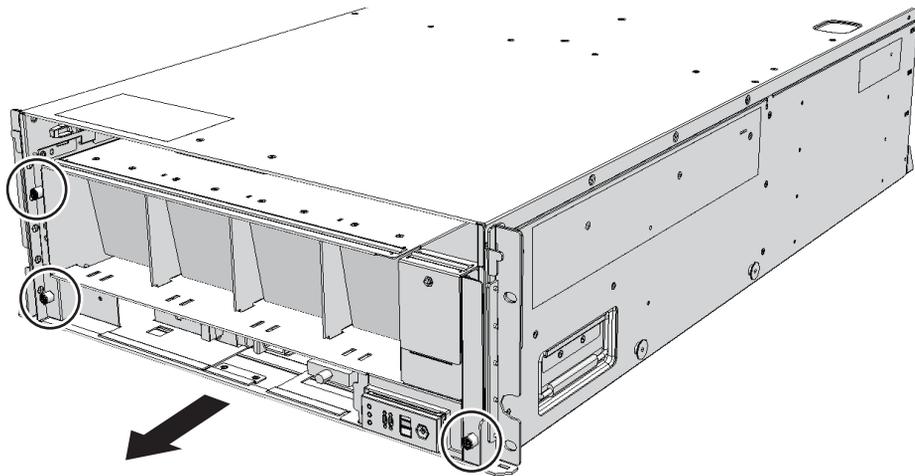
Figure B-16 Removing fan shelf

6. Loosen three screws of the fan shelf and partially pull out the fan shelf.

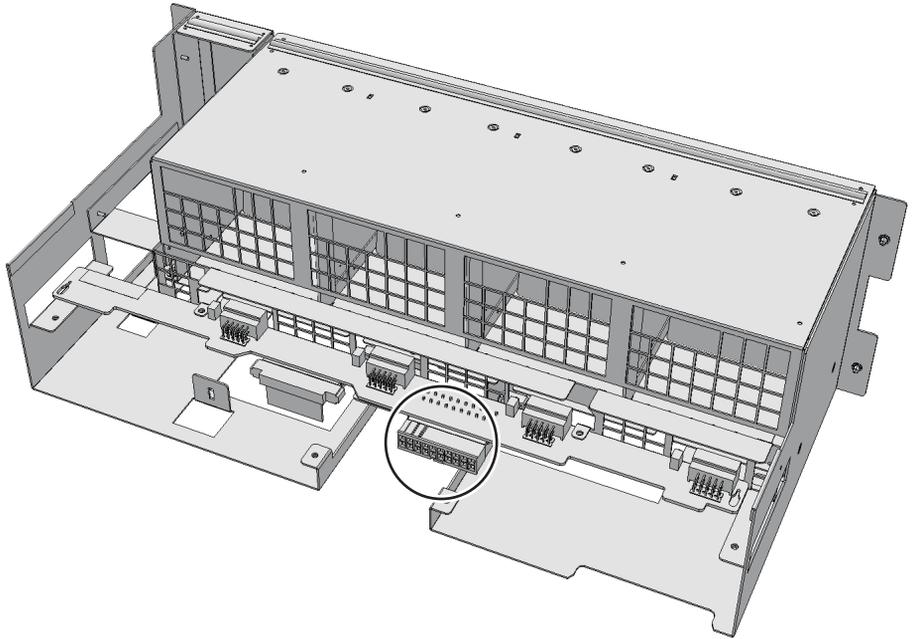
Figure B-17 Removing cable (cable (PWR))

8. Remove the cable connected to the fan backplane from the connector.

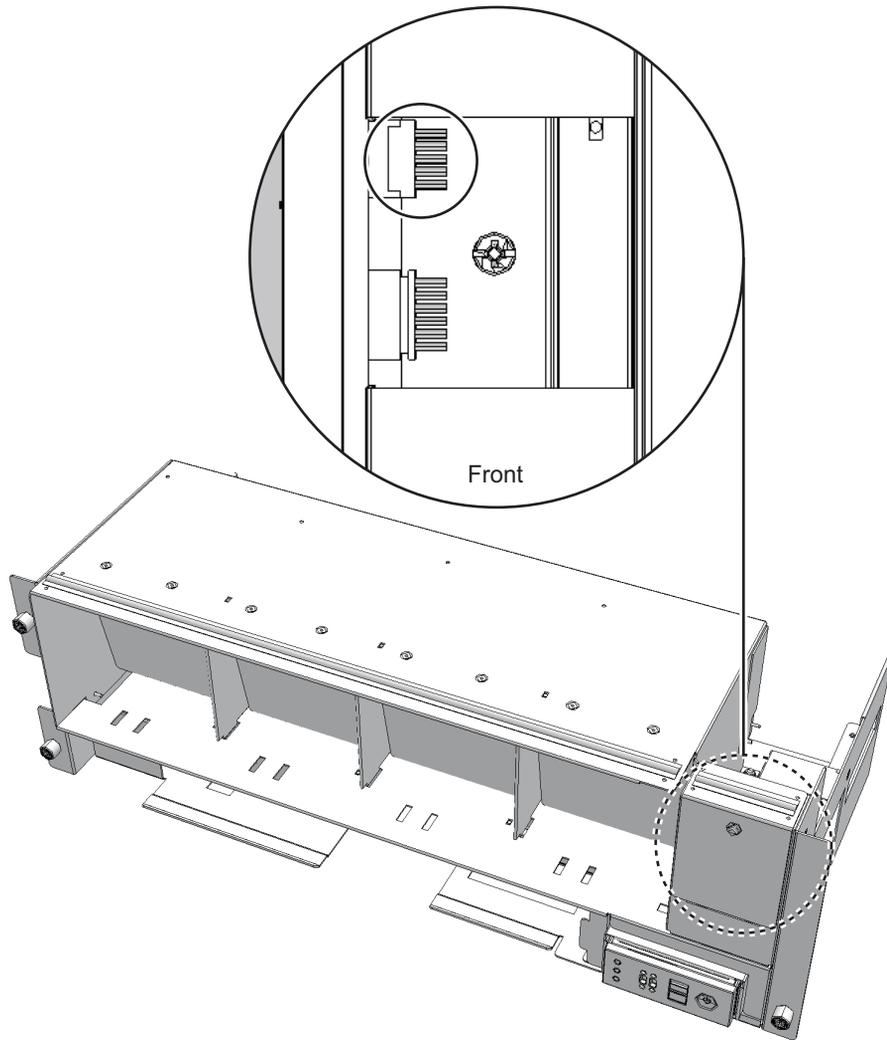
Figure B-19 Operation panel cables

9. Remove the cable connecting the fan shelf and operation panel from the

connector on the operation panel side.

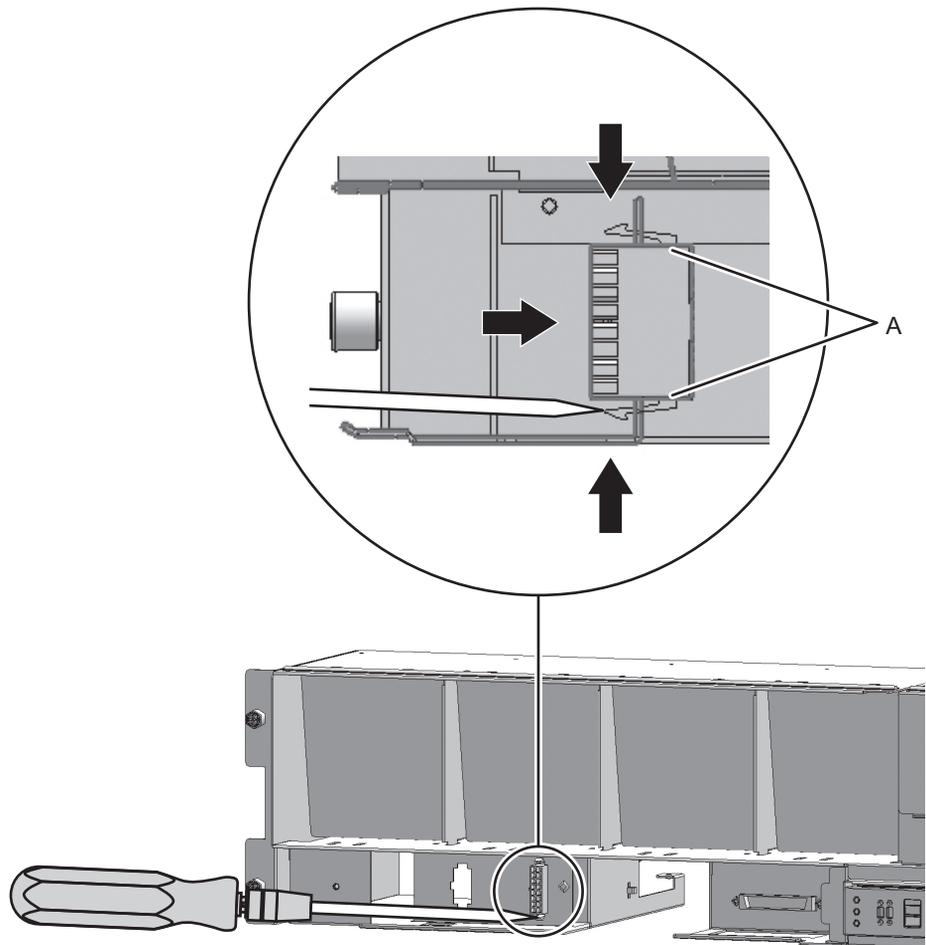
Figure B-20 Removing cable (cable (PWR))

10. **Remove the cable from the terminal board.**
 - **For the cable (PWR), push the connector toward the far end, while pushing the lower latch (A in the figure) upward with a flathead screwdriver. Confirm that the lower latch (A in the figure) is pushed into the inside of the terminal board. Push the connector toward the far end, while pushing the upper latch downward with the flathead screwdriver.**

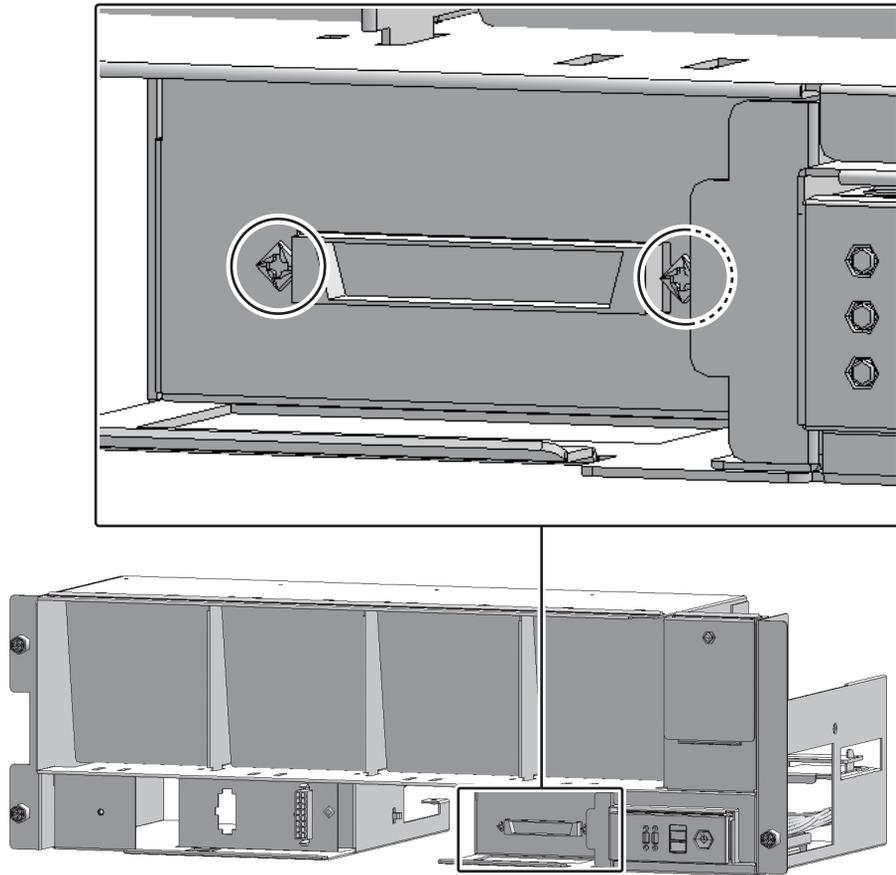
Figure B-21 Removing cable (cable (SIG))

- For the cable (SIG), remove the two screws of the cable connector with a Phillips screwdriver (bit No. 1), and then remove the cable from the terminal board.

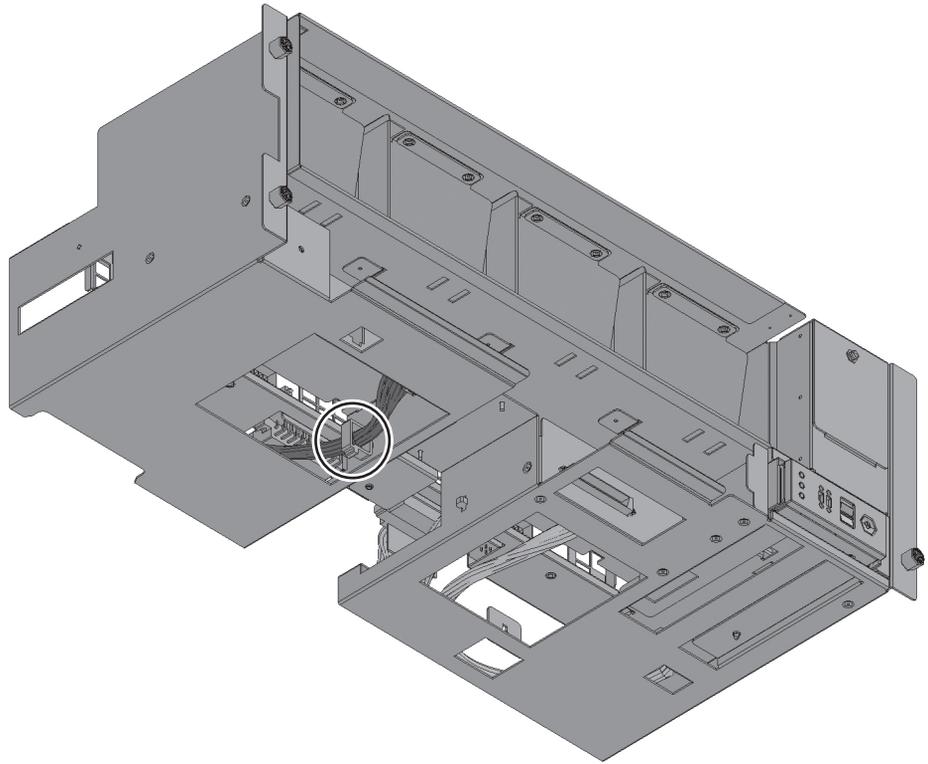
Figure B-22 Removing cable (cable (PWR))

11. **Remove the cable from the clamps.**

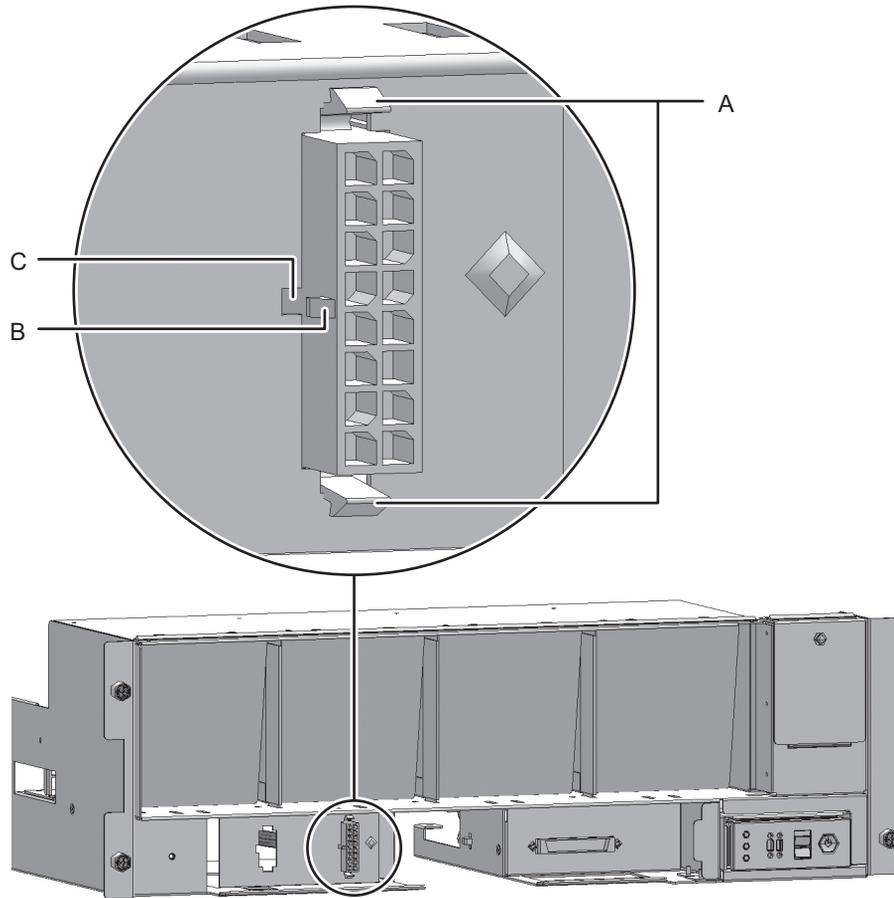
Figure B-25 Installing cable (cable (PWR))

1. **Install the cable on the terminal board.**
 - **For the cable (PWR), install the connector that has latches (A in the figure) on its both ends to the terminal board.**
Install the tab (B in the figure) of the connector to fit it to the notched section (C in the figure) of the terminal board.

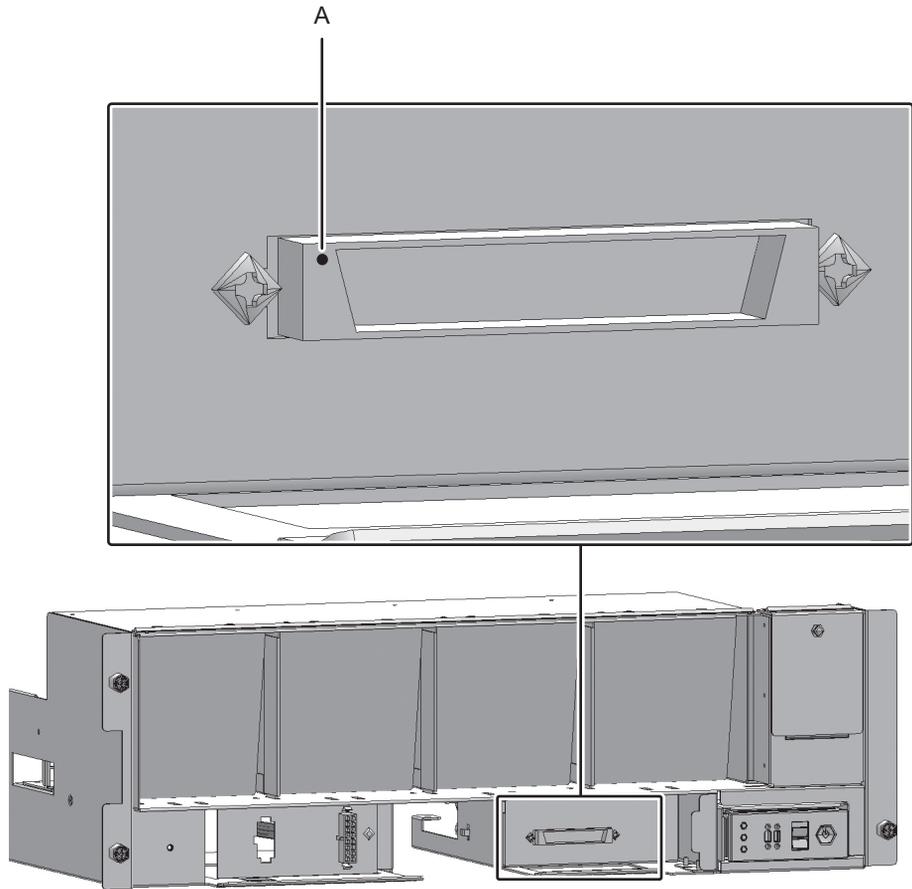
Figure B-26 Installing cable (cable (SIG))

- **For the cable (SIG), install the connector that has a threaded hole on itself to the terminal board.**

Use the screw that has been removed from the same location before. Tighten the screw with a Phillips screwdriver (bit No. 1). When installing the connector, orient the connector so that the dot mark (A in the figure) shown in Figure A-26 is to the left.

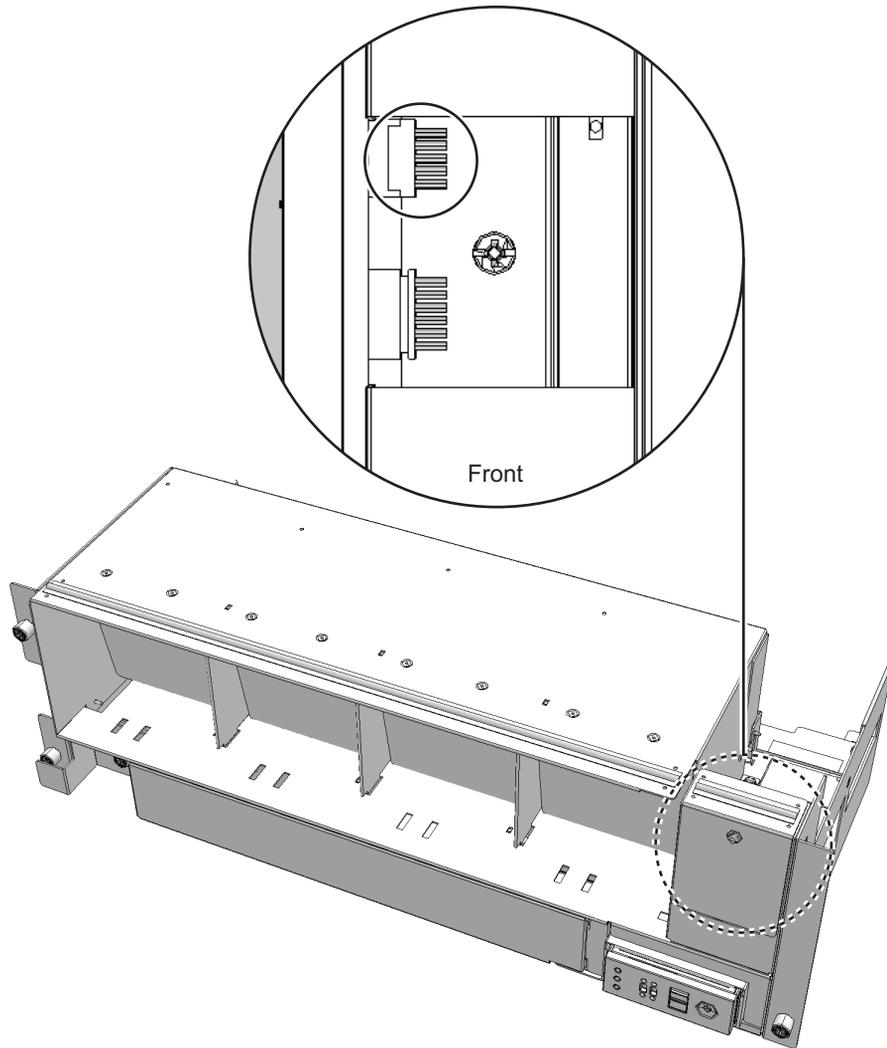
Figure B-27 Operation panel cables

2. **Connect the cable to the connector of the fan backplane.**
3. **Connect the cable connecting the fan shelf and operation panel to the connector on the operation panel side.**

Perform this step only when you install the cable (SIG).
If you install the cable (PWR), proceed on to Step 4.

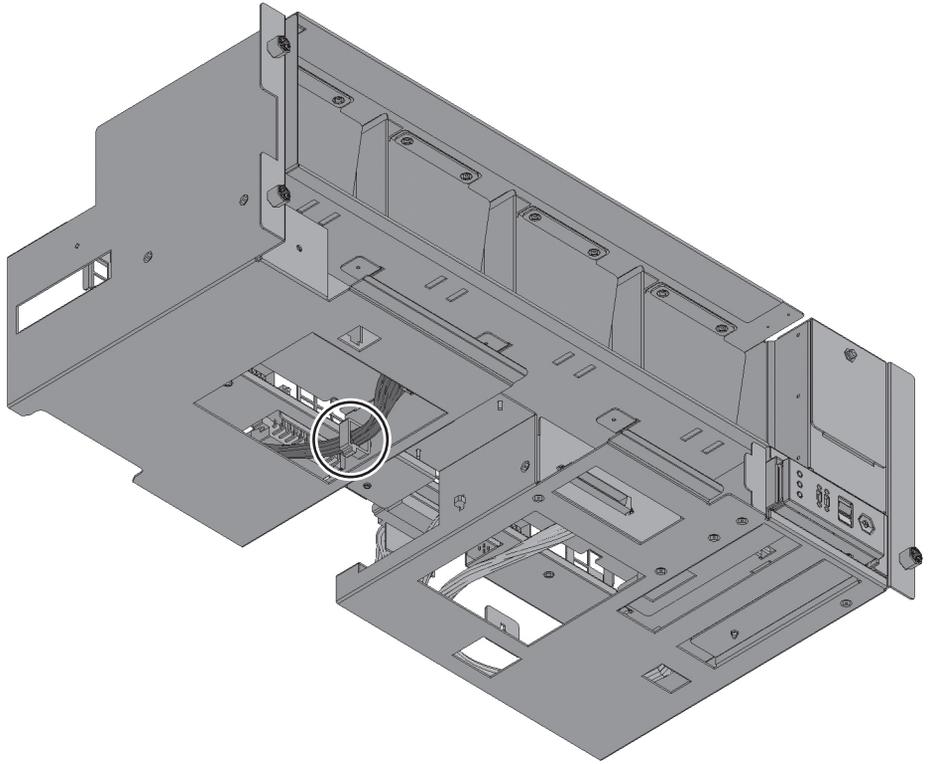
Figure B-28 Fixing cable (cable (PWR))

4. **Fix the cable with the clamps.**
