# **Fujitsu M10/SPARC M10 Systems**

Product Notes for XCP Version 2042

Manual Code: C120-E699-02EN  
October 2013

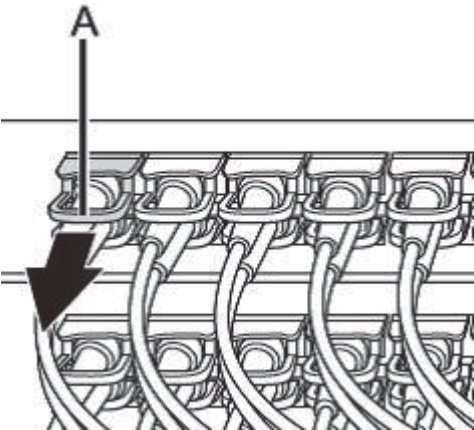
Figure 8-1      Tabs and pull-out directions of crossbar cables

Hold the tab (A in Figure 8-1) of the crossbar cable (optical), and pull it straight in the arrow direction to remove it. At this time, do not pull out the crossbar cable by holding the cable part. If you pull the cable part, the connector is not unlocked completely, which may cause a damage.
  - b. **Reattach the labels of the removed cables.**

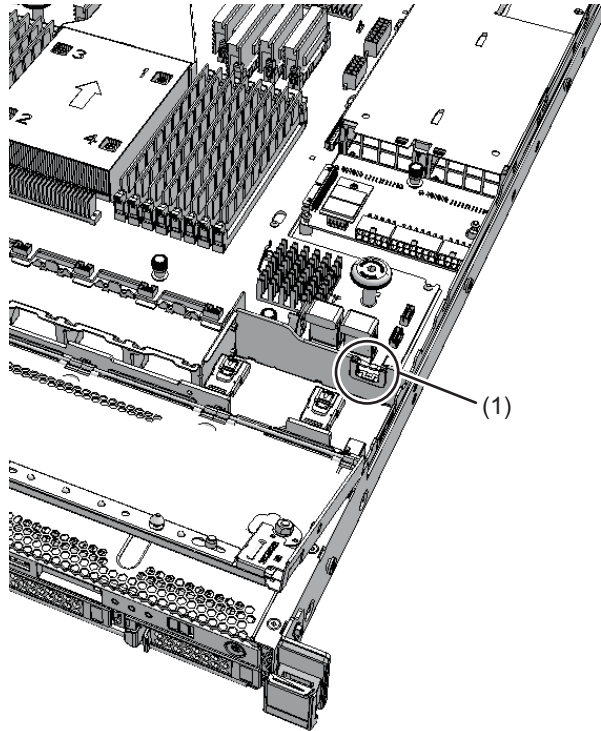
Figure 8-4 Location of cable guide

6. **Store cables of the motherboard unit in the cable guide.**

Location number	Component
1	Cable guide

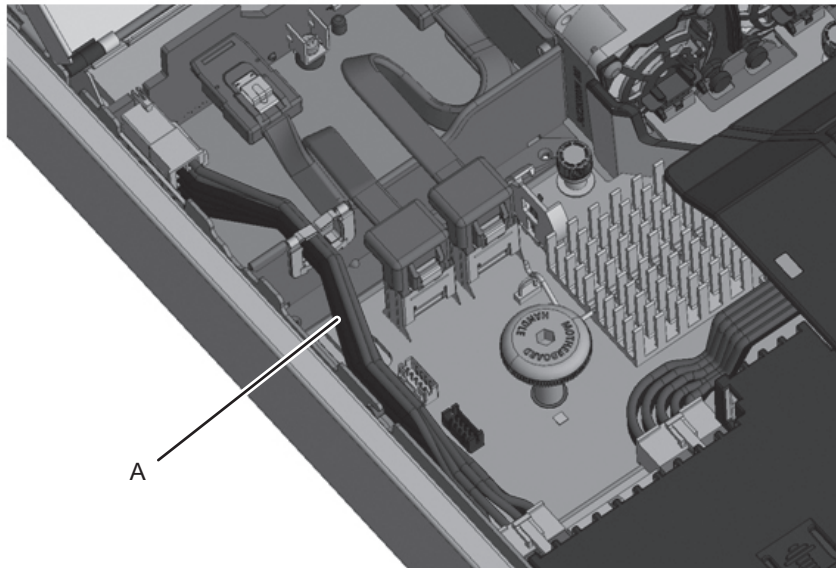
Figure 8-5 Storing cable (red/black)

- a. **Store the cable (red/black) (A in the figure) connecting the HDD backplane to the PSU backplane in the cable guide from the middle of the clamp.**

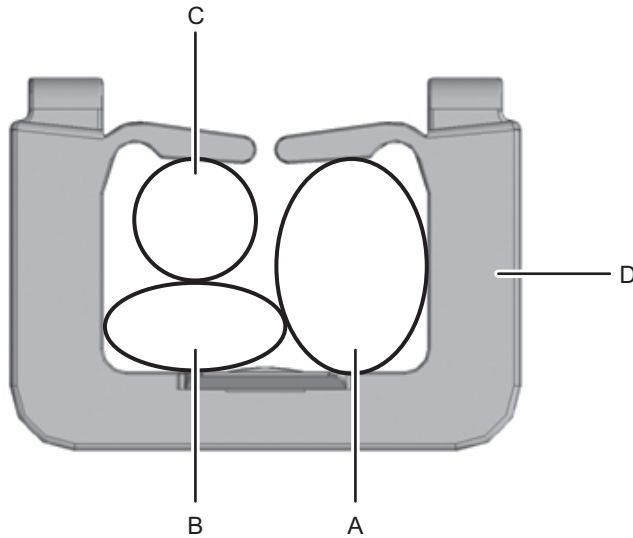
Figure 8-8 Cross section of the guide viewed from the front, after storage of the cables

- d. Confirm that each cable is stored in the cable guide, as shown in Figure 8-8.

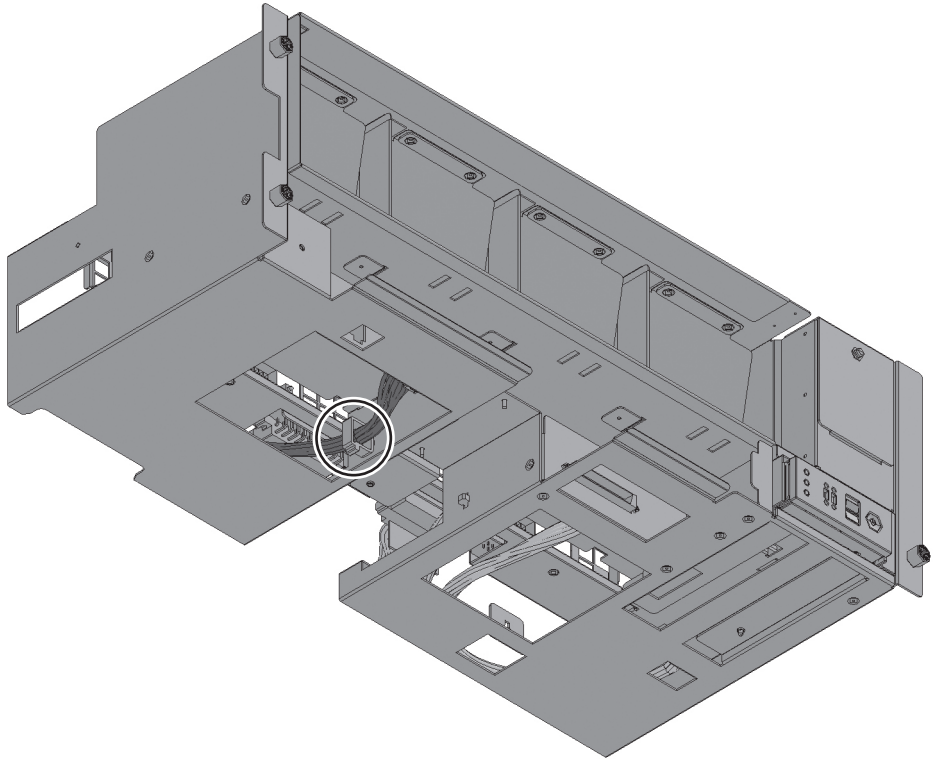
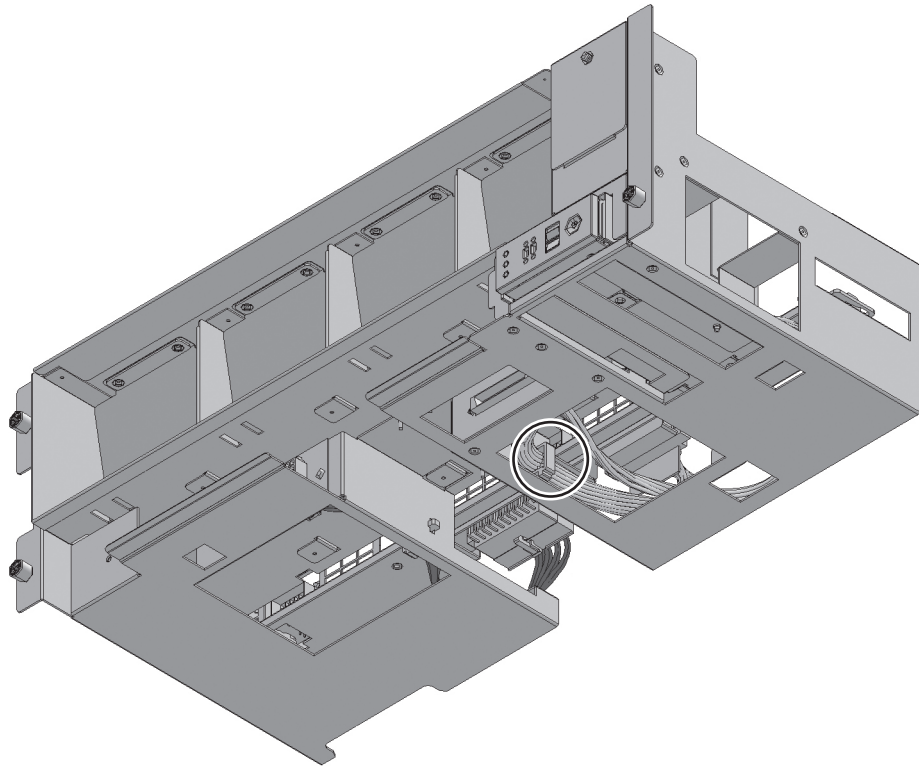
11. **Remove the cable from the clamps.**

Figure B-22 Removing cable (cable (PWR))

Figure B-23 Removing cable (cable (SIG))
