## Fujitsu M10/SPARC M10 Systems

Product Notes for XCP Version 2043

Manual Code: C120-E701-02EN

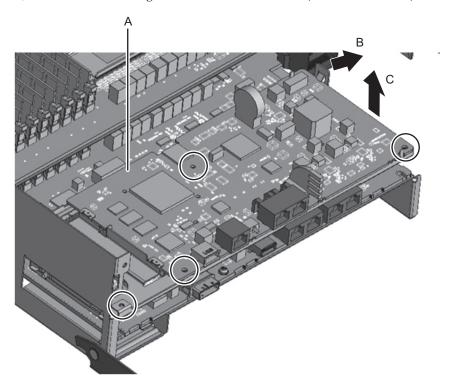
Figure 8-13 Releasing connection of XSCF board (for SPARC M10-4)

■ For SPARC M10-4, remove the four screws fixing the XSCF board (A in the figure) and rear cover. Tilt the right lever of the XSCF mount by fingers about 5 mm (0.2 in.) to the right (B in the figure). Lift up the right side of the XSCF board and release connection of the connector (C in the figure).

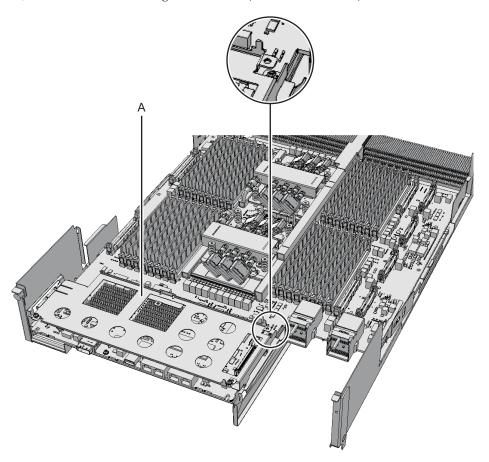
Figure 8-16 Screw fixing XSCF mount (for SPARC M10-4S)

5. Remove the one screw fixing the XSCF mount (A in the figure).

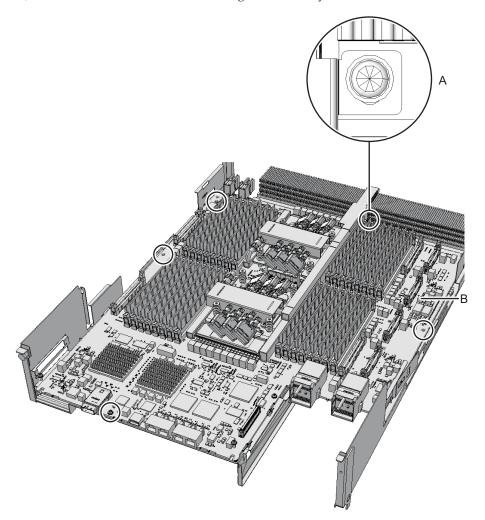
Figure 8-20 Positions of screws fixing CPU memory unit board

7. Remove the one black screw (A in the figure) fixing the center part of the radiator on the front side and the four screws fixing the CPU memory unit board (B in the figure).

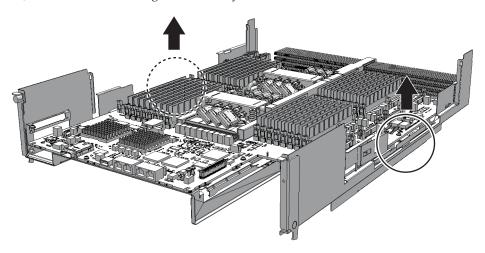
Figure 8-21 Removing CPU memory unit board

8. Insert your fingers under the board of the connector unit located at the center of the right and left sides of the CPU memory unit board. Lift the CPU memory unit board, and disconnect and remove the connector.

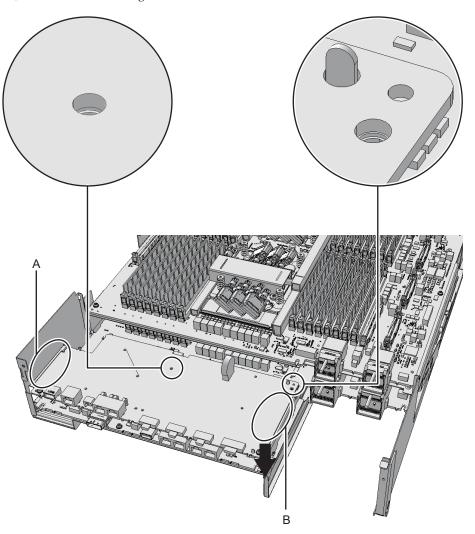
Figure 8-28 Installing XSCF board

■ For SPARC 10-4S, insert the XSCF board into the left guide (A in the figure), and press down the right connector unit (B in the figure) to connect the connector. Then, fix it with two screws.

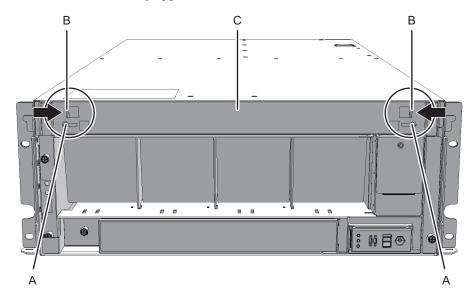
Figure B-6 Removing upper cover

- 1. Remove the front cover.
  - For details, see "5.4.3 Removing front cover."
- 2. Remove all the fan units.
  - For details, see "19.4 Removing Fan Unit."
- Loosen two screws (A in the figure) of the upper cover and slide the right and left stoppers (B in the figure) inward. Then, remove the upper cover (C in the figure).

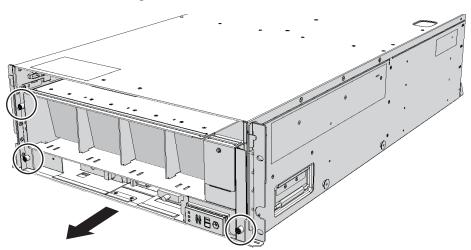
Figure B-9 Removing fan shelf

6. Loosen three screws of the fan shelf and partially pull out the fan shelf.

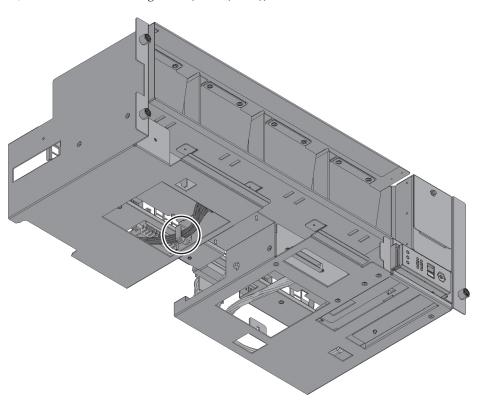
Figure B-22 Removing cable (cable (PWR))

11. Remove the cable from the clamps.

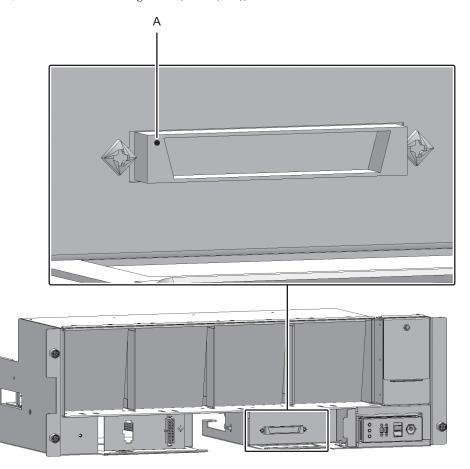
Figure B-26 Installing cable (cable (SIG))

For the cable (SIG), install the connector that has a threaded hole on itself to the terminal board.

Use the screw that has been removed from the same location before. Tighten the screw with a Phillips screwdriver (bit No. 1). When installing the connector, orient the connector so that the dot mark (A in the figure) shown in Figure B-26 is to the left.

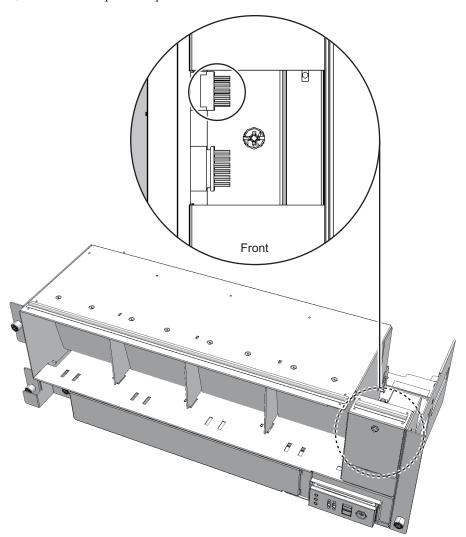
Figure B-27 Operation panel cables

- 2. Connect the cable to the connector of the fan backplane.
- 3. Connect the cable connecting the fan shelf and operation panel to the connector on the operation panel side.

Perform this step only when you install the cable (SIG). If you install the cable (PWR), proceed on to Step 4.
