Fujitsu M10/SPARC M10 Systems

Product Notes for XCP Version 2044

Manual Code: C120-E702-03EN
April 2014

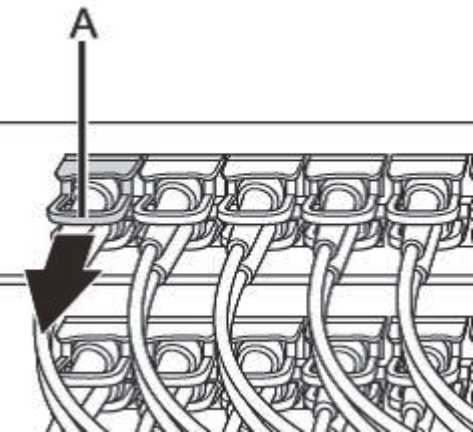
Figure 8-1 Tabs and pull-out directions of crossbar cables

Hold the tab (A in Figure 8-1) of the crossbar cable (optical), and pull it straight in the arrow direction to remove it. At this time, do not pull out the crossbar cable by holding the cable part. If you pull the cable part, the connector is not unlocked completely, which may cause a damage.
 - b. **Reattach the labels of the removed cables.**

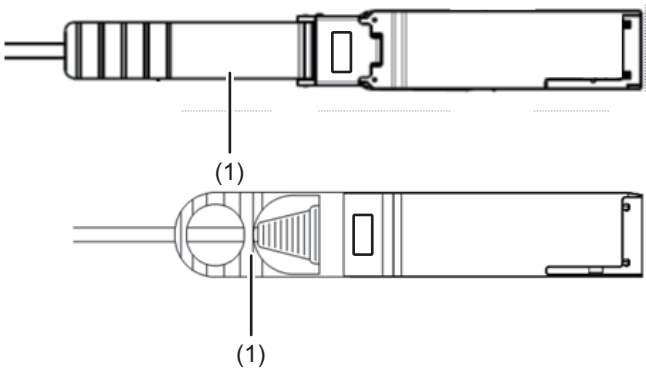
Figure 8-2 Shape and tab of crossbar cable (optical)

Note— There are two types of crossbar cables (optical). Connect cables of the same type to the same port number. Cables can be distinguished by tab shape. For tab shape, see Figure 8-2.

Number in figure	Description
1	Tab

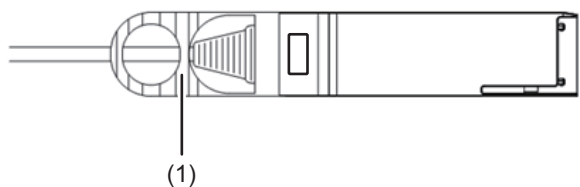
Figure 8-3 Shape and tab of link cable (optical)

Note - The two link cables are the same. Each cable has the same indication labels on the both ends. When connecting cables, ensure that cable ends having the same label are connected to the corresponding positions of the link card and link board.

Number in figure	Description
1	Tab

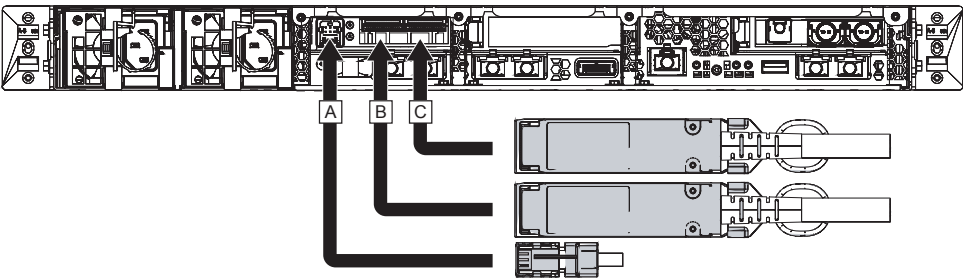
Figure 8-4 Connection of the link cables and management cable (SPARC M10-1 side)

Note - The two ports have the same shape and thus you may connect them incorrectly. Check the labels to confirm that each cable is connected to the correct port.
Hold the connector part of the link cable (electrical) or link cable (optical) and insert it straight into the opening. Do not hold the cable part when inserting the cable.

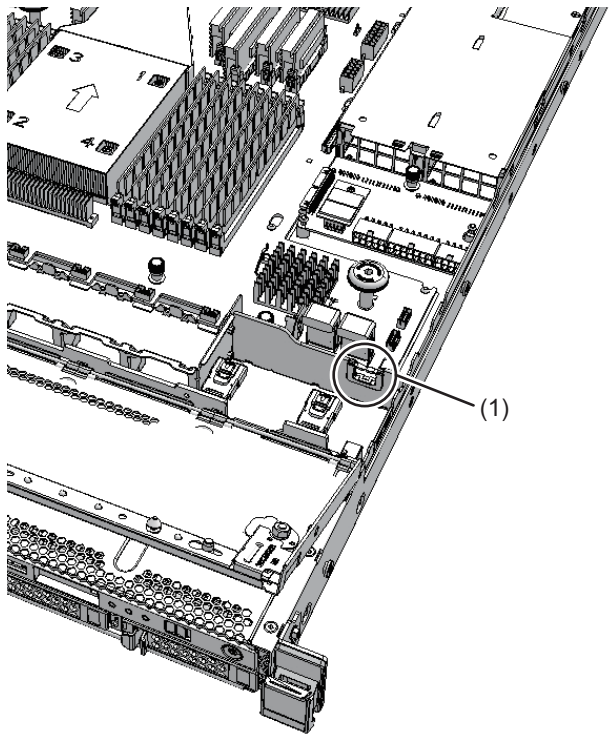
Figure 8-5 Location of cable guide

6. Store cables of the motherboard unit in the cable guide.

Location number	Component
1	Cable guide

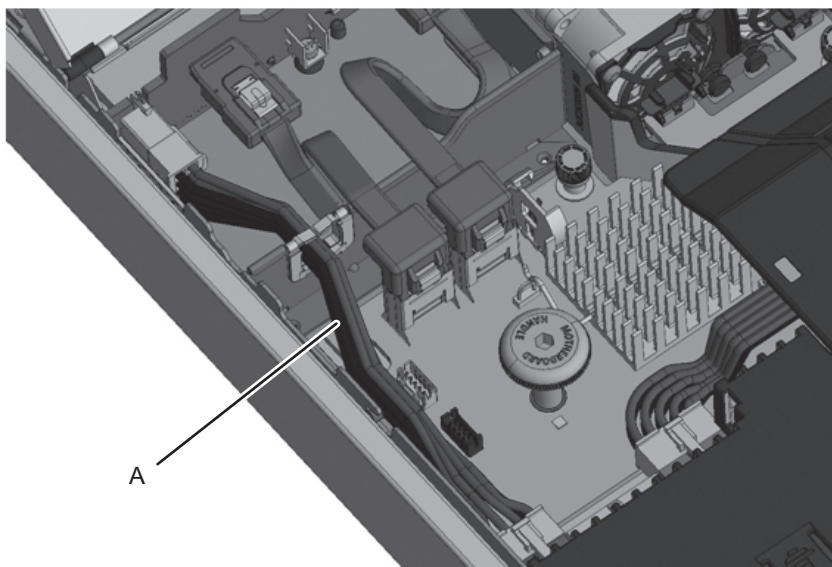
Figure 8-6 Storing cable (red/black)

- a. Store the cable (red/black) (A in the figure) connecting the HDD backplane to the PSU backplane in the cable guide from the middle of the clamp.

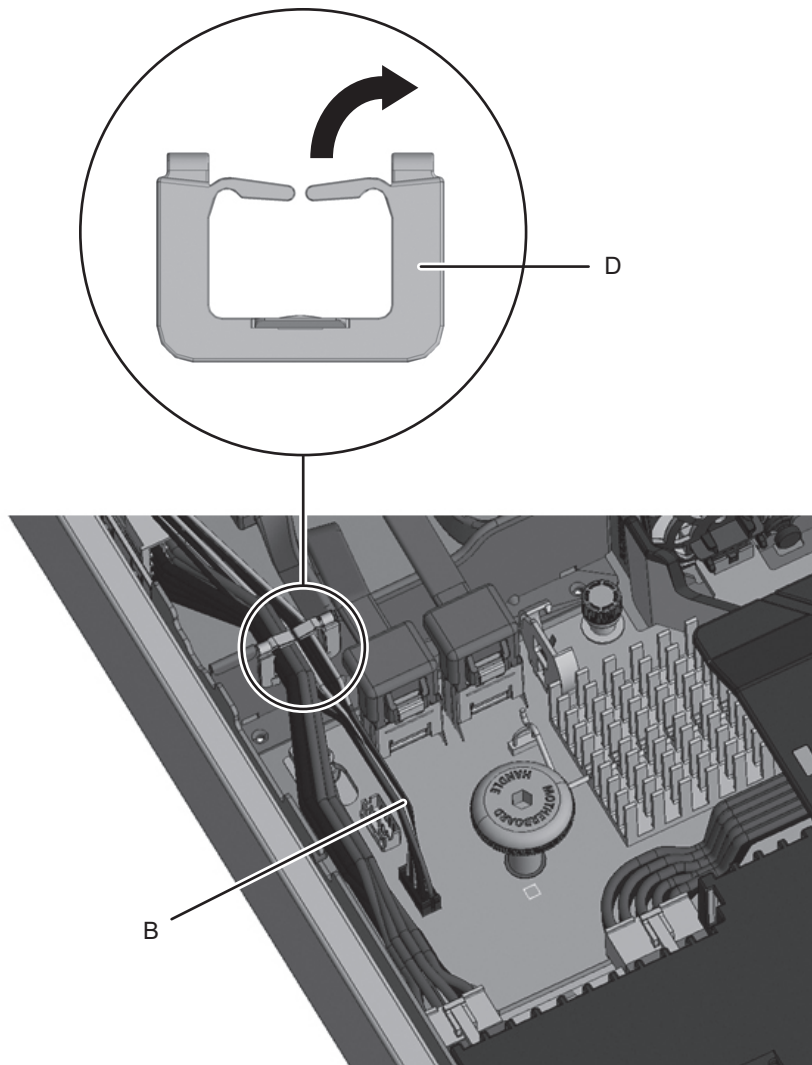
Figure 8-7 Storing cables (black/yellow/white)

- b. Push up one side of the clamp at upper part of the cable guide from the middle to open it (D in the figure). Then, store the cables (black/yellow/white) (B in the figure) connecting the operation panel to the motherboard unit in the cable guide.

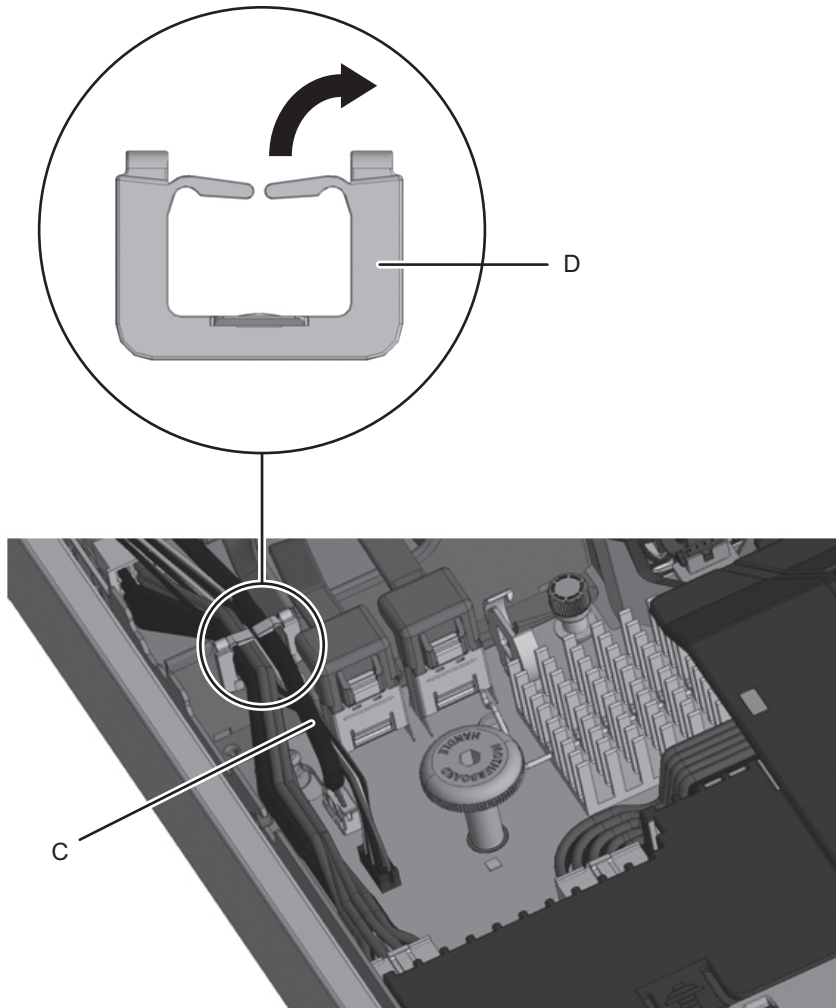
Figure 8-8 Storing cable (black)

- c. Push up one side of the clamp at upper part of the cable guide from the middle to open it (D in the figure). Then, store the cable (black) (C in the figure) connecting the operation panel to the motherboard unit in the cable guide.

- d. Confirm that each cable is stored in the cable guide, as shown in Figure 8-8.

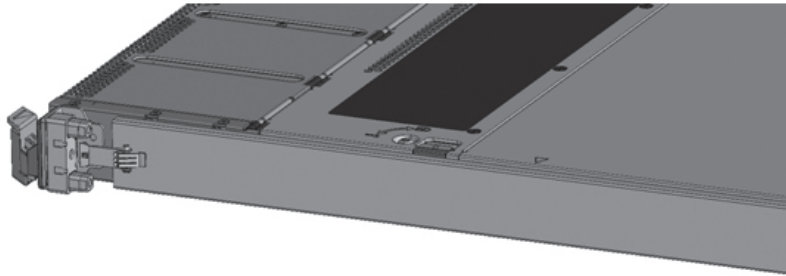
Figure 8-10 A state where a fan unit cover is closed

- e. Confirm that each laid-out cable will not interfere with the fan unit cover, and close the fan unit cover.**

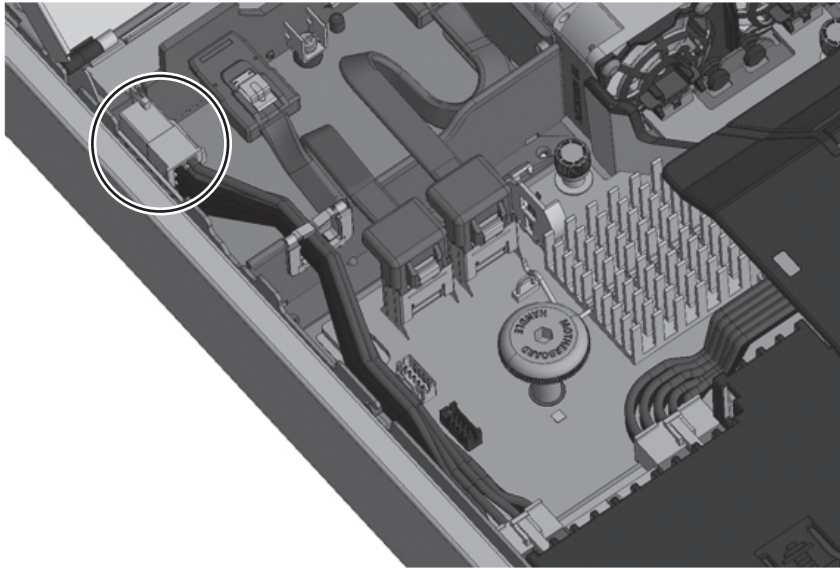
Figure 8-11 Cable for the HDD backplane

- 2. Remove one cable of the HDD backplane which connects the PSU backplane and the HDD backplane.**

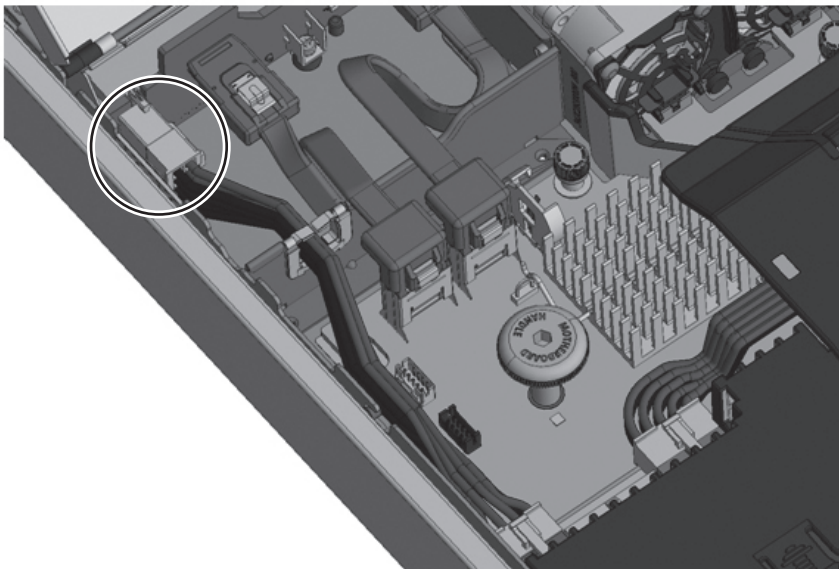
Figure 8-12 Cable for the HDD backplane

5. **Connect one cable connecting the PSU backplane with the HDD backplane.**

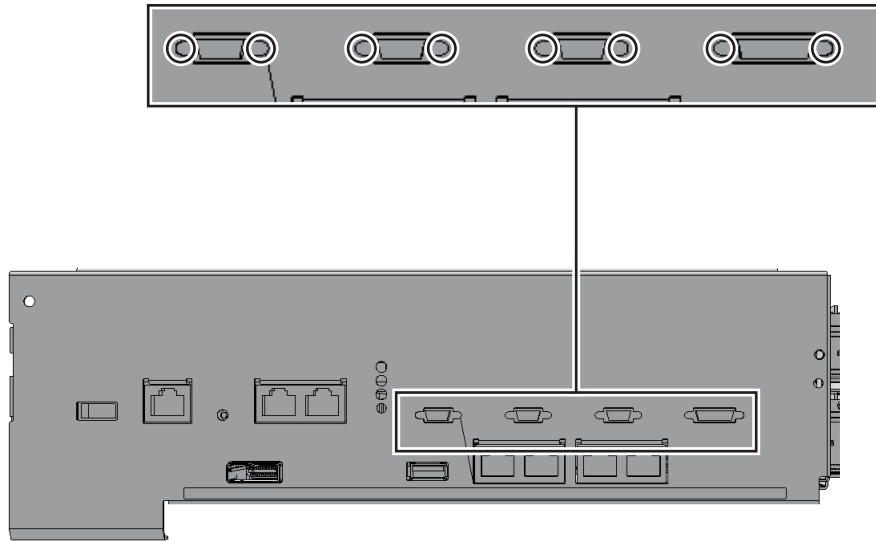
Figure 8-13 Screw positions at both ends of XSCF cable connection port (for SPARC M10-4S)

For SPARC M10-4, this procedure is not necessary.

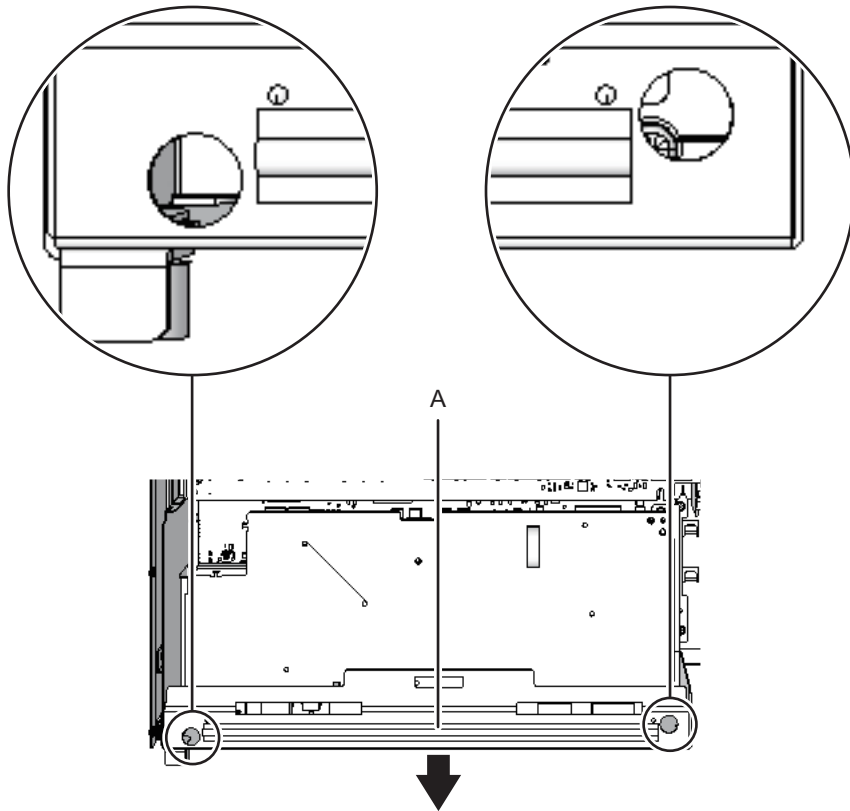
Figure 8-14 Removing rear cover

2. **Loosen the two screws from the upper part of the rear side of the CPU memory unit lower. Then, remove the rear cover (A in the figure) by pulling it to the direction of arrow.**

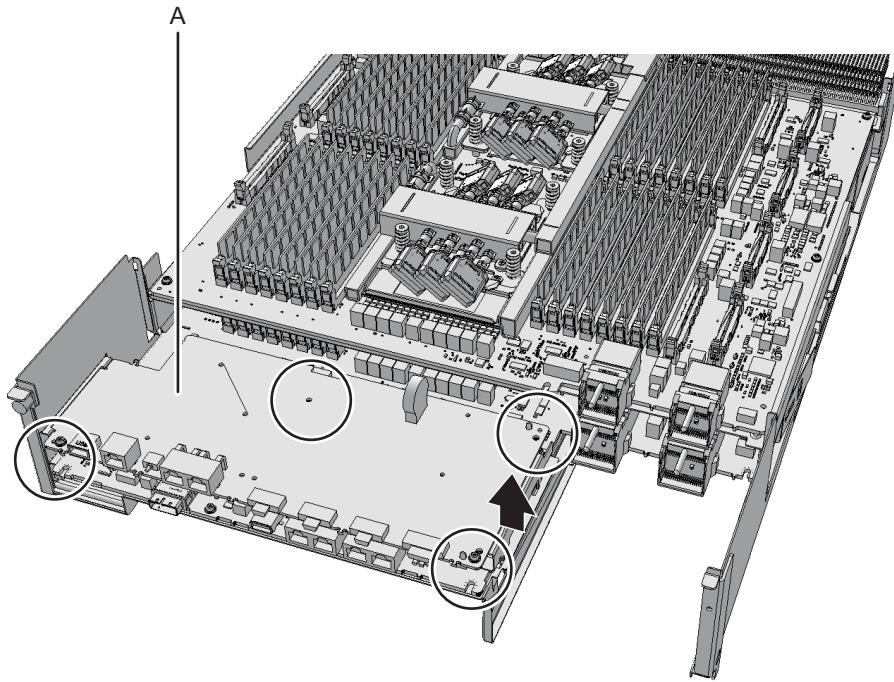
Figure 8-15 Releasing connected XSCF board

3. **Remove the XSCF board.**
 - For SPARC M10-4S, remove the four screws fixing the XSCF board (A in the figure). Then, lift the right side of the XSCF board to release connection of the connector.

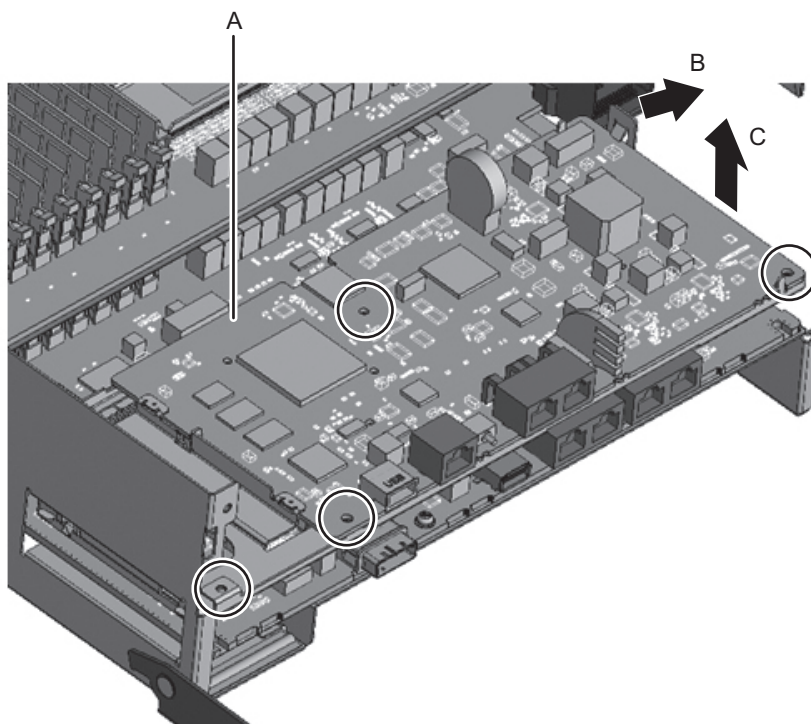
Figure 8-16 Releasing connection of XSCF board (for SPARC M10-4)

- For SPARC M10-4, remove the four screws fixing the XSCF board (A in the figure) and rear cover. Tilt the right lever of the XSCF mount by fingers about 5 mm (0.2 in.) to the right (B in the figure). Lift up the right side of the XSCF board and release connection of the connector (C in the figure).

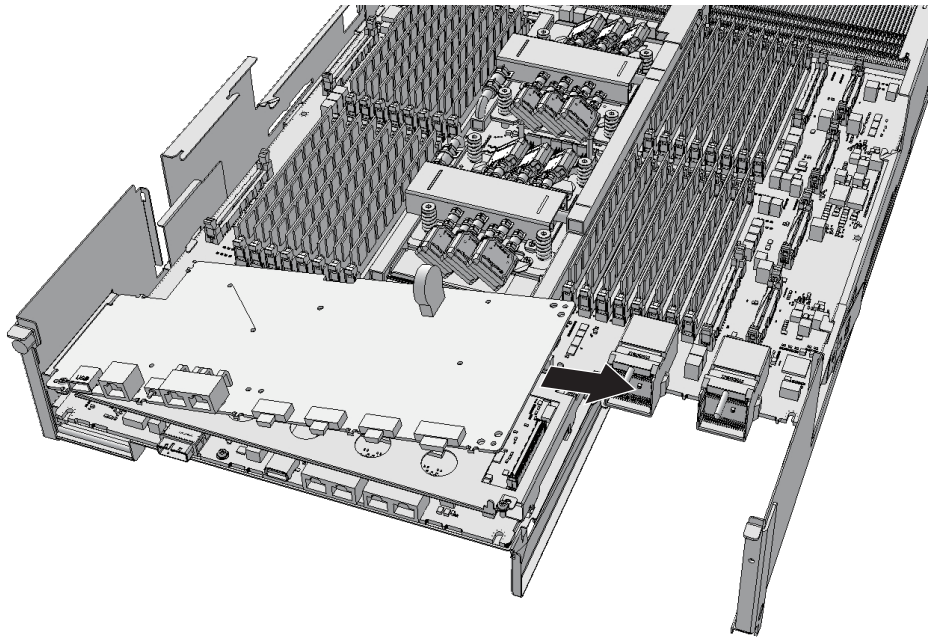
Figure 8-17 Pulling out XSCF board (for SPARC M10-4S)

4. **Pull out the XSCF board obliquely to the right direction (arrow).**

Note - Place the removed XSCF board on a grounded static-removal ESD mat.

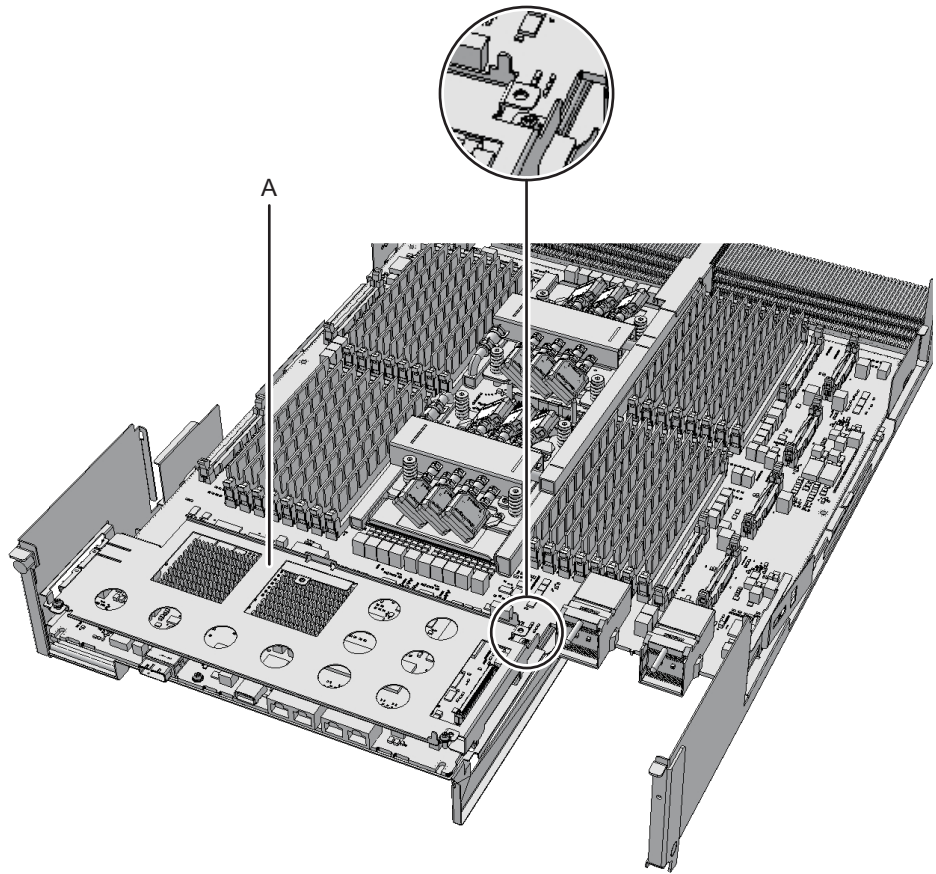
Figure 8-19 Screw fixing XSCF mount (for SPARC M10-4S)

5. Remove the one screw fixing the XSCF mount (A in the figure).

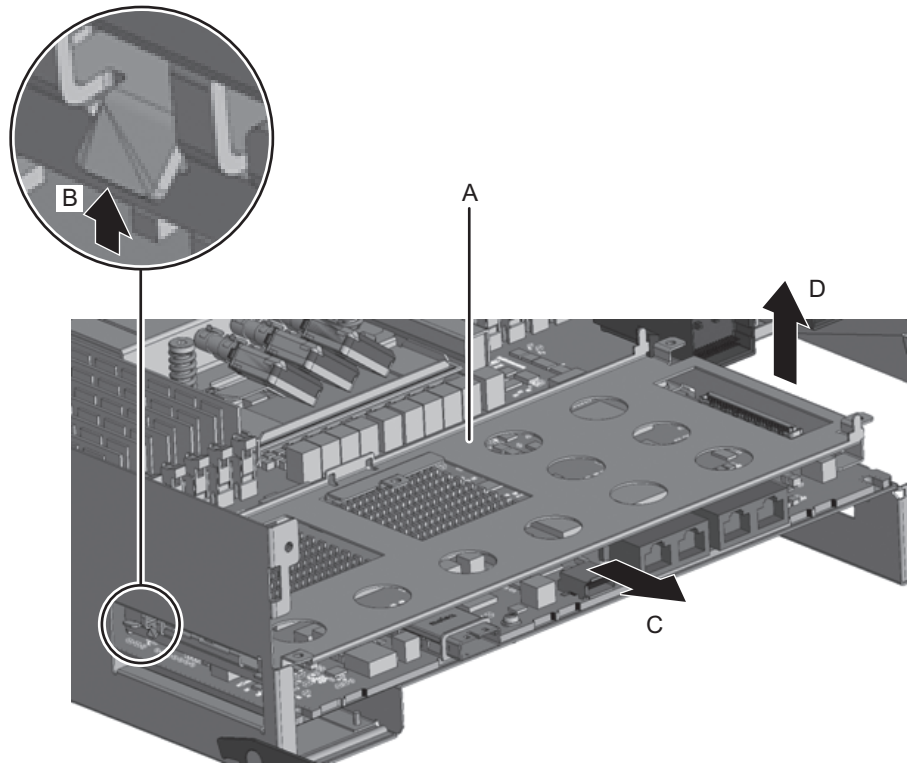
Figure 8-21 Removing XSCF mount (for SPARC M10-4S)

6. Lift up the left projecting lever of the XSCF mount (A in the figure) by fingers about 2 mm (0.1 in.) (B in the figure) and slide it to the front about 8 mm (0.4 in.) (C in the figure). Then, remove it upward (D in the figure).

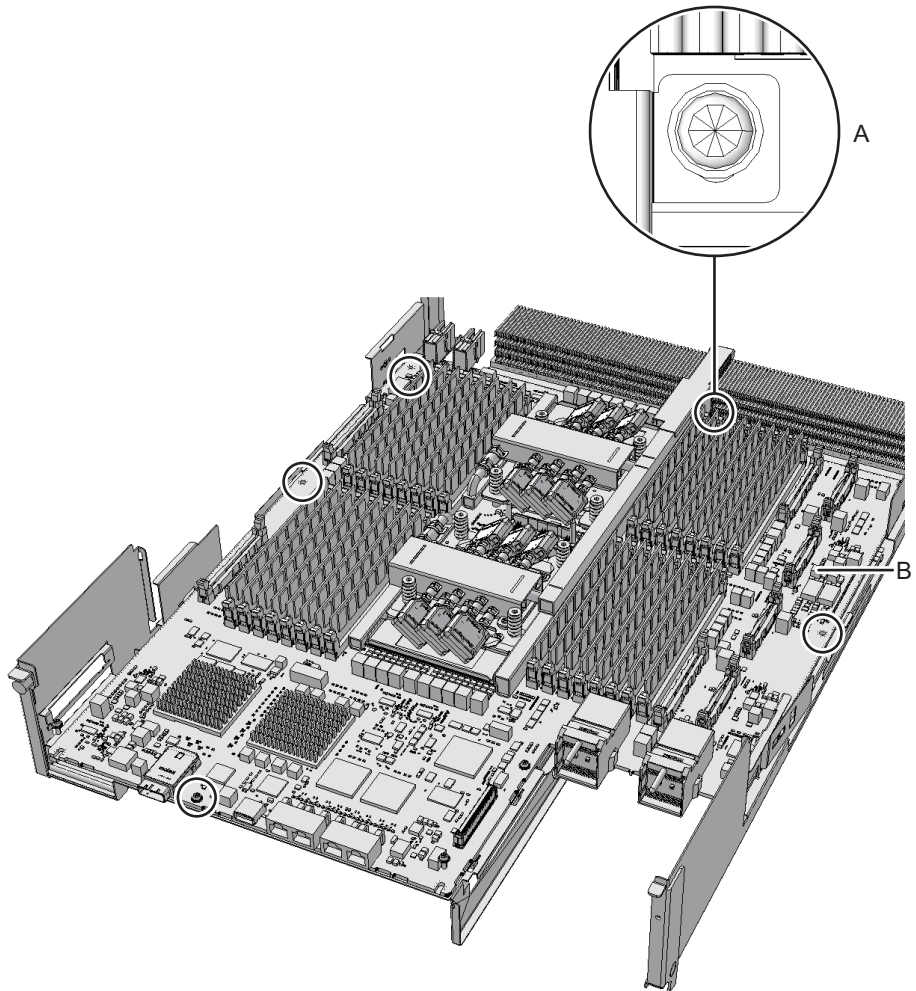
Figure 8-23 Positions of screws fixing CPU memory unit board

7. **Remove the one black screw (A in the figure) fixing the center part of the radiator on the front side and the four screws fixing the CPU memory unit board (B in the figure).**

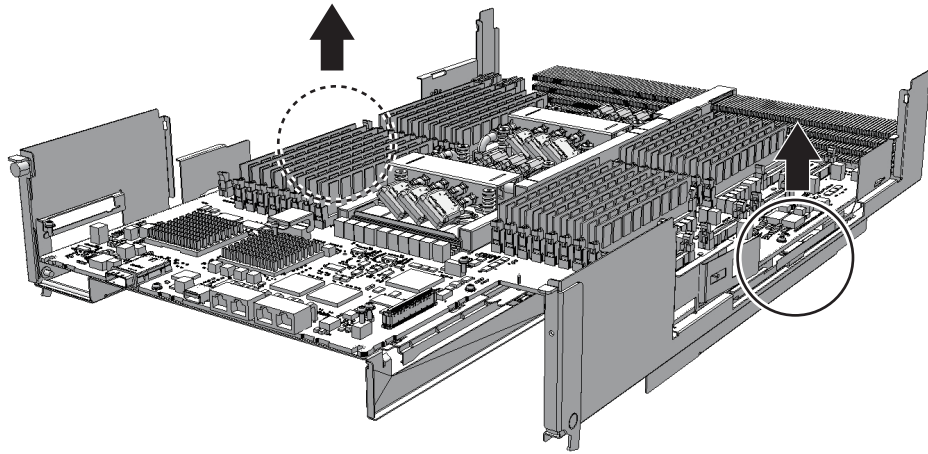
Figure 8-24 Removing CPU memory unit board

8. **Insert your fingers under the board of the connector unit located at the center of the right and left sides of the CPU memory unit board. Lift the CPU memory unit board, and disconnect and remove the connector.**

Note - Place the removed CPU memory unit board on a grounded antistatic ESD mat.

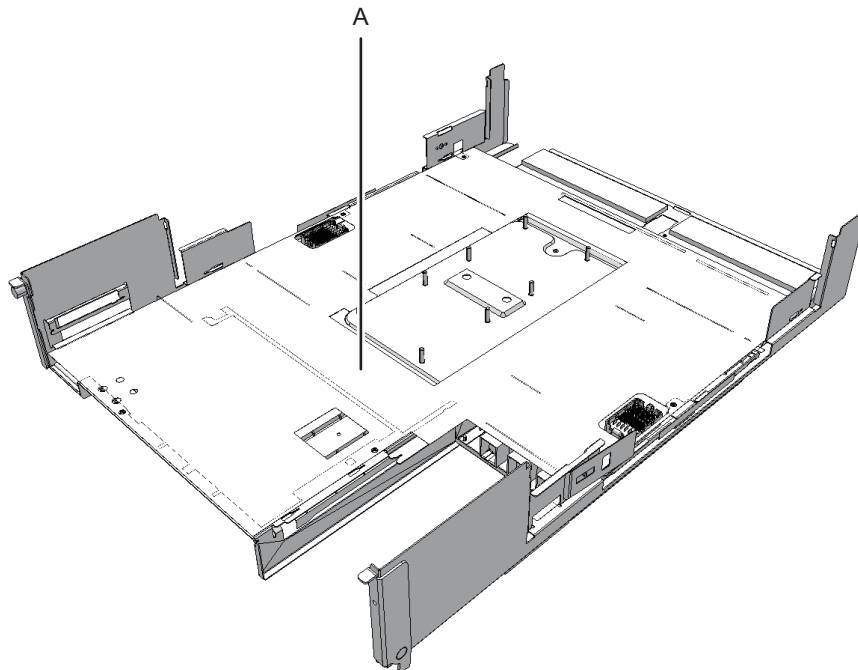
Figure 8-25 Removing sheet

9. **Remove the sheet (A in the figure).**

You can expand the CPU memory unit upper with the operations you have done so far. You do not have to perform Step 10.

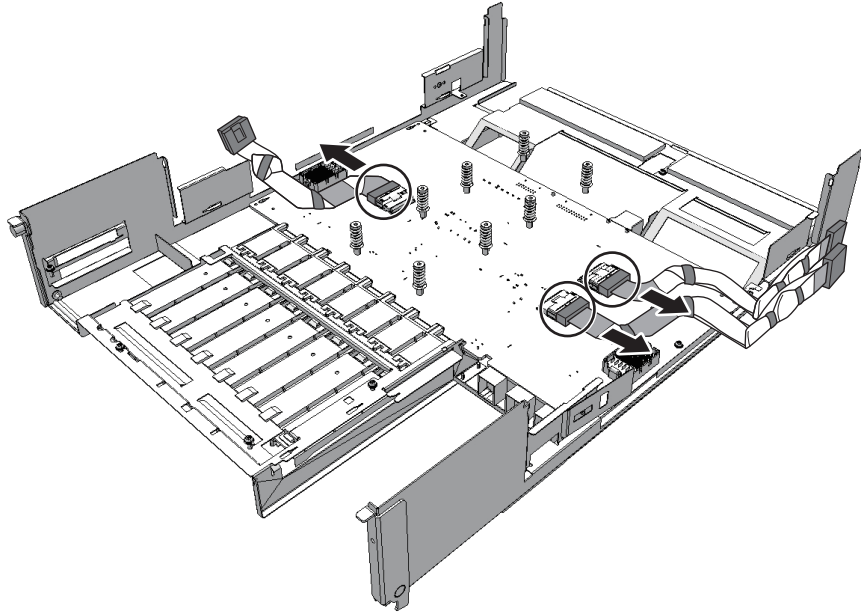
Figure 8-26 Removing PCIe cable

10. **Remove the three PCIe cables.**

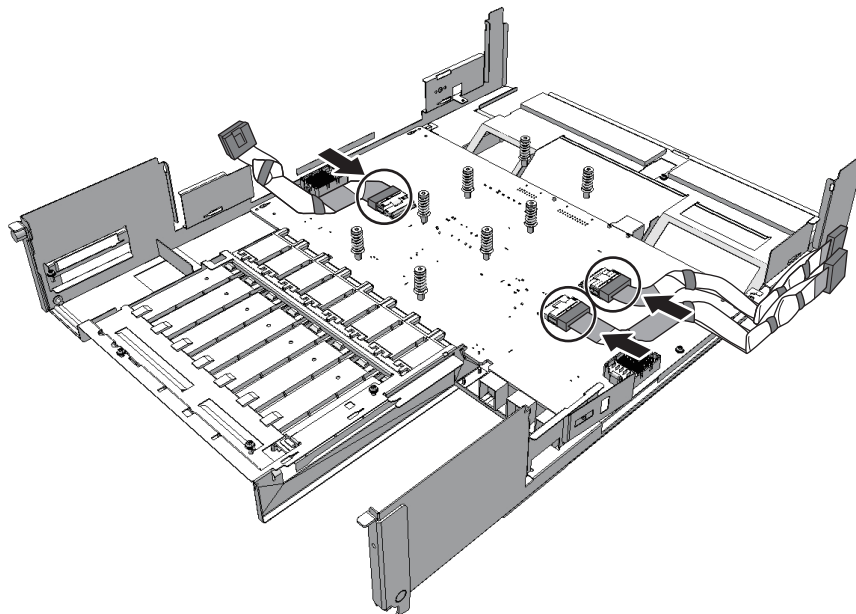
Figure 8-27 Installing PCIe cable

When expanding the CPU memory unit upper or when replacing the PCIe cable, connect the PCIe cable. You can reduce the CPU memory unit upper by performing the procedure from Step 2.

Note - Ensure that the PCIe cables are firmly attached and fixed.

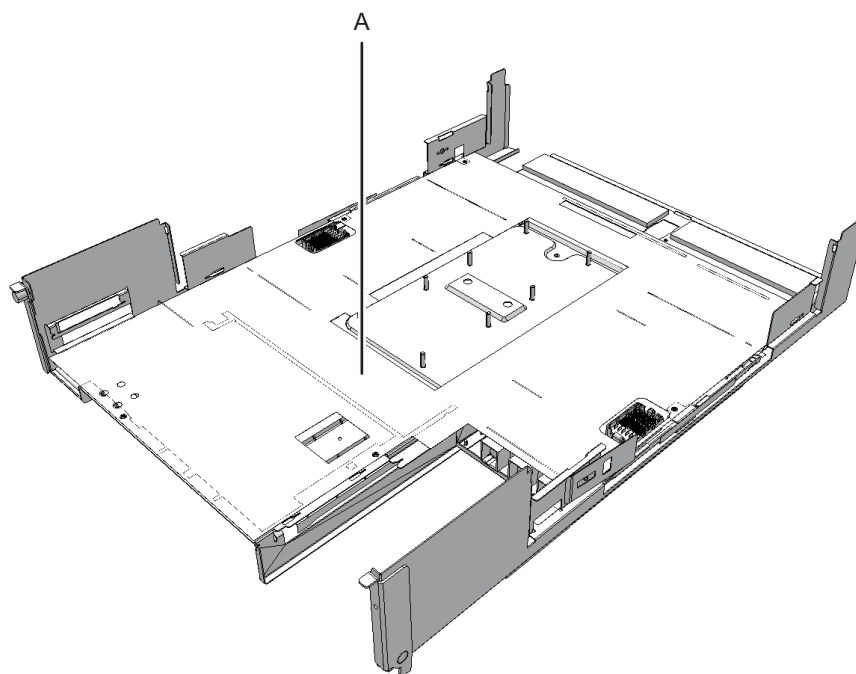
Figure 8-28 Installing sheet

2. Install a sheet (A in the figure).

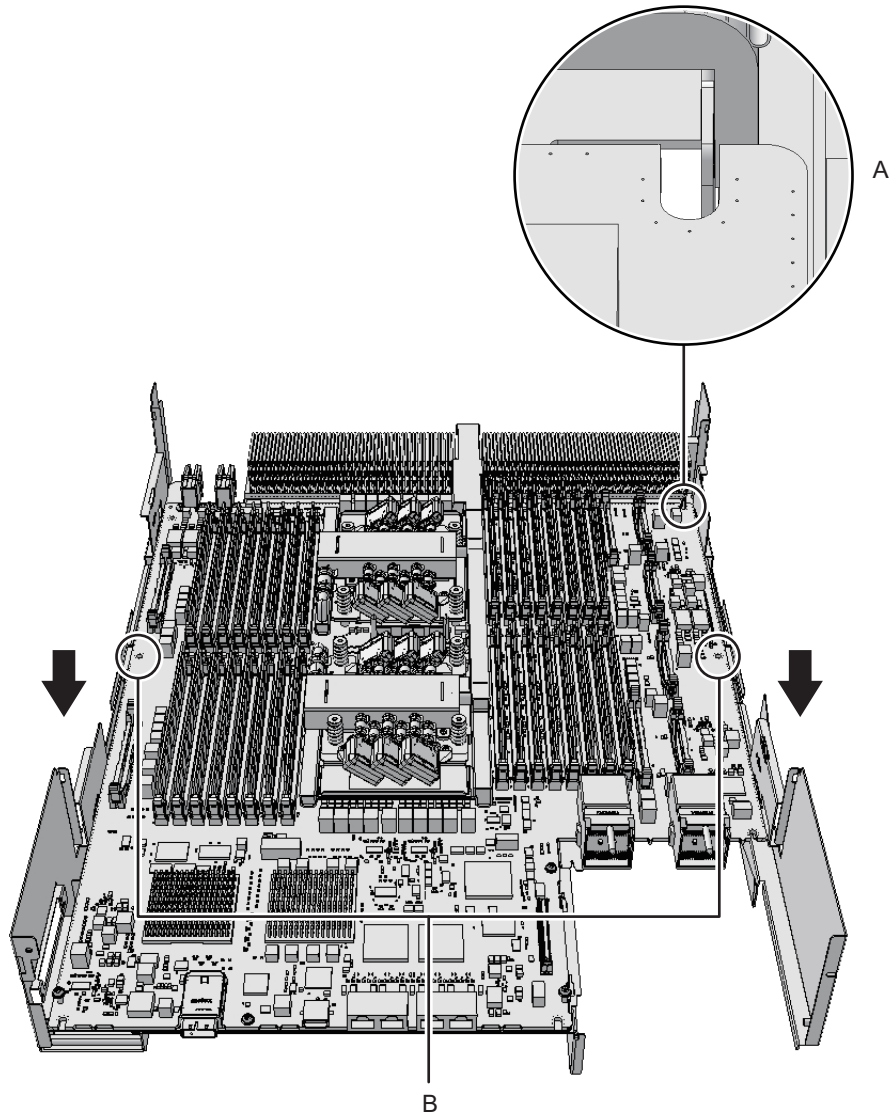
Figure 8-29 Installing CPU memory unit board

3. **Install the CPU memory unit board with the right guide (A in the figure) on the front side of the board as a guide. Press the connector unit (B in the figure) at the center of right and left sides of the CPU memory unit board to connect the connector.**

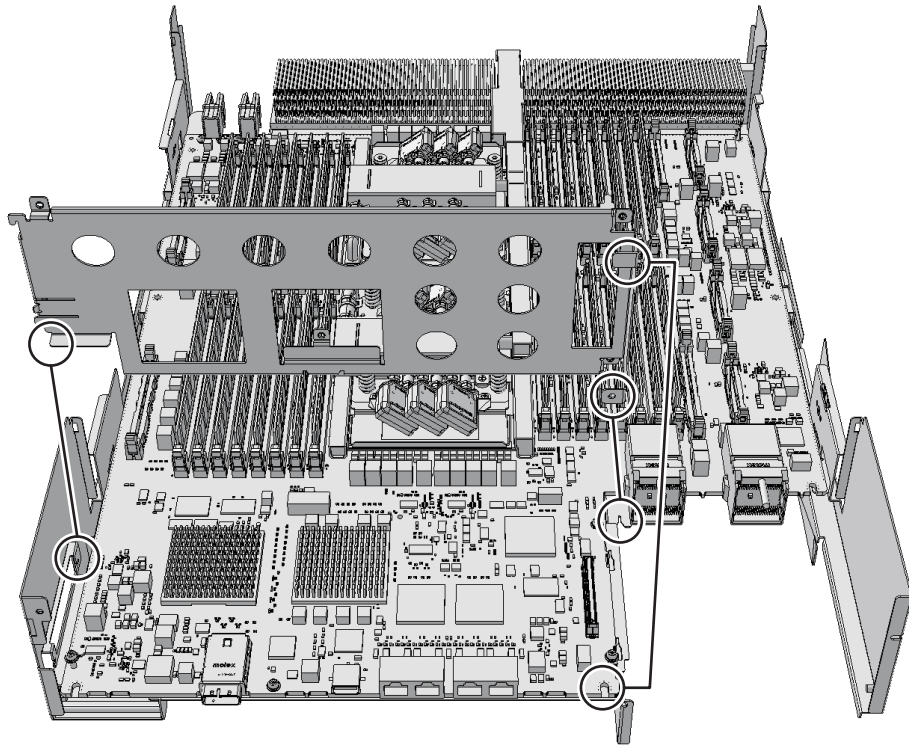
Figure 8-30 Installing XSCF mount

4. **Fix the CPU memory unit board with four screws and center part of the radiator on the front side with one black screw.**
5. **install the XSCF mount by sliding it to the front side, and fix it with one screw.**
Align the guide on one part of the left side and the guides on two parts on the lower right side to install the XSCF mount.

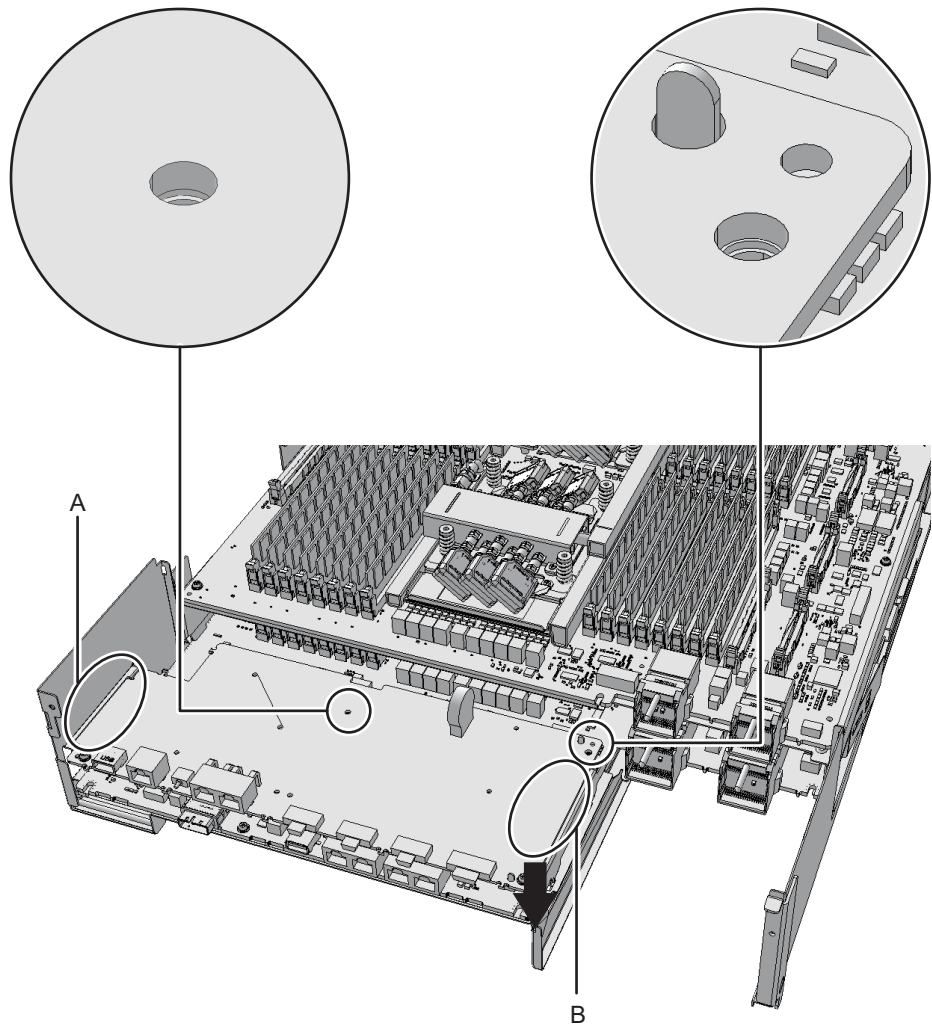
Figure 8-31 Installing XSCF board

6. **Install the XSCF board.**
 - For SPARC 10-4S, insert the XSCF board into the left guide (A in the figure), and press down the right connector unit (B in the figure) to connect the connector. Then, fix it with two screws.

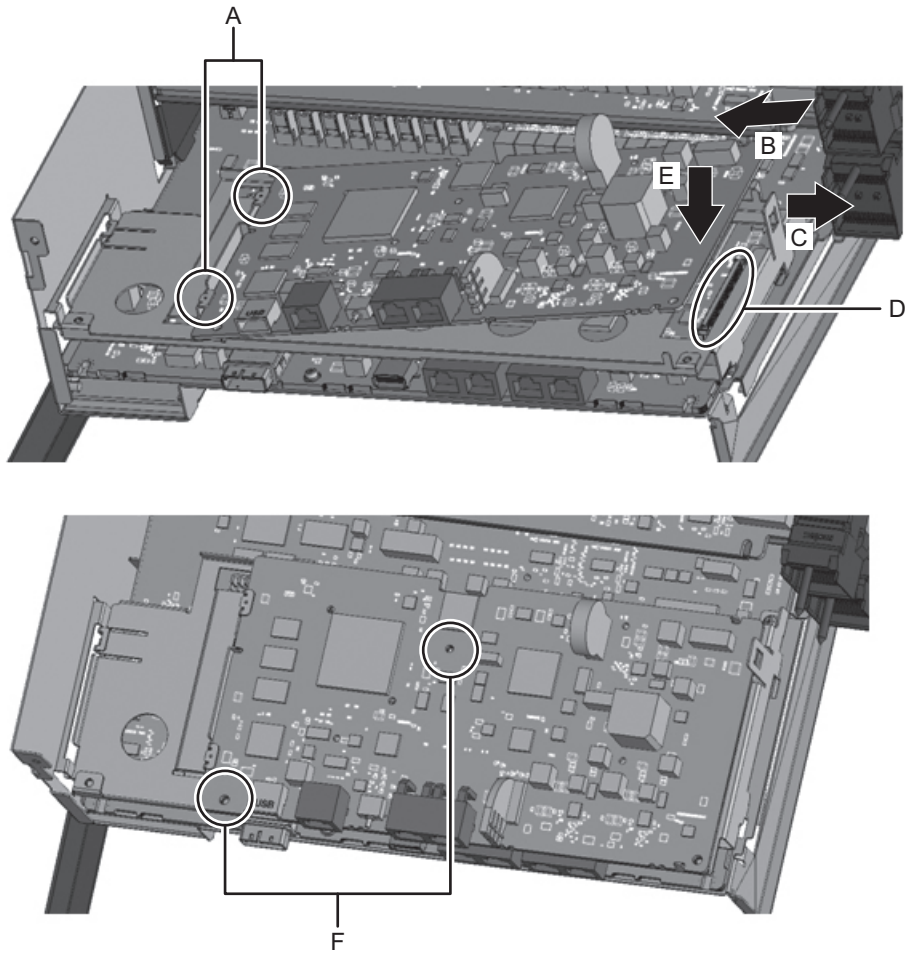
Figure 8-32 Installing XSCF board (for SPARC M10-4)

- For SPARC M10-4, insert the XSCF board into two positions (A in the figure) on the guide of the mount (B in the figure), and press the right lever of the mount about 5 mm (0.2 in.) to the right (C in the figure) to connect the connector unit (D in the figure). Then, fix it with two screws (F in the figure).

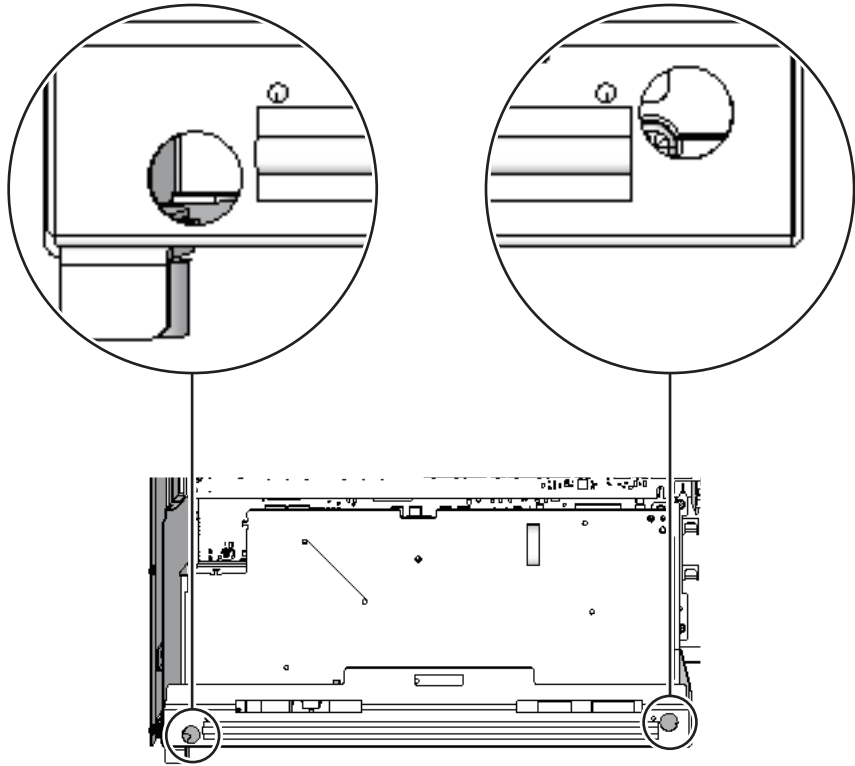
Figure 8-33 Screws for rear cover

7. **Attach the rear cover with two screws from the upper part of the rear side of the CPU memory unit lower.**

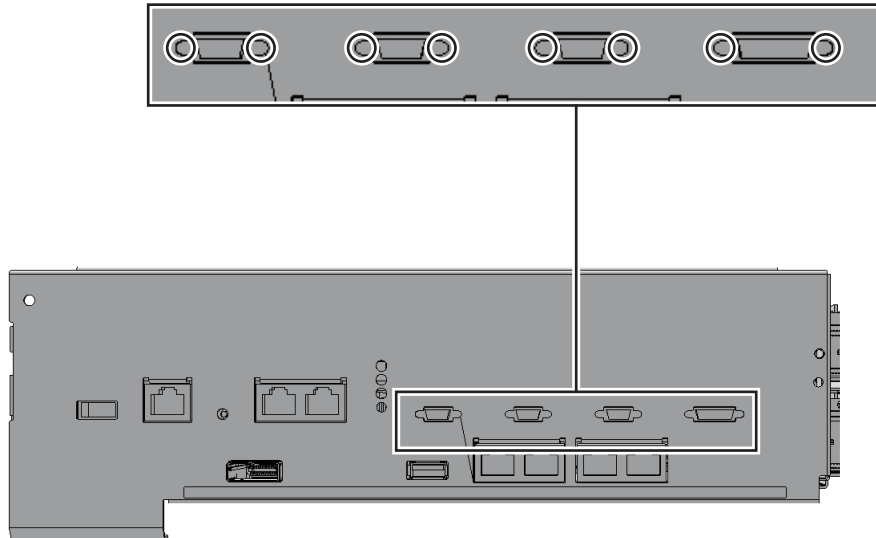
Figure 8-34 Screw positions at both ends of XSCF cable connection port (for SPARC M10-4S)

8. **Install the eight screws at both ends of the XSCF cable connection port on the rear side of the CPU memory unit lower.**

For SPARC M10-4, this procedure is not necessary.

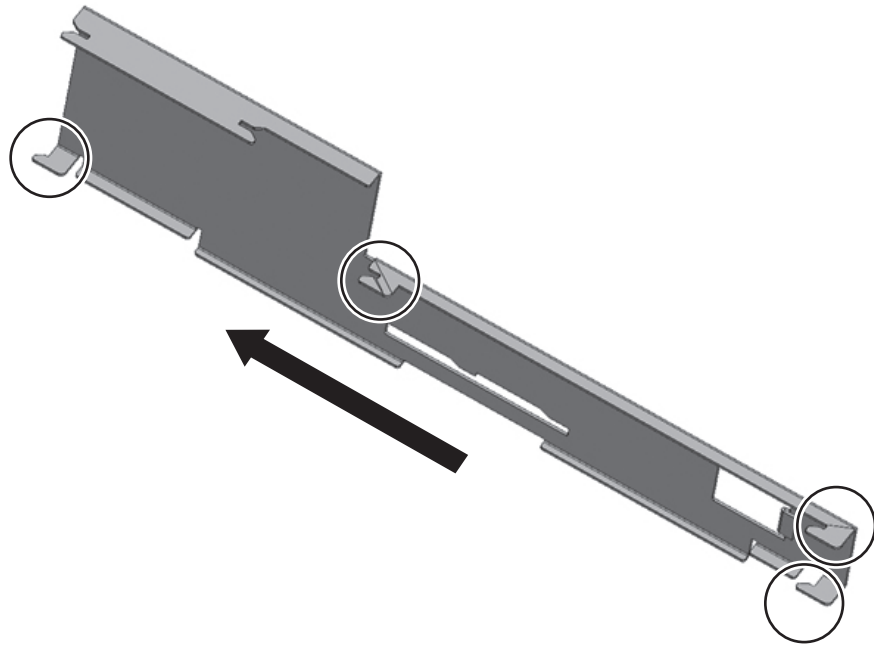
Figure 8-35 Clip positions of right and left side guides

4. **Install the right and left side guides.**

Note—Be careful not to damage the PCIe cable when installing the right and left side guides.

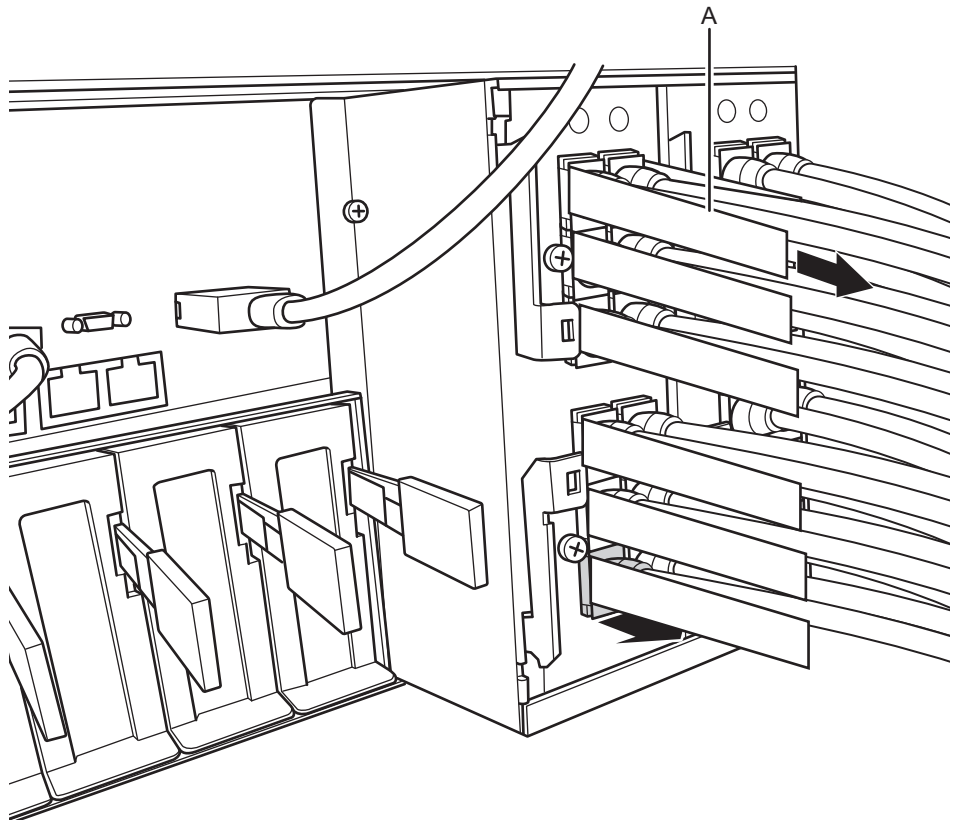
Figure 8-37 Removing crossbar cable (electrical)

1. **Remove two crossbar cables (electrical) from SPARC M10-4S.**
Hold the tab (A in the figure) of the crossbar cable (electrical), and pull it straight in the arrow direction to remove it. At this time, do not pull out the crossbar cable by holding the cable part. If you pull the cable part, the connector is not unlocked completely, which may cause a damage.
2. **Remove two crossbar cables (electrical) from the other cabinet.**
Hold the tab (A in the figure) of the crossbar cable (electrical), and pull it straight in the arrow direction to remove it. At this time, do not pull out the crossbar cable by holding the cable part. If you pull the cable part, the connector is not

unlocked completely, which may cause a damage.

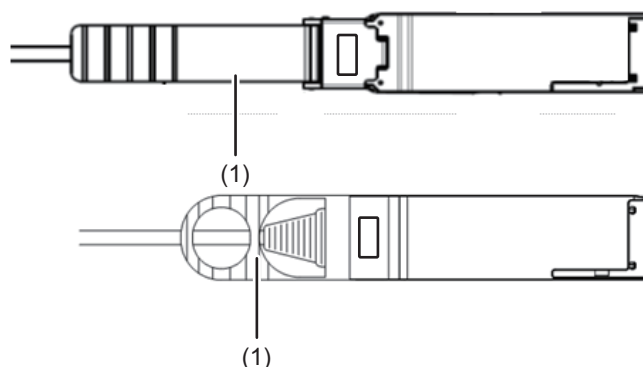
Figure 8-38 Shape and tab of crossbar cable (optical)

1. **Connect two crossbar cables (optical) each to SPARC M10-4S and the crossbar box.**
There are two types of crossbar cables (optical). Connect cables of a same type to a same port number. Cables can be distinguished by tab shape. For tab shape, see Figure 8-7.

Number in figure	Description
1	Tab

Hold the connector part of the crossbar cable (optical), and insert it straight into the opening. Do not hold the cable part when inserting the cable.

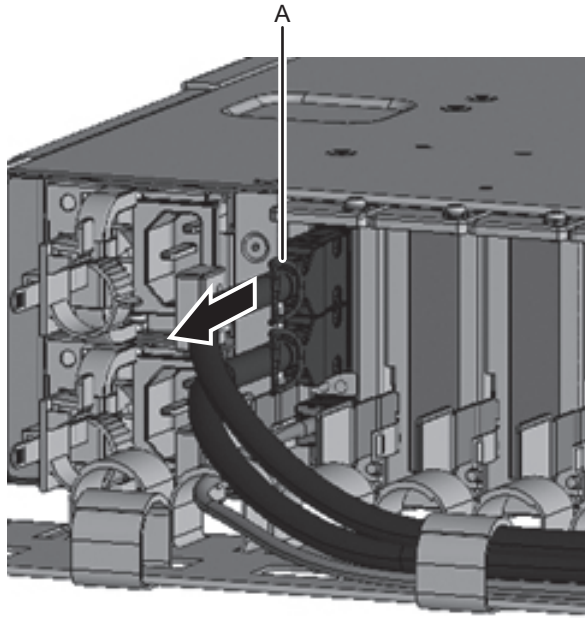
Figure 8-39 Removing link cable

Hold the tab (A in the figure) for the link cable (electrical) or link cable (optical), and pull it straight to the cable side to remove it. At this time, do not pull out the crossbar cable by holding the cable part. If you pull the cable part, the connector is not unlocked completely, which may cause a damage.

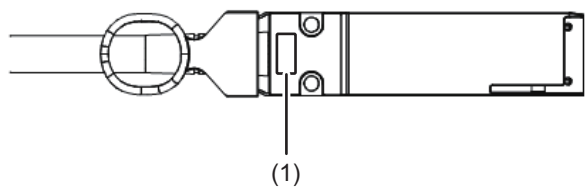
Figure 8-41 Label position of link cable (electrical)

Number in figure	Description
1	Label

- Before using the link cable, confirm that labels of a same number (0 or 1) are attached to the connectors at both ends.
If no label is attached, attach labels supplied with the link cable so that the same number is displayed on the connectors at both ends. For state of the labels correctly attached, see Figure 8-40. For attachment positions, see Figure 8-41 and Figure 8-42.

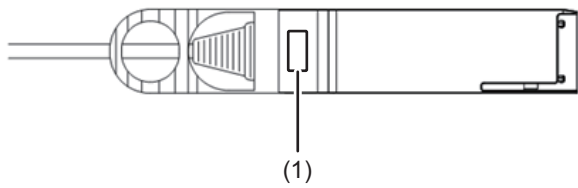
Figure 8-42 Label position of link cable (optical)

Number in figure	Description
1	Label

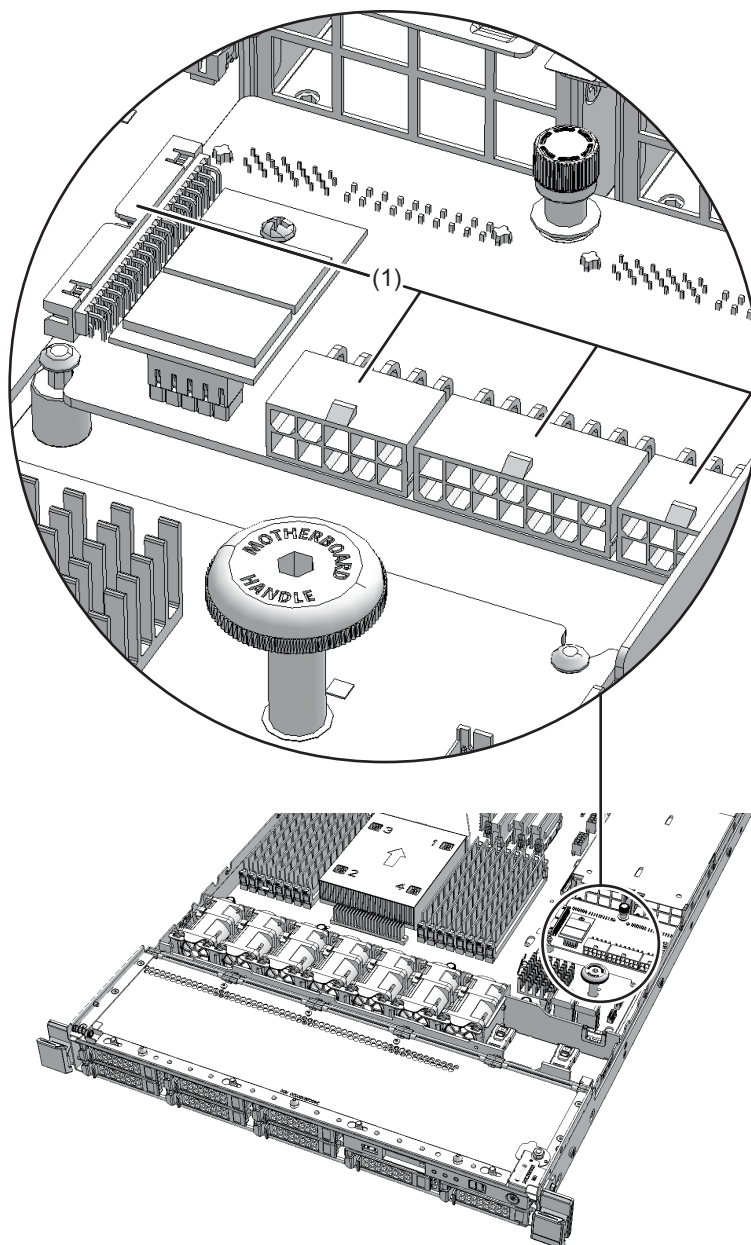
Figure A-1 Location of the cable kit

The cable kit contains three cables to connect the mother board unit with the PSU backplane and one cable to connect the mother board unit with the HDD backplane.

Location number	Component
1	Cable kit
