Fujitsu M10/SPARC M10 Systems

Product Notes for XCP Version 2044

Manual Code: C120-E702-03EN
April 2014

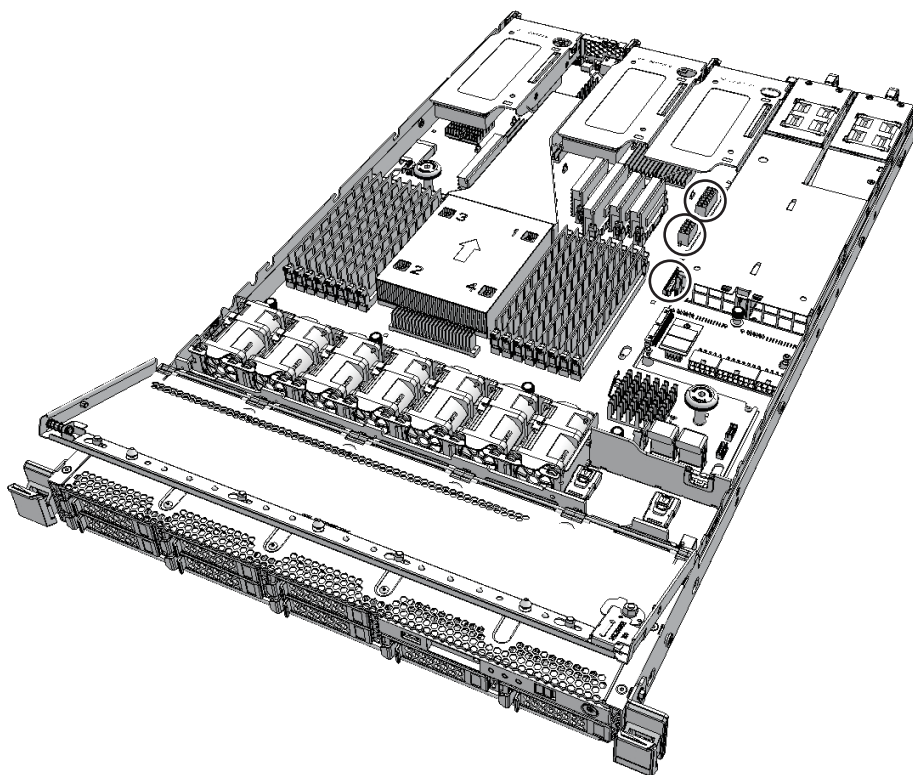
Figure A-2 Cables of motherboard unit

Note - Write down the connection positions for the cables before removing them to restore them correctly.

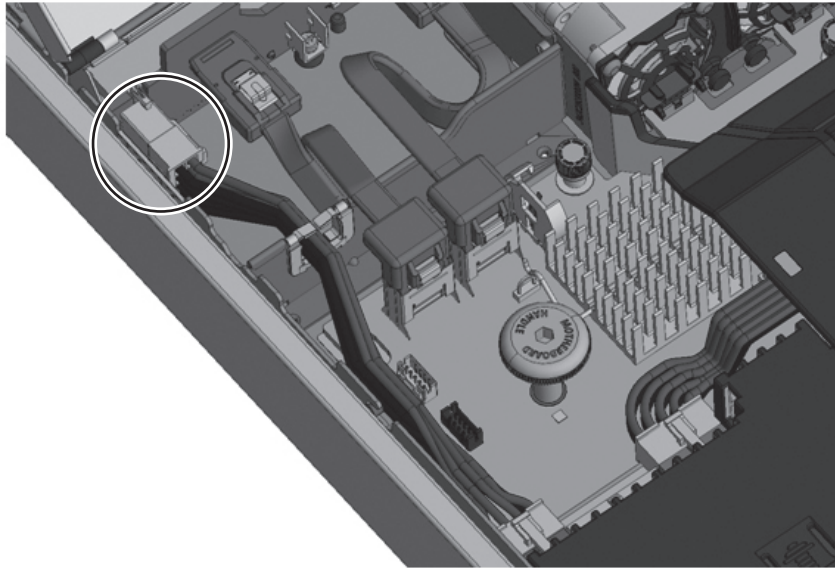
Figure A-3 Cable for the HDD backplane

2. **Remove one cable of the HDD backplane which connects the PSU backplane and the HDD backplane.**

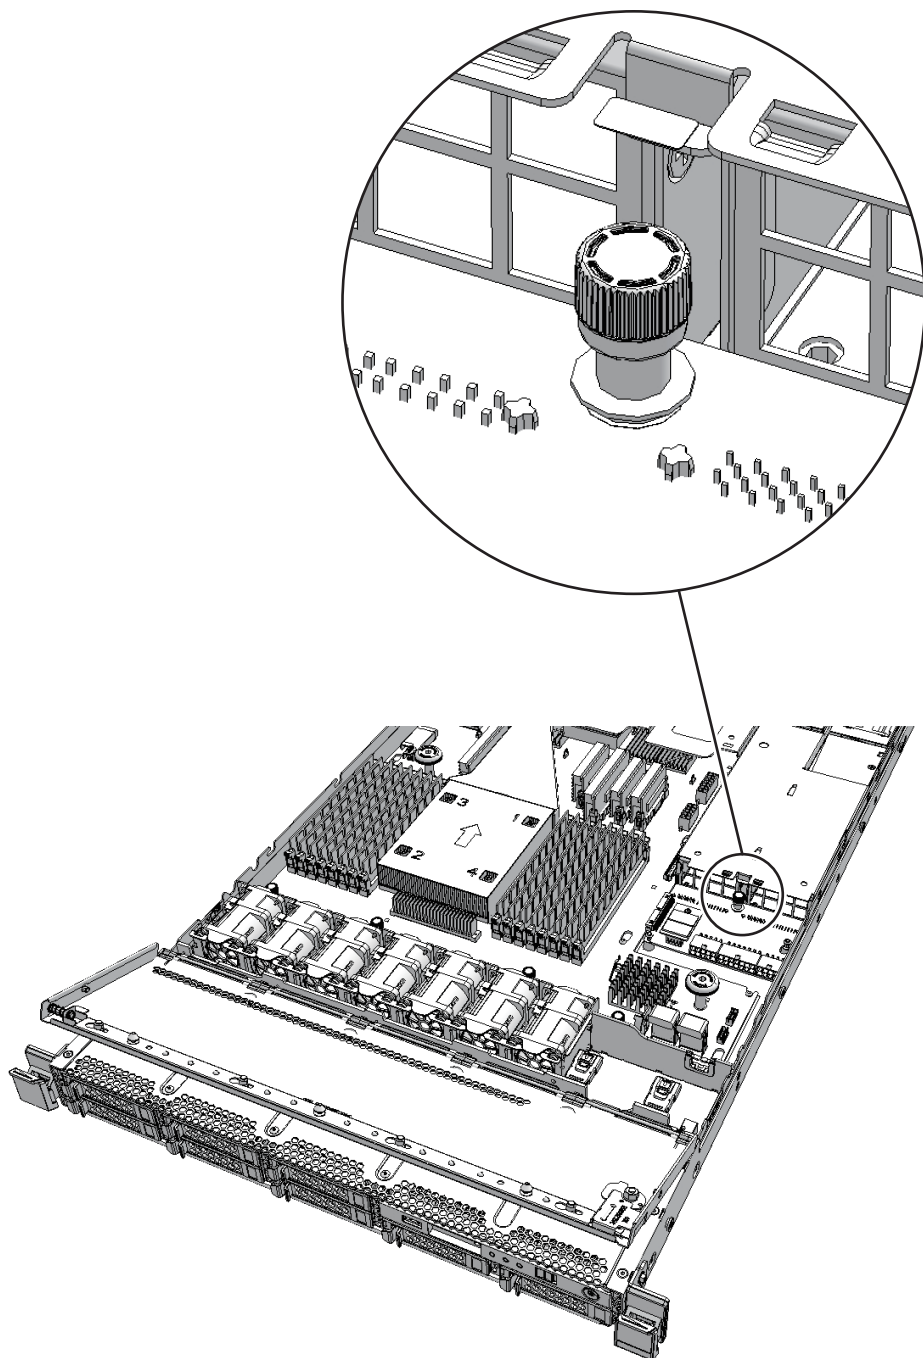
Figure A-4 Screws for PSU backplane

3. Loosen one screw that fixes the PSU backplane.

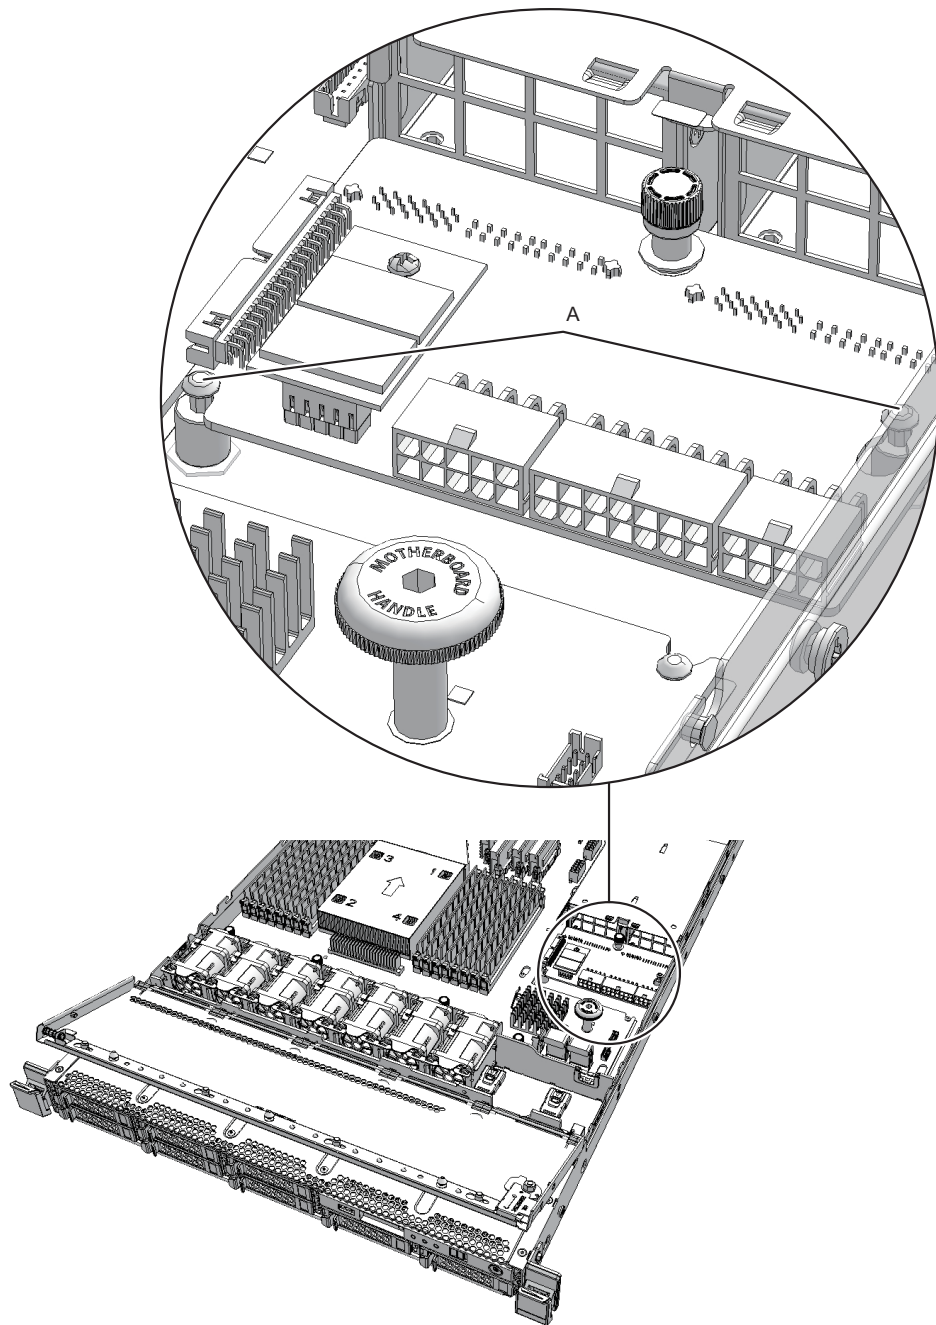
Figure A-5 Fixing screws for PSU backplane

4. Slide the PSU backplane to the rear side of the cabinet and remove it from the two fixing pins (A in the figure).

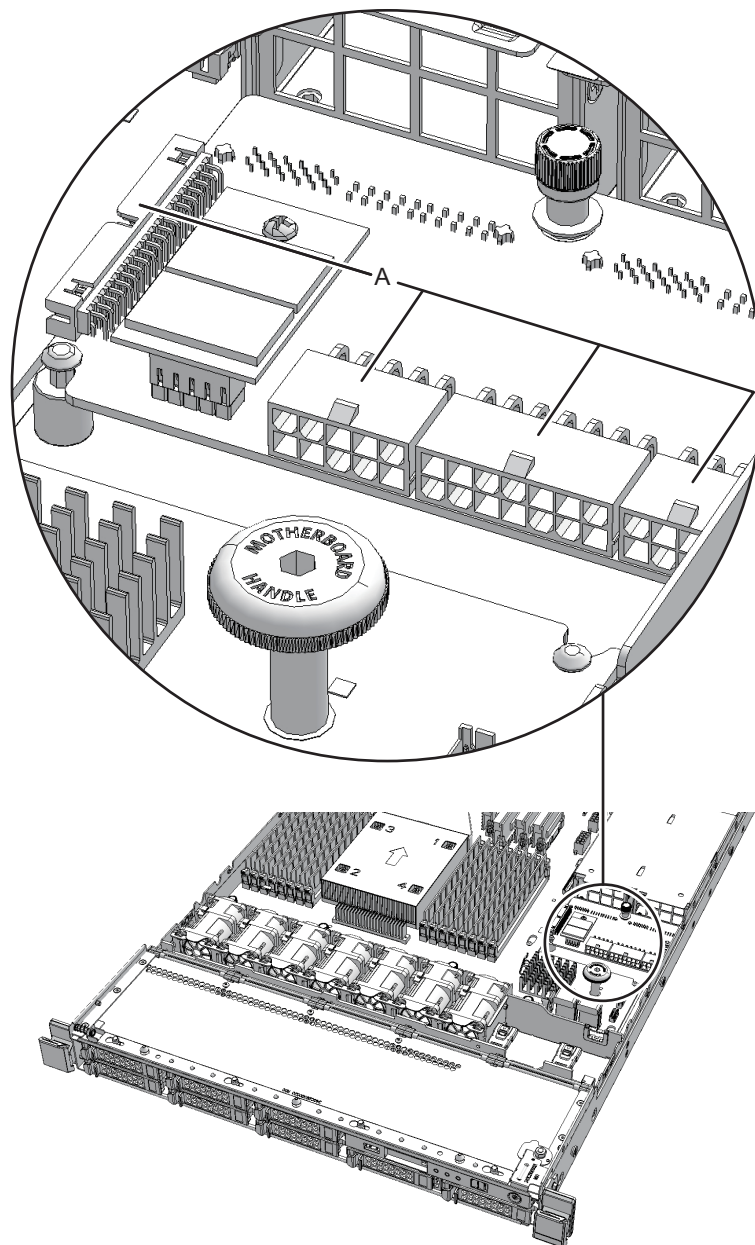
Figure A-6 Cable for PSU backplane

5. Lift the PSU backplane and remove the four cables (A in the figure).

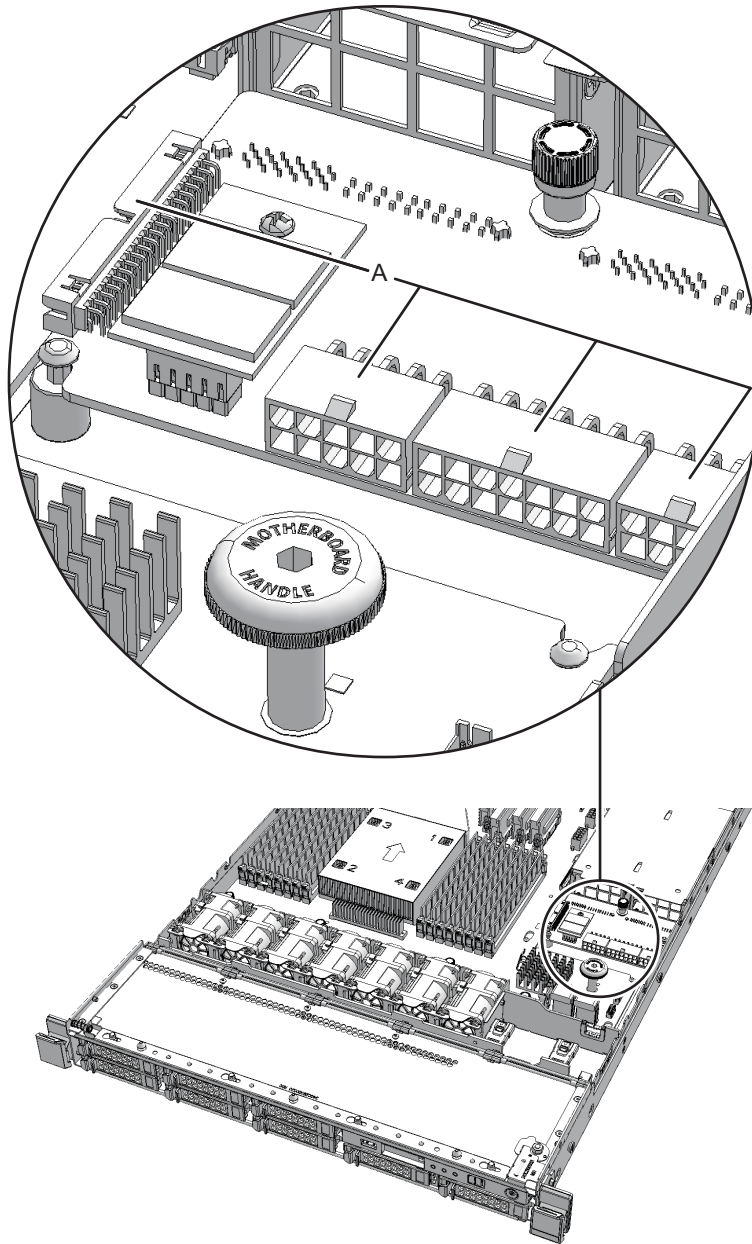
Figure A-7 Cable for PSU backplane

1. **Hold the PSU backplane and connect the four cables (A in the figure).**

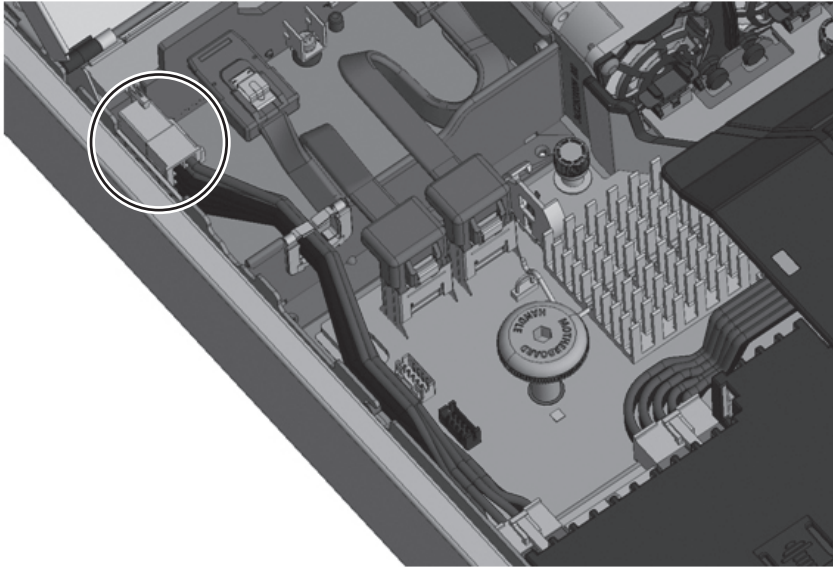
Figure A-8 Cable for the HDD backplane

2. **Install the PSU backplane.**
3. **Confirm that the two fixing pins are inserted into the PSU backplane. Then, slide the PSU backplane to the rear side of the cabinet.**
4. **Tighten the one screw that fixes the PSU backplane.**
5. **Connect one cable connecting the PSU backplane with the HDD backplane.**

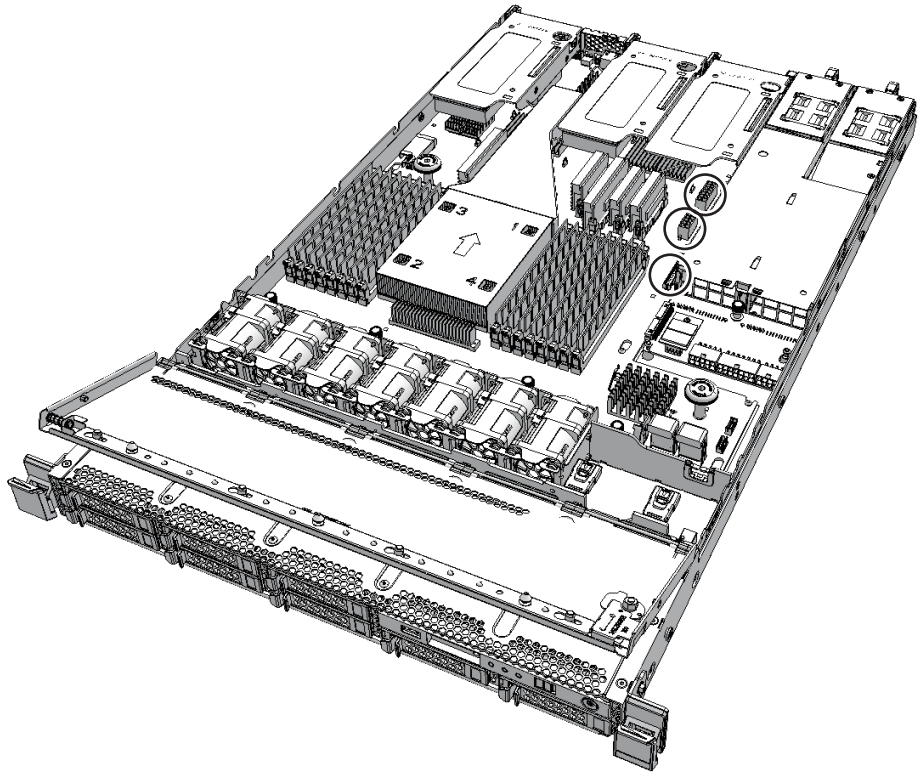
Figure A-9 Cables of motherboard unit

6. **Connect the three cables connecting the PSU backplane with the motherboard unit.**

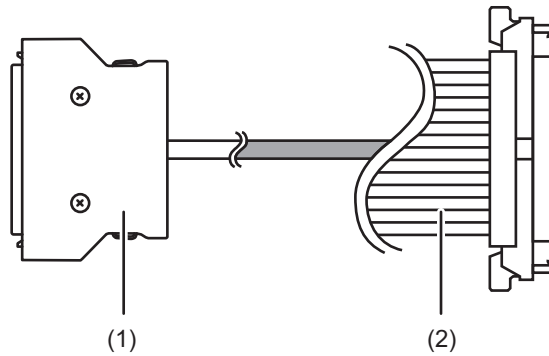
Figure B-1 Cable (SIG) (Between crossbar backplane unit and terminal board)

- Cable (SIG)
Cable for connecting the crossbar backplane unit and terminal board (SIG)

Location number	Component
1	Connector (terminal board (SIG) side)
2	Connector (crossbar backplane unit side)

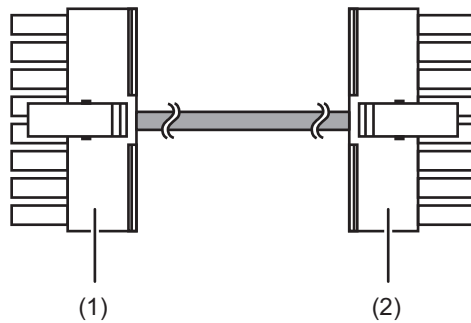
Figure B-2 Cable (PWR) (Between crossbar backplane unit and terminal board)

- Cable (PWR)
Cable for connecting the crossbar backplane unit and terminal board (PWR)

Location number	Component
1	Connector (terminal board (PWR) side)
2	Connector (crossbar backplane unit side)

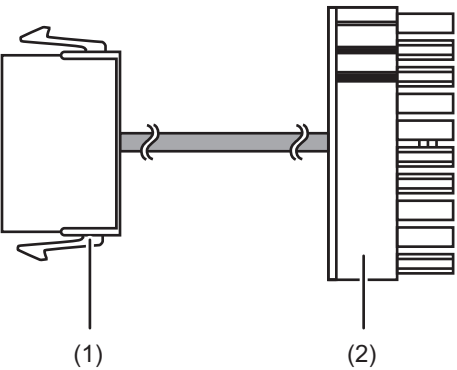
Figure B-3 Cable (PWR) (Between terminal board and fan backplane)

- Cable (PWR)
Cable for connecting the terminal board and fan backplane (PWR)

Location number	Component
1	Connector (terminal board side)
2	Connector (fan backplane (PWR) side)

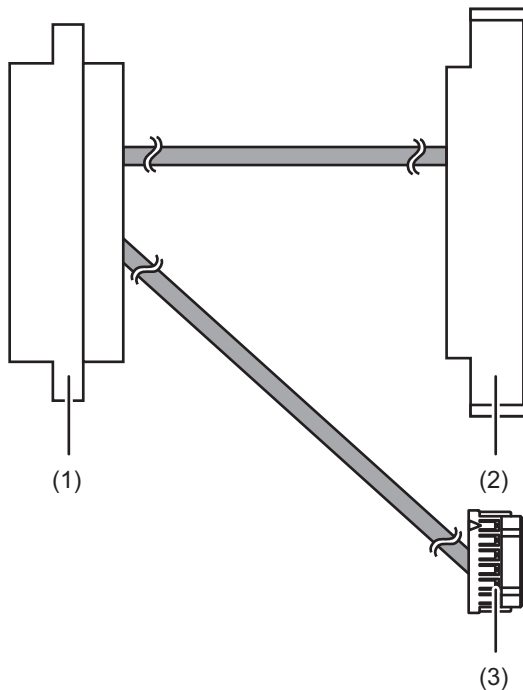
Figure B-4 Cable (SIG) (Between terminal board-fan backplane and operation panel)

- Cable (SIG)
Cable for connecting the terminal board and fan backplane (SIG) and operation panel

Location number	Component
1	Connector (terminal board side)
2	Connector (fan backplane (SIG) side)
3	Connector (operation panel side)

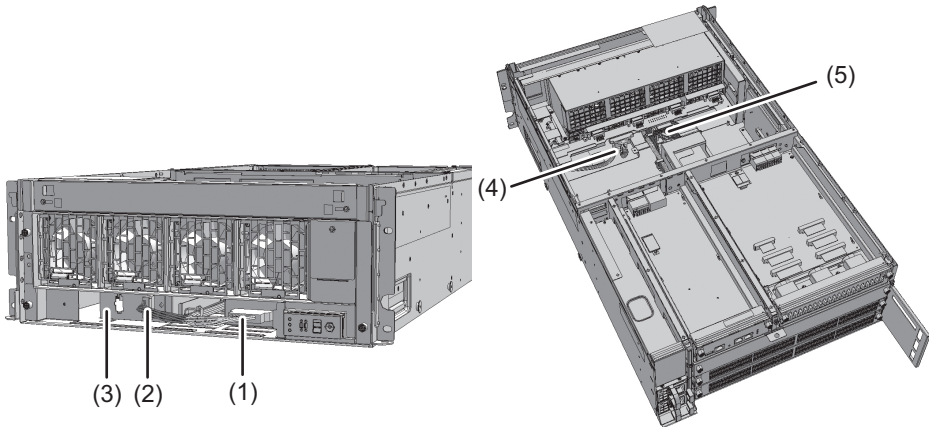
Figure B-5 Location of cable kit

The connection positions of the cable kit are as follows.

Location number	Component	Connection
1	Cable (SIG)	Crossbar backplane unit and terminal board (SIG)
2	Cable (PWR)	Crossbar backplane unit and terminal board (PWR)
3	Terminal board	
4	Cable (SIG)	Terminal board (SIG) and fan backplane
5	Cable (PWR)	Terminal board (PWR) and fan backplane

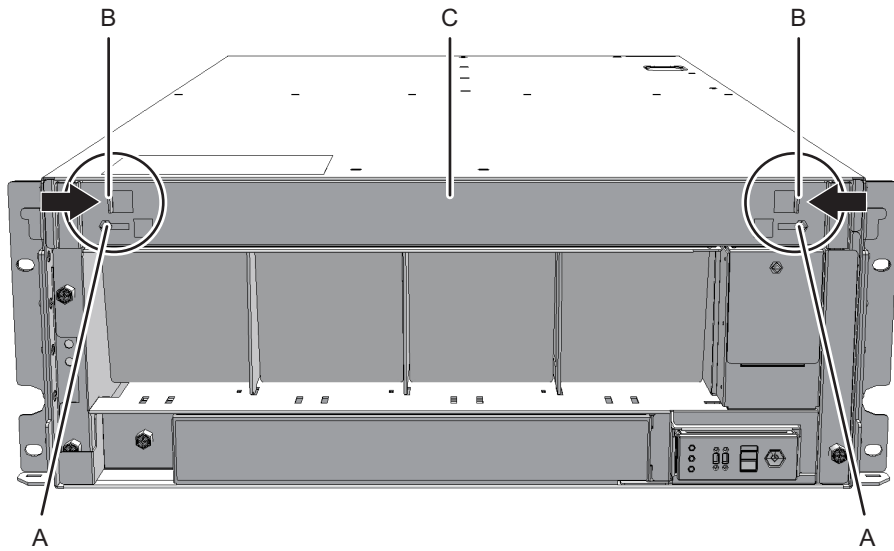
Figure B-6 Removing upper cover

1. **Remove the front cover.**
For details, see "5.4.3 Removing front cover."
2. **Remove all the fan units.**
For details, see "19.4 Removing Fan Unit."
3. **Loosen two screws (A in the figure) of the upper cover and slide the right and left stoppers (B in the figure) inward. Then, remove the upper cover (C in the figure).**

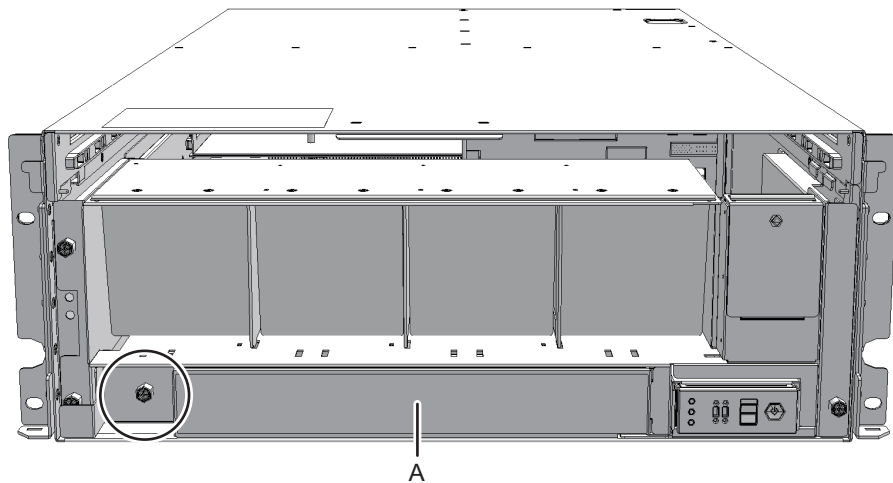
Figure B-7 Removing lower cover

4. Loosen one screw (A in the figure) of the lower cover and slide the lower cover to the left to remove it.

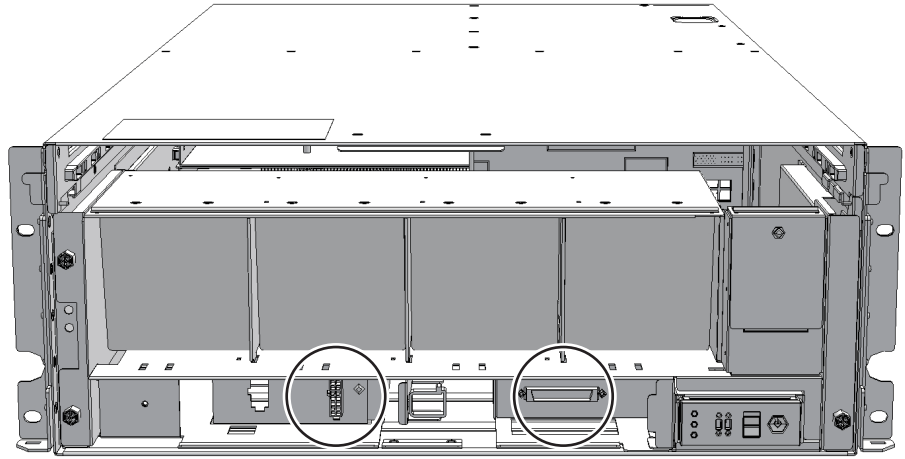
Figure B-8 Removing cables

5. Remove the two cables connected to the fan shelf from the connectors. Arrange the removed cables in the center.

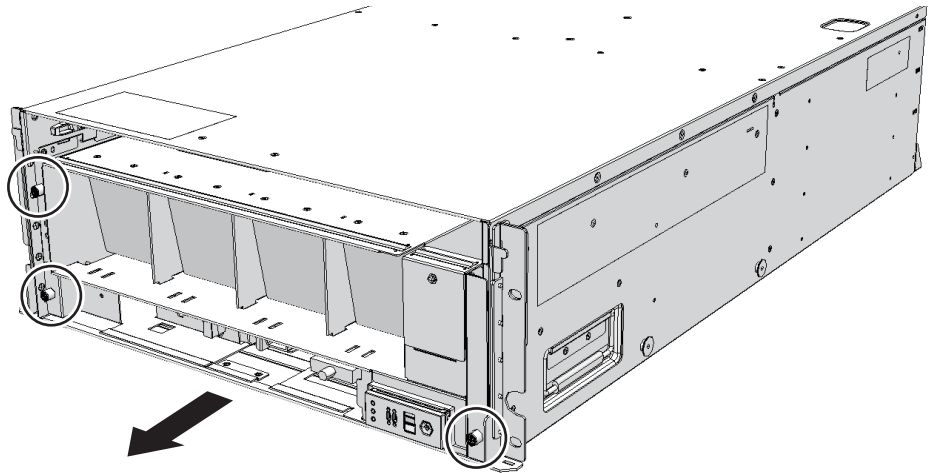
Figure B-9 Removing fan shelf

6. **Loosen three screws of the fan shelf and partially pull out the fan shelf.**

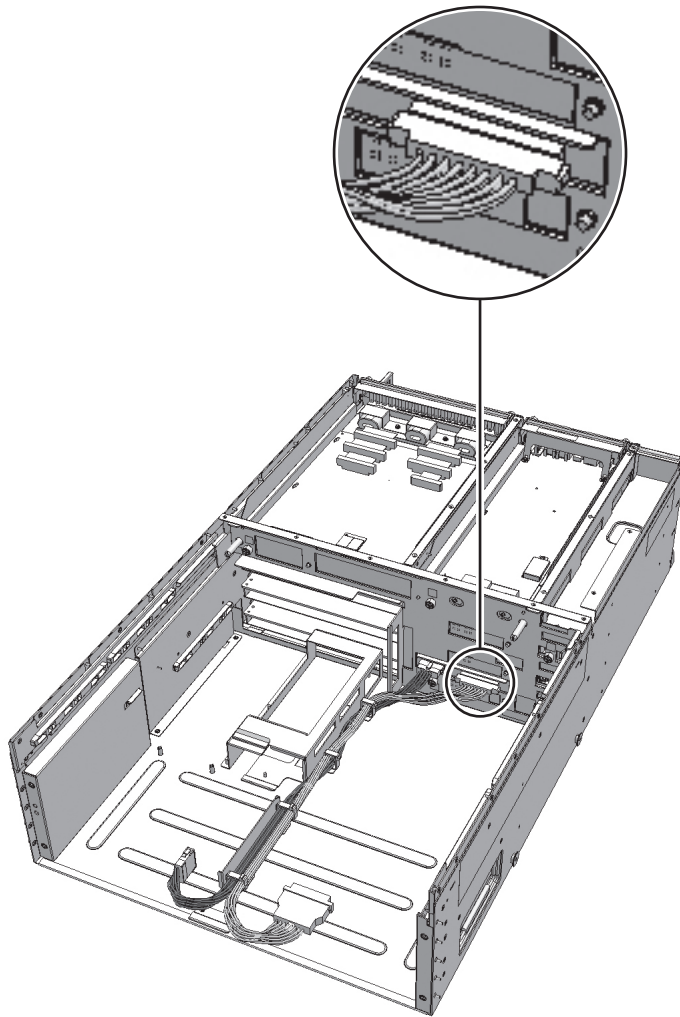
Figure B-10 Removing cable (cable (SIG))

8. **Remove the cable connected to the crossbar backplane unit from the connector.**

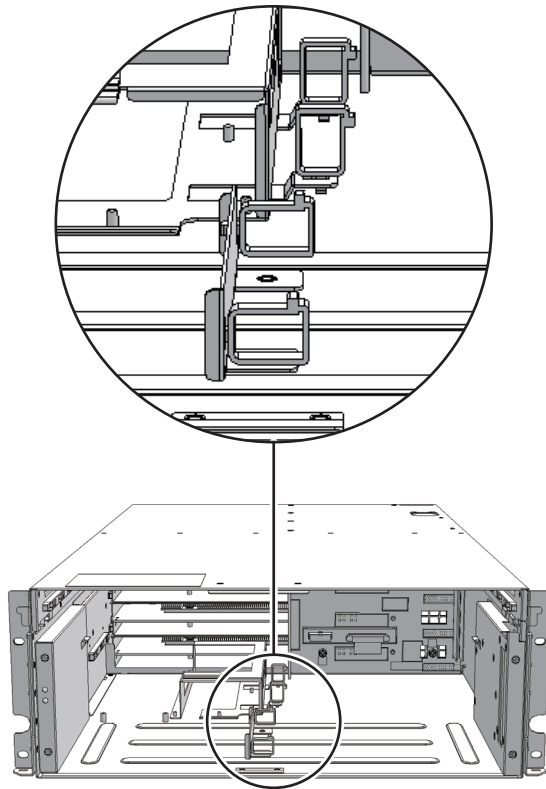
Figure B-12 Removing cables

9. **Remove the cable from the clamps.**

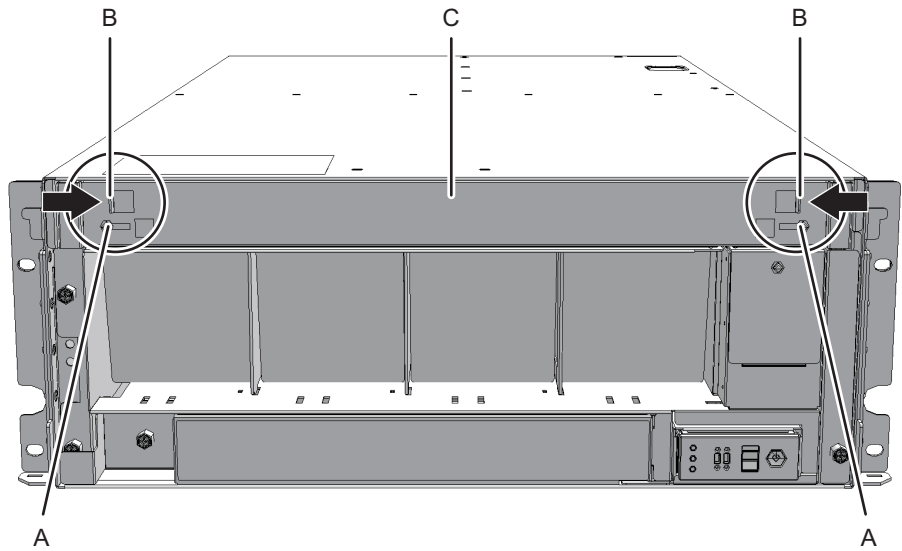
Figure B-13 Removing upper cover

1. **Remove the front cover.**
For details, see "5.4.3 Removing front cover."
2. **Remove all the fan units.**
For details, see "19.4 Removing Fan Unit."
3. **Loosen two screws (A in the figure) of the upper cover and slide the right and left stoppers (B in the figure) inward. Then, remove the upper cover (C in the figure).**

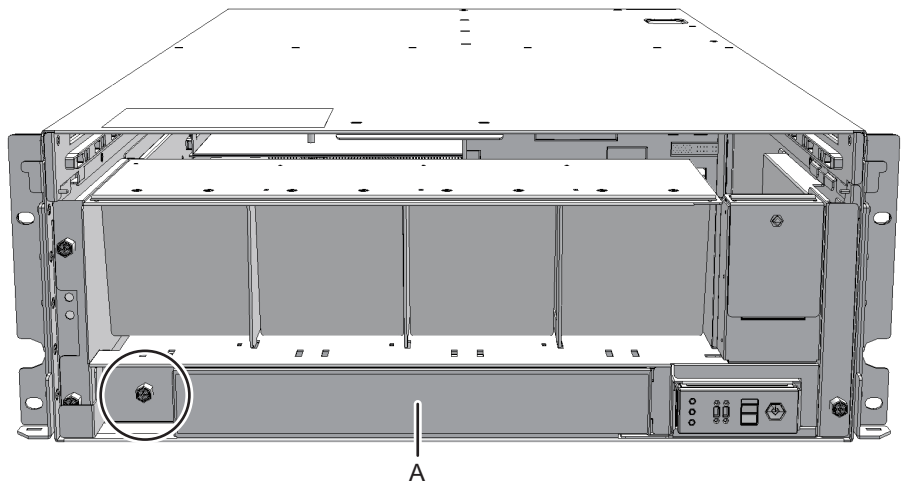
Figure B-14 Removing lower cover

4. **Loosen one screw (A in the figure) of the lower cover and slide the lower cover to the left to remove it.**

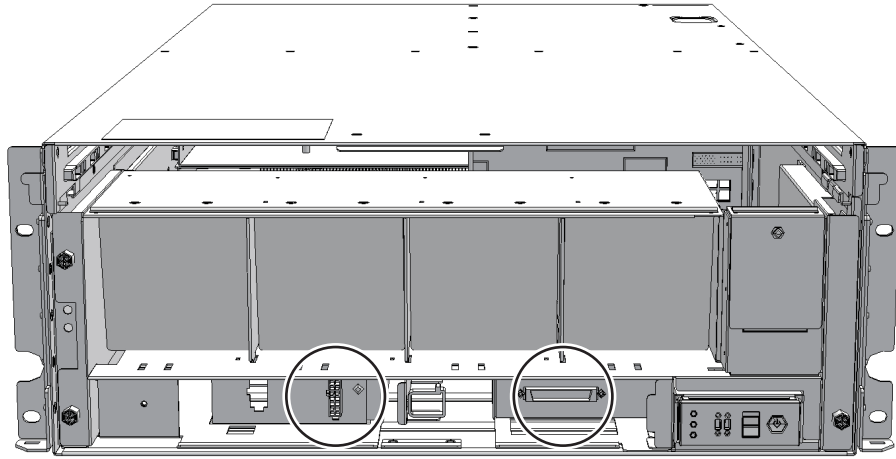
Figure B-15 Removing cables

5. **Remove the two cables connected to the fan shelf from the connectors. Arrange the removed cables in the center.**

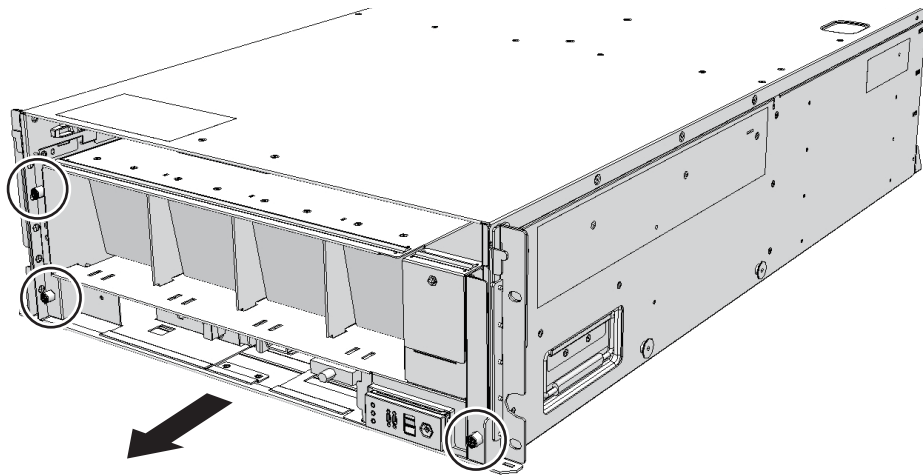
Figure B-16 Removing fan shelf

6. **Loosen three screws of the fan shelf and partially pull out the fan shelf.**

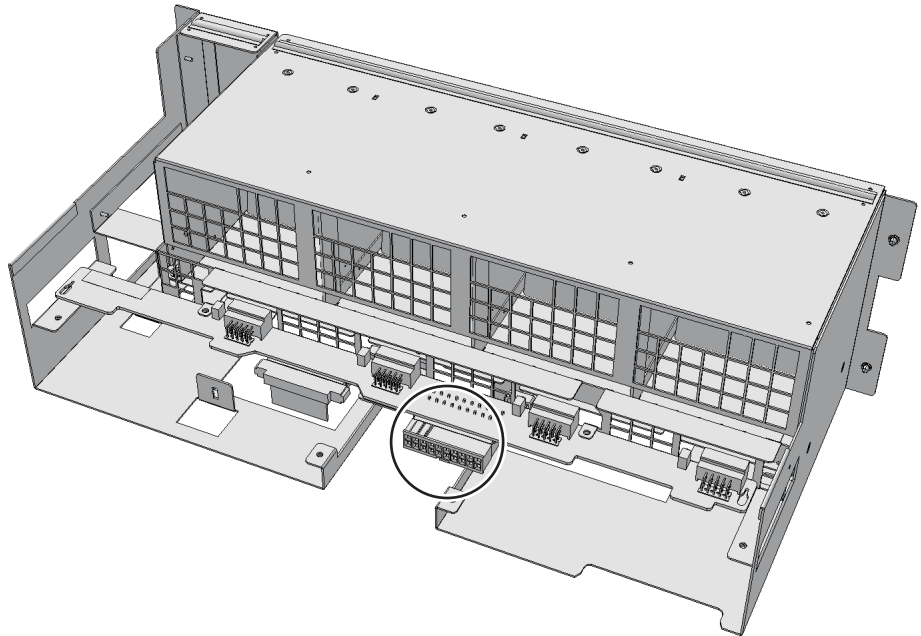
Figure B-17 Removing cable (cable (PWR))

8. **Remove the cable connected to the fan backplane from the connector.**

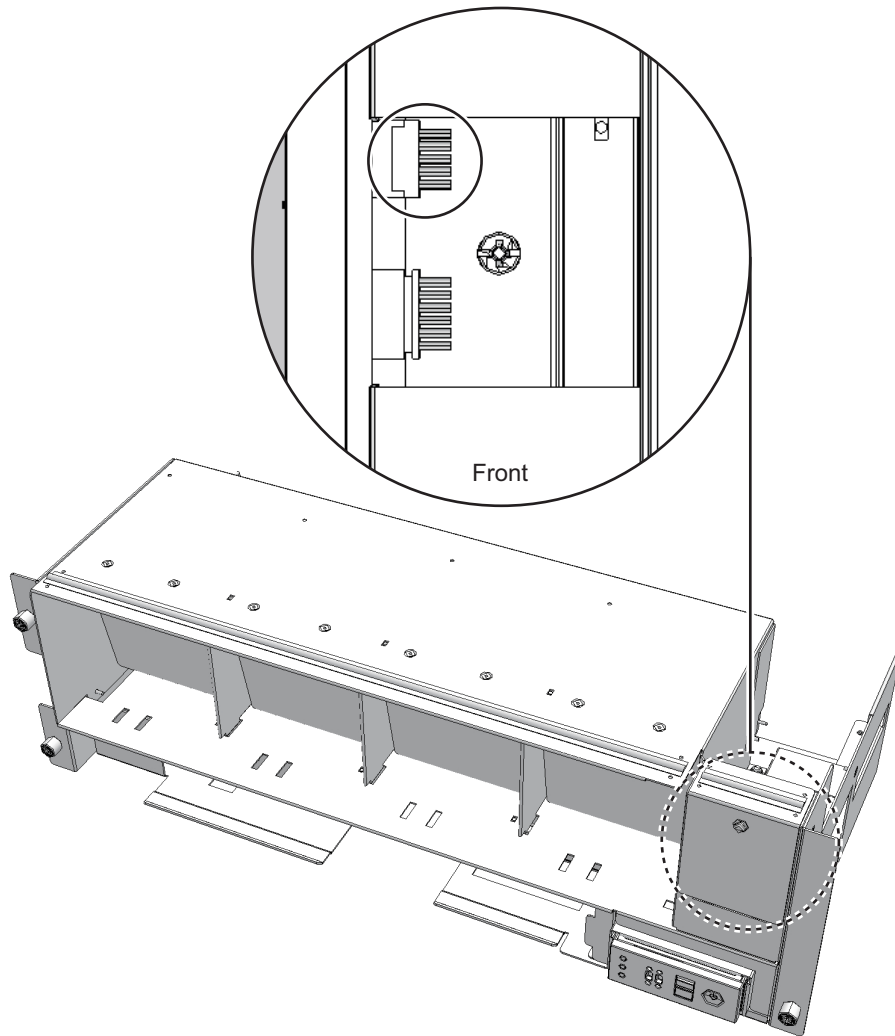
Figure B-19 Operation panel cables

9. Remove the cable connecting the fan shelf and operation panel from the

connector on the operation panel side.

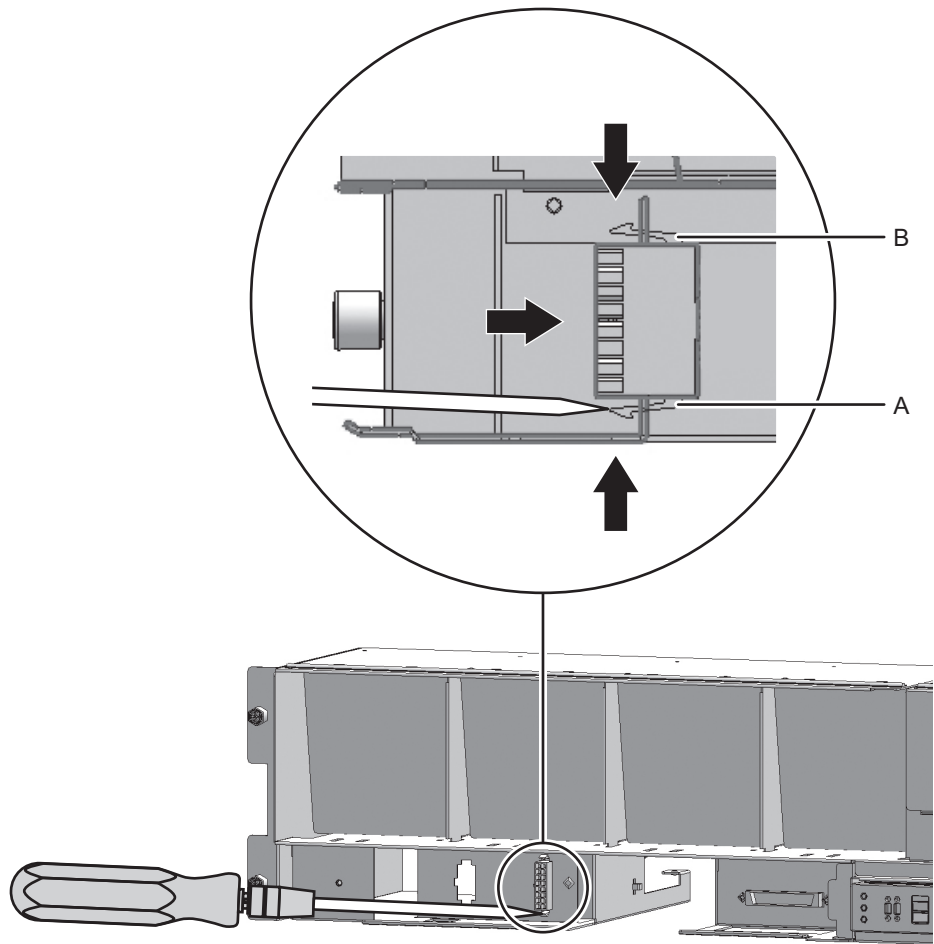
Figure B-20 Removing cable (cable (PWR))

10. **Remove the cable from the terminal board.**
 - **For the cable (PWR), push the connector toward the far end, while pushing the lower latch (A in the figure) upward with a flathead screwdriver. Confirm that the lower latch (A in the figure) is pushed into the inside of the terminal board. Push the connector toward the far end, while pushing the upper latch (B in the figure) downward with the flathead screwdriver.**

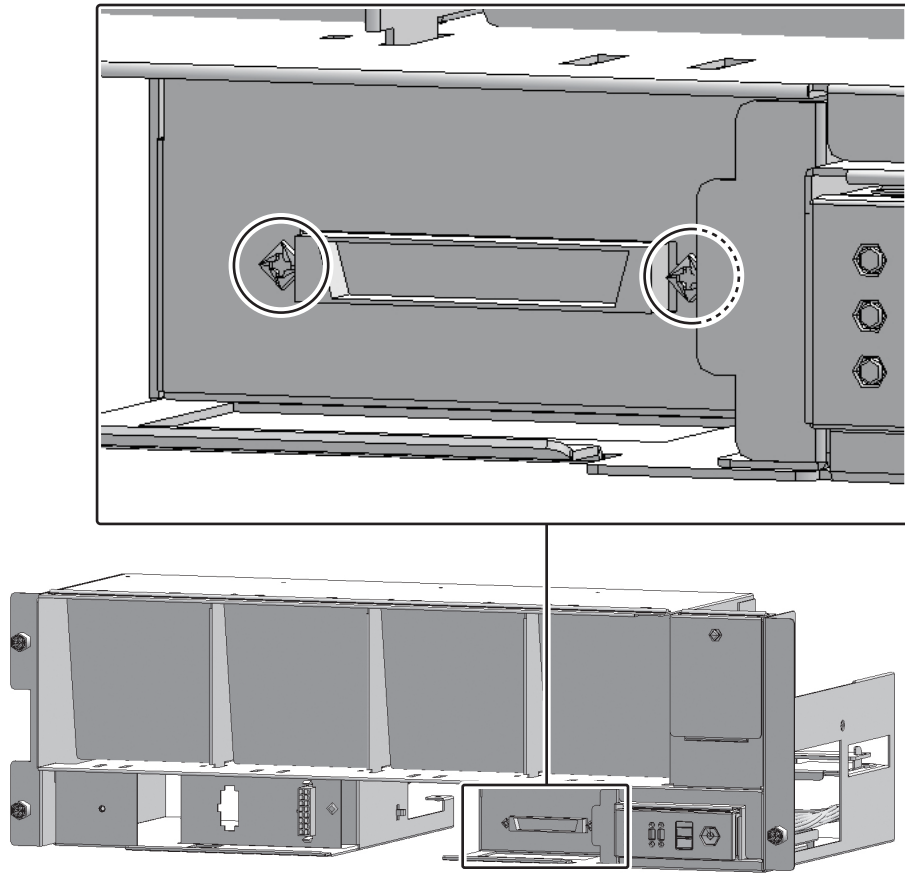
Figure B-21 Removing cable (cable (SIG))

- For the cable (SIG), remove the two screws of the cable connector with a Phillips screwdriver (bit No. 1), and then remove the cable from the terminal board.

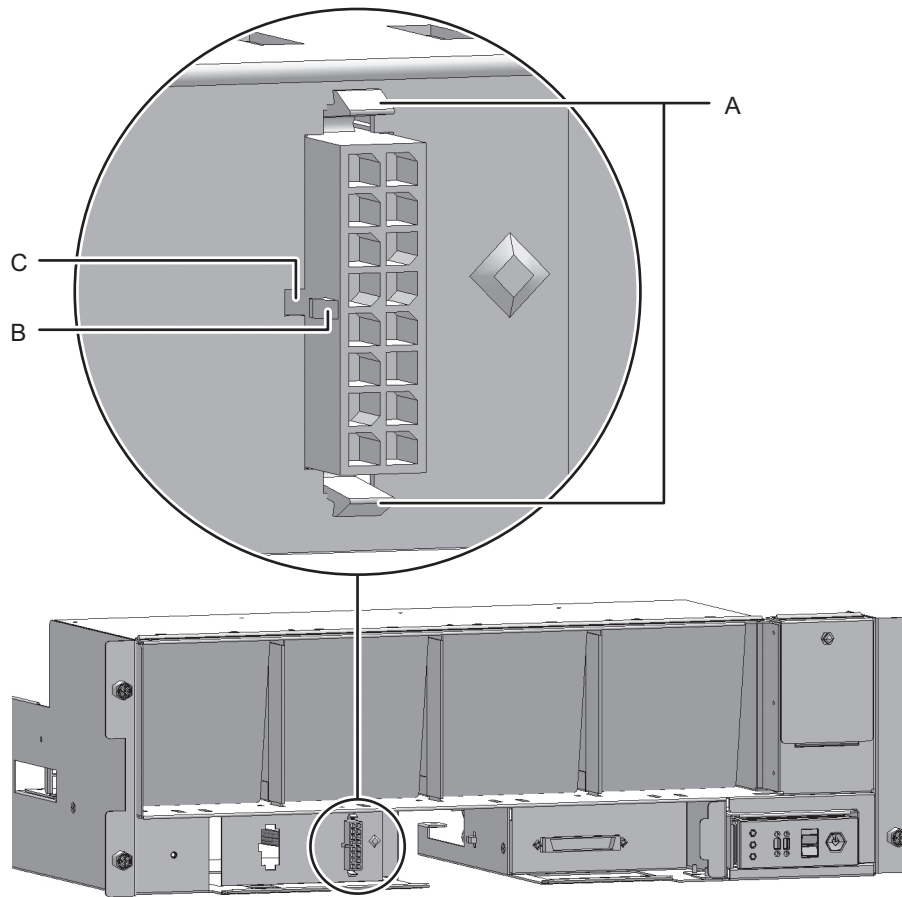
Figure B-25 Installing cable (cable (PWR))

1. **Install the cable on the terminal board.**
 - **For the cable (PWR), install the connector that has latches (A in the figure) on its both ends to the terminal board.**
Install the tab (B in the figure) of the connector to fit it to the notched section (C in the figure) of the terminal board.

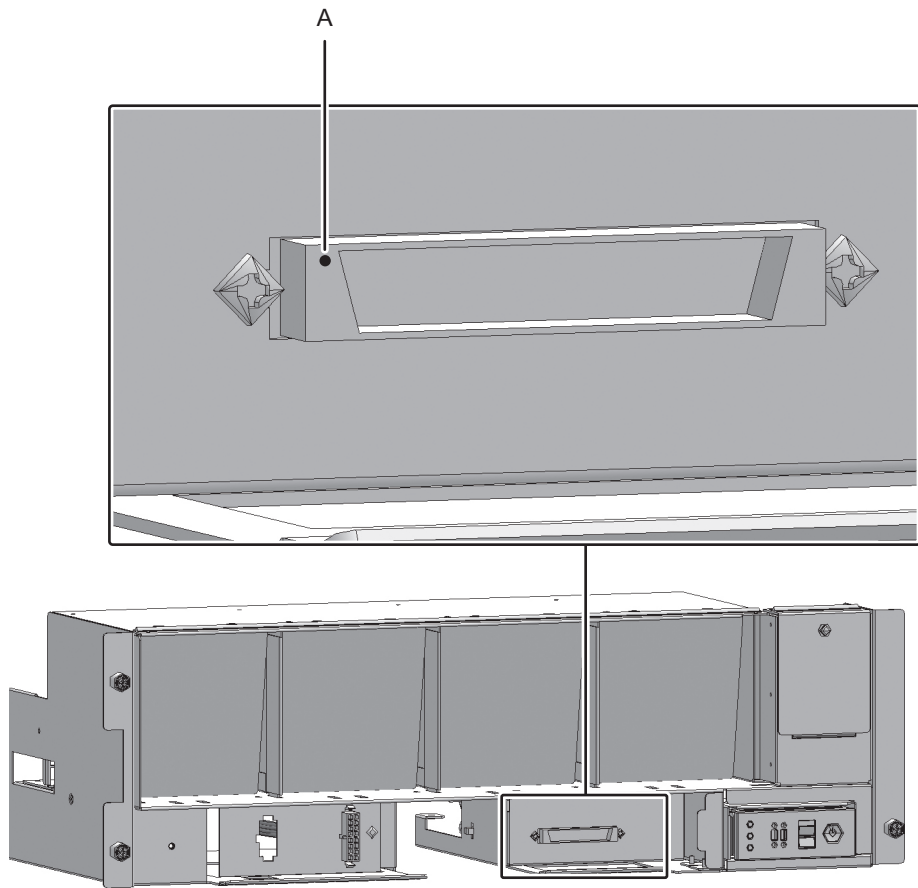
Figure B-26 Installing cable (cable (SIG))

- **For the cable (SIG), install the connector that has a threaded hole on itself to the terminal board.**
Use the screw that has been removed from the same location before. Tighten the screw with a Phillips screwdriver (bit No. 1). When installing the connector, orient the connector so that the dot mark (A in the figure) shown in Figure B-26 is to the left.

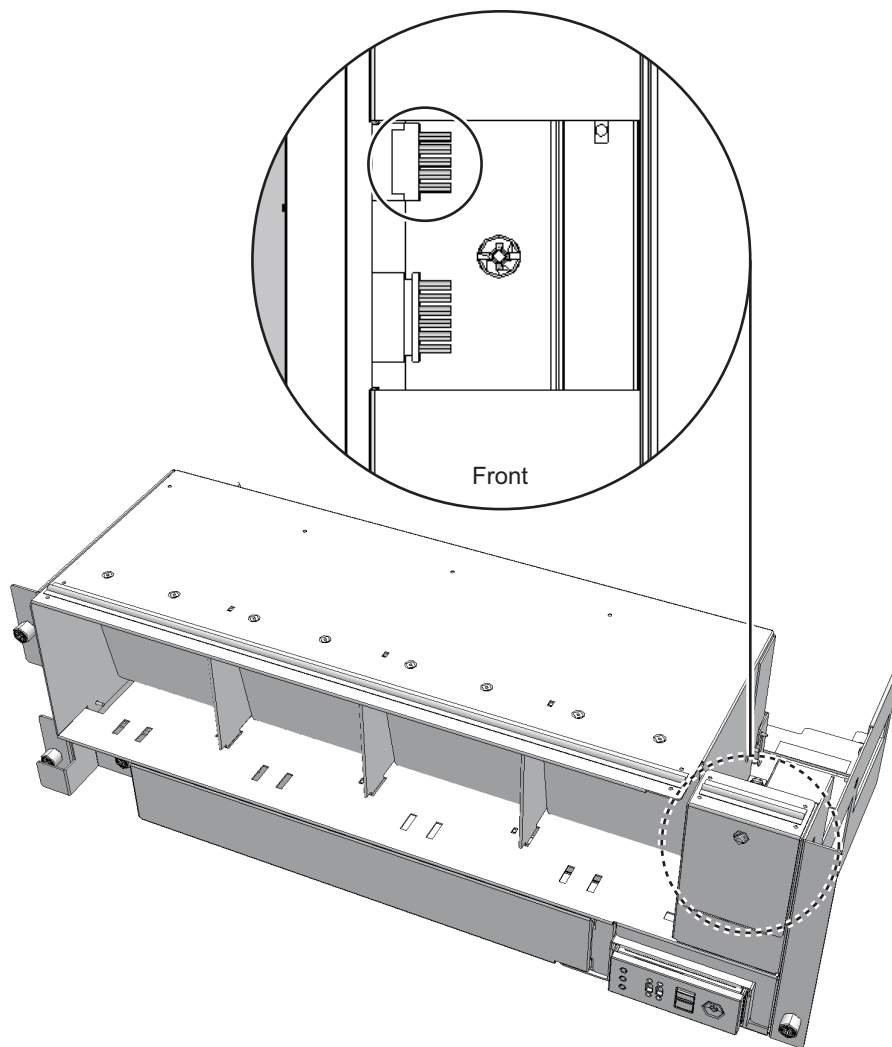
Figure B-27 Operation panel cables

2. **Connect the cable to the connector of the fan backplane.**
3. **Connect the cable connecting the fan shelf and operation panel to the connector on the operation panel side.**

Perform this step only when you install the cable (SIG).
